## D/DRC Case

1817 Pickens Street

**DESIGN/DEVELOPMENT REVIEW COMMISSION**  
**DESIGN REVIEW DISTRICT**  
**HISTORIC AGENDA**  
**EVALUATION SHEET**  
Case # 1

**NATURE OF REQUEST:** Request Certificate of Design Approval for exterior changes

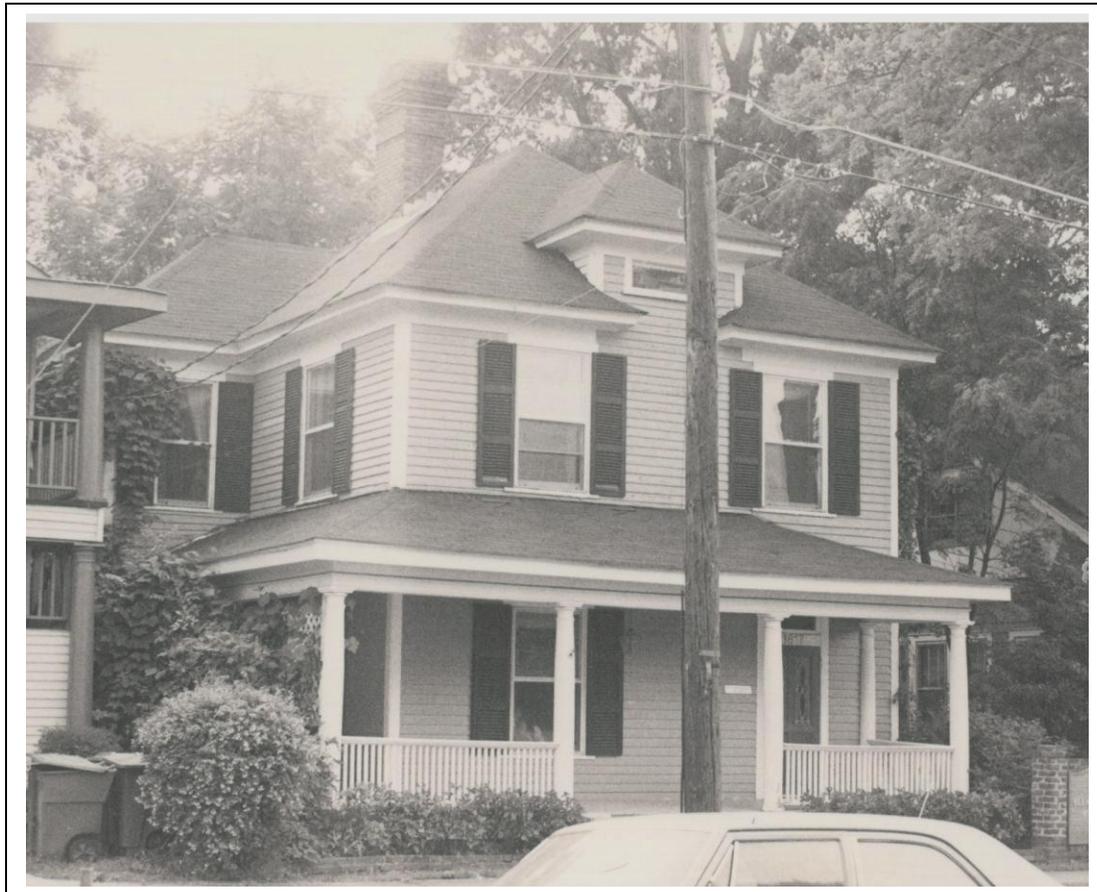
**Above:** 1992 survey photo from city files

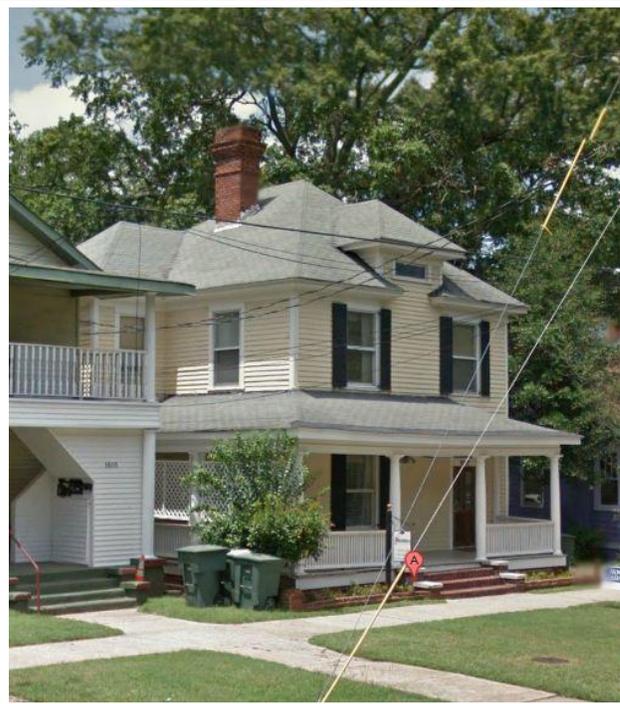
**Right:** Google view of house

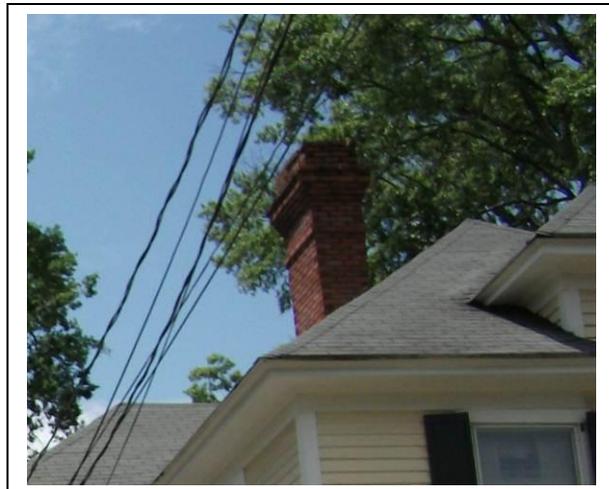
Removing the chimney was an exterior alteration that destroyed historic material that helped characterize the property. This was the only chimney on the roof. Its detailing was consistent with an early twentieth-century chimney type and it was original to the building. It was the most ornate chimney of its neighbors facing Pickens Street. Its removal does not meet this guideline.

**Below:** Staff photo of chimney, 2011

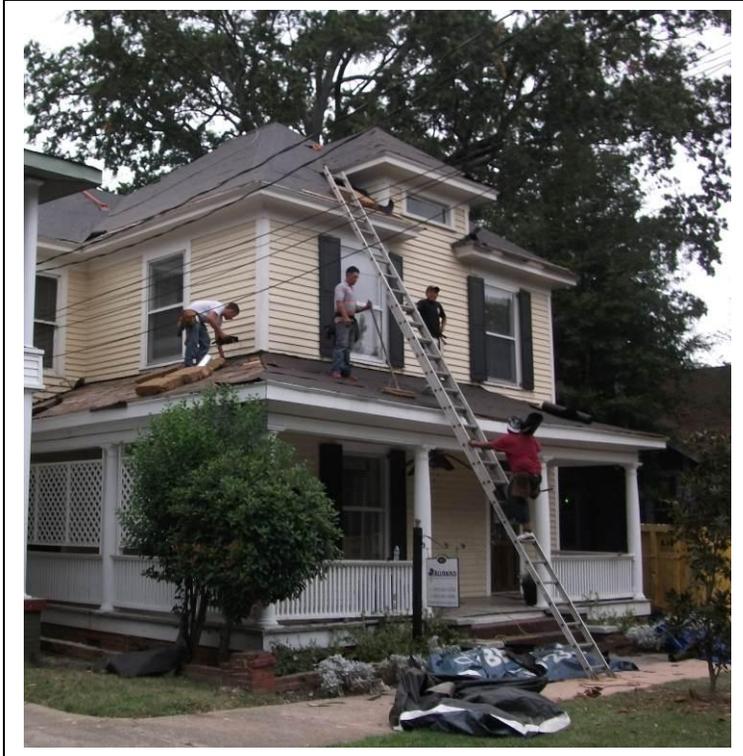
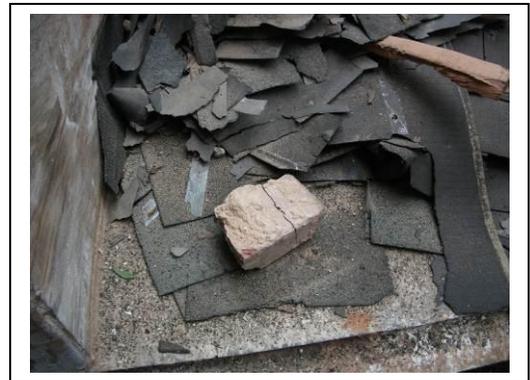
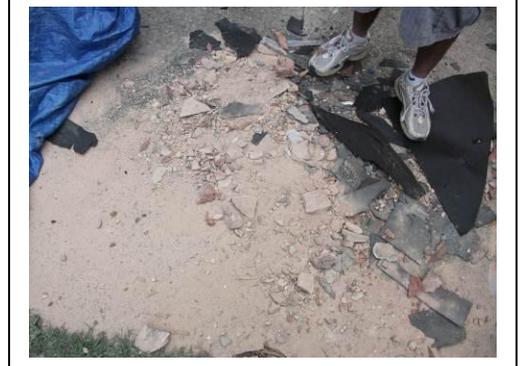
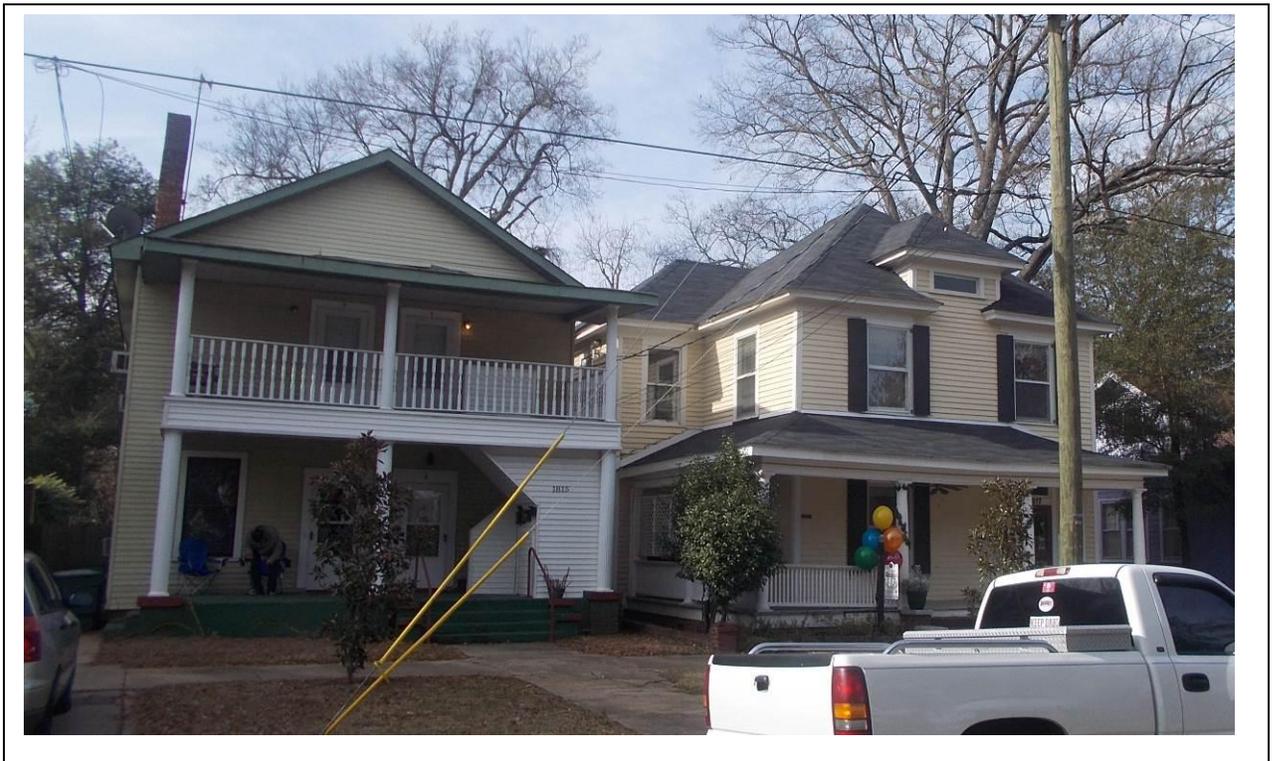
Staff received a complaint about a chimney being demolished at this site on October 14, 2013 and immediately went to the site. There was no permit for work being conducted, which was a re-shingle job for the roof. Staff spoke with the workers on site and with their boss by phone about the need for a permit and for approval from the D/DRC to remove a chimney. At the time staff visited, the chimney was removed completely from the roof plane up; the bricks were in a dumpster. Staff asked to see the bricks, which had been dropped off the roof and were broken. The mortar attached to the bricks was very sandy and flaked off easily. The bricks were oversized, but probably typical for the era.

Images above by staff show the work conducted on the roof, the mortar and brick dust and broken brick resulting from the drop of materials from the roof onto a concrete sidewalk, and the building as it looks today.

Staff recommends that to comply with Section 17-674(d) of the City Code of Ordinances that the chimney be rebuilt exactly, within a period of 120 days.

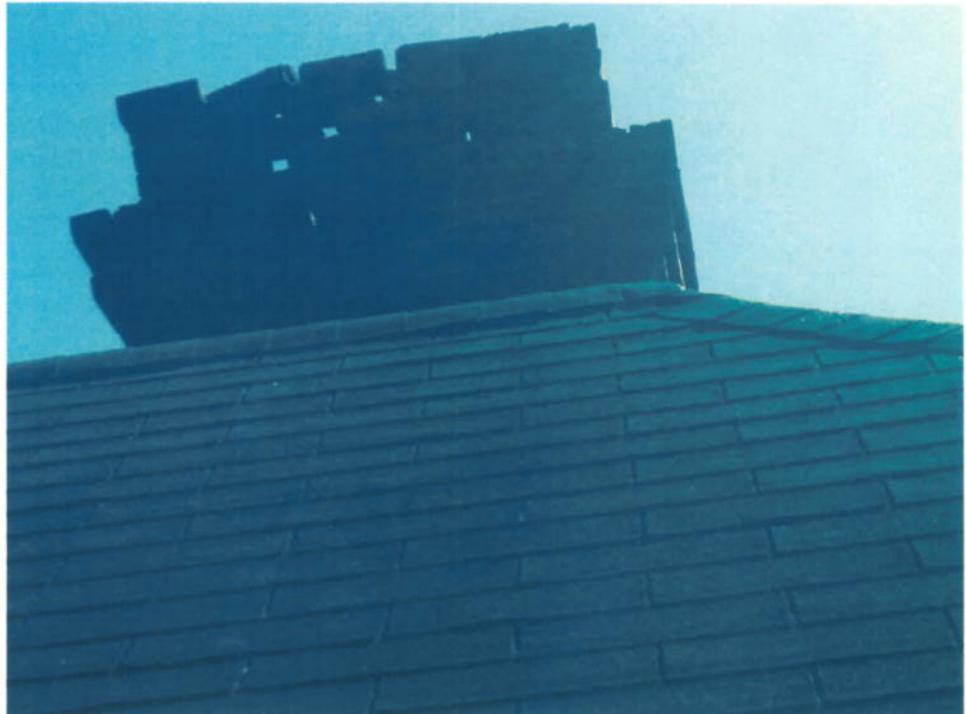
This guideline requires the repair of deteriorated features. The applicant has provided one photograph showing some mortar loss in the top courses of the chimney. Chimneys typically deteriorate from the top down because the soft lime mortar loses its binders over the years from rain water. Mortar has a life span and must be re-applied after several decades; this is a normal maintenance process for historic masonry. The mortar on this chimney was not repaired when it showed signs of deterioration.

The severity of the deterioration of this chimney could not be assessed by staff because it was completely removed by the time staff arrived at the site. The photograph from the applicant and staff's view of the sandy mortar indicates that there were areas of deterioration at the top courses of the chimney due to mortar loss, but there does not seem to be any indication that the bricks themselves were deteriorated or that the mortar loss continued further down than the top few courses. The chimney should have been repaired with new mortar and with re-pointing for deteriorated joints to comply with this guideline.

During repairs, they presented me a picture of the "chimney" (picture below) which you can plainly see was not active and falling apart. Since this chimney was no longer in use, nor was their any future intent to use it, we decided to "roof over" the chimney part and discard the remaining bricks.
