## D/DRC Case

3848 Wilmot Avenue

**DESIGN/DEVELOPMENT REVIEW COMMISSION**  
**DESIGN REVIEW DISTRICT**  
**HISTORIC AGENDA**  
**EVALUATION SHEET**  
Case # 6

**NATURE OF REQUEST:** Request Certificate of Design Approval for demolition

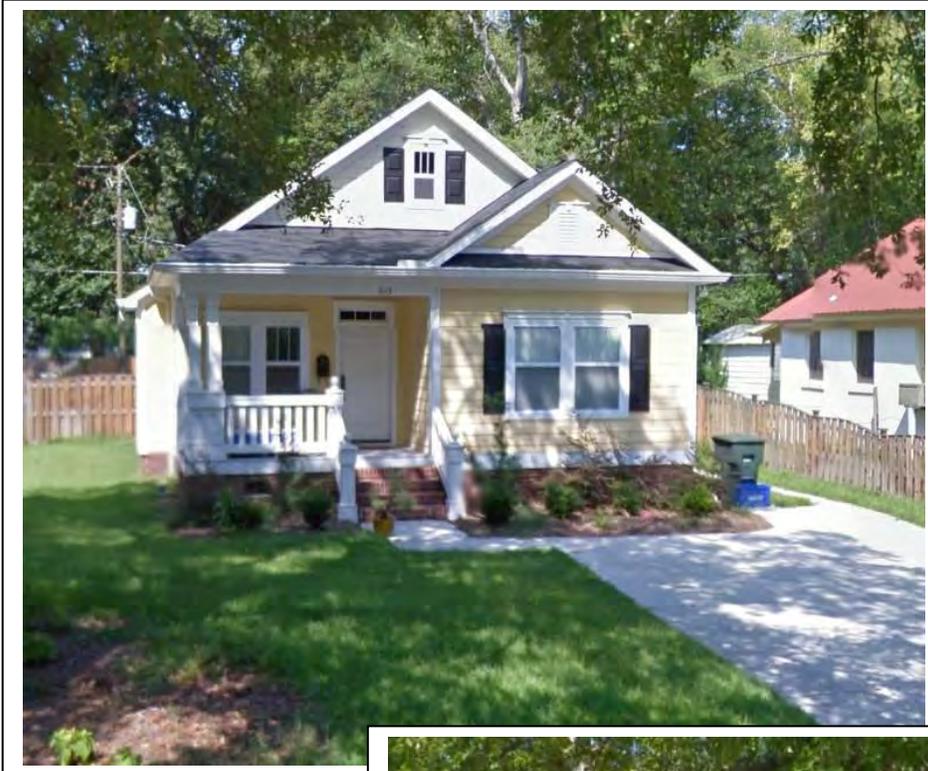
613 Howard Street

This was built by the applicant and her husband and is similar to what is being proposed for 3848 Wilmot Avenue. This is located in Shandon and fits in well with the Bungalows in the area, but it would be out of character for Sherwood Forest.

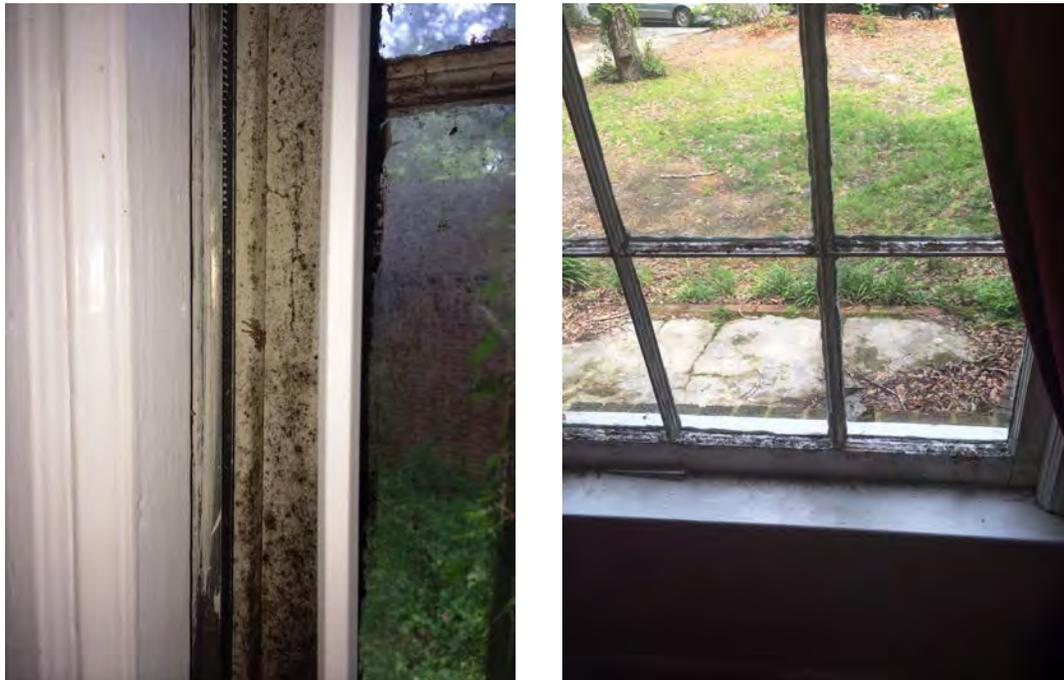
We have completed an inspection of the referenced home and the results of this inspection reveal fungal growth throughout the home on the walls, ceiling and trim. The home is vacant and unconditioned. It is our opinion the fungal growth on the plaster walls and ceilings can be properly remediated. However, the trim and windows will need to be removed and replaced. All the wallpaper in the home should be removed. Fungal growth is typically behind this type wallpaper exposed to these conditions.

**Fungal Growth on Windows and Trim**

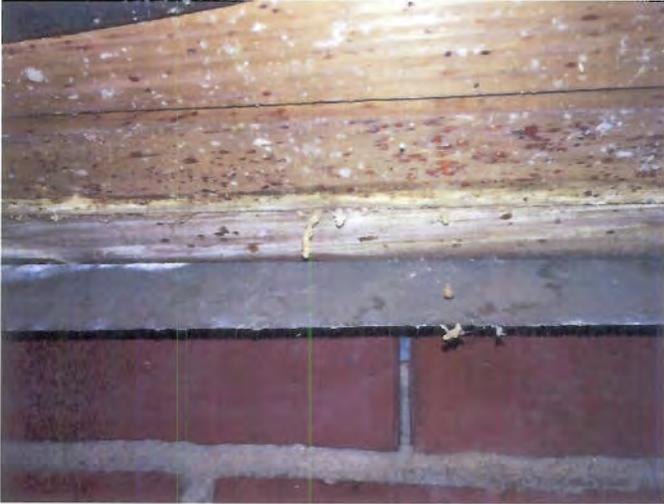
1a). active termites noted at time of this inspection throughout various areas of crawlspace, damages exist. (Recommend structure be treated for the aid and control of termites and repairs be made).

TERMITE DAMAGE/ACTIVITY TO FOUNDATION SILL

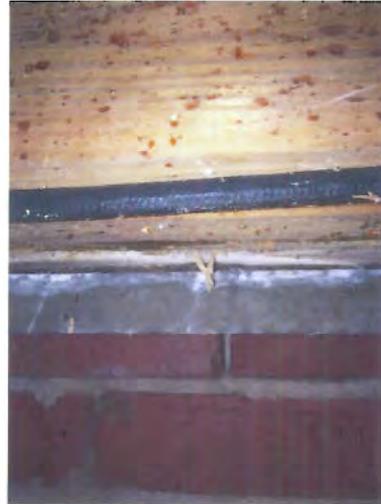
TERMITE DAMAGE/ACTIVITY TO FOUNDATION SILL

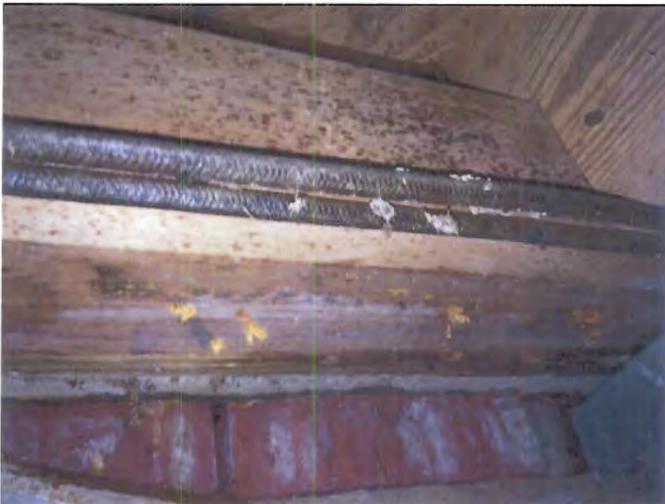
TERMITE DAMAGE/ACTIVITY TO FOUNDATION SILL

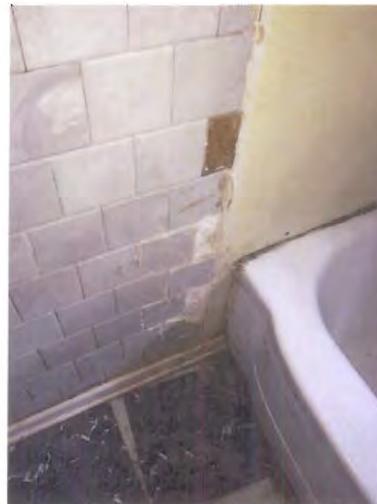
BATHROOM FROM INSIDE

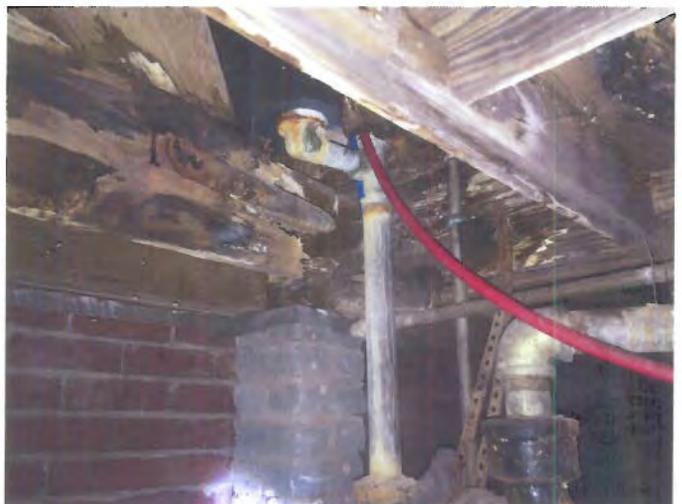
3b). Excessive water damage exist to bathroom subfloor, caused by a previous leak (Repairs Highly recommended).

WATER DAMAGE TO BATHROOM SUBFLOOR

1. Demo bathroom, COMPLETE tear out.
  2. Install new substructure wood members using treated material as needed.
  3. Install new floor and wall coverings, using Contractors grade in stock items ONLY.
  4. Install New prefabbed shower-tub unit.
  5. Install New commode unit, using new flange, Wax seal and supply line.
  6. Remove approximately 20' total of interior foundation sill.
  7. Install New foundation sill using treated material as needed.
- NOTE: This Estimate Doesn't include any plumbing and/or painting (Additional cost \$2200).

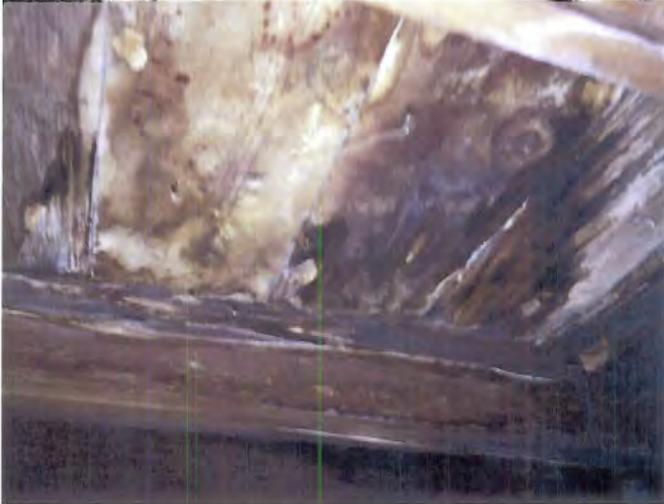
WATER DAMAGE TO BATHROOM SUBFLOOR

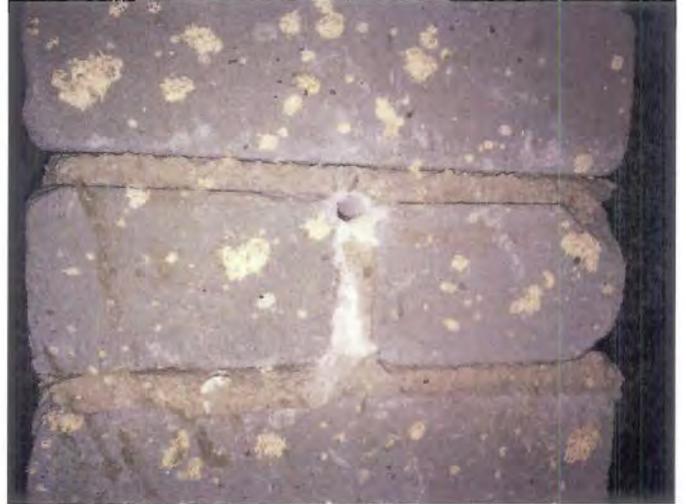
2). Drill holes noted.  
(Continued on next page)

DRILL HOLES NOTED

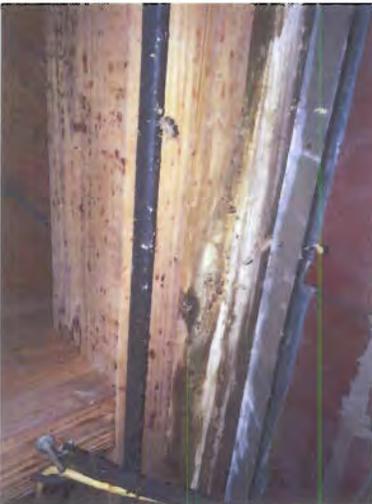
TERMITE DAMAGE/ACTIVITY TO FOUNDATION SILL

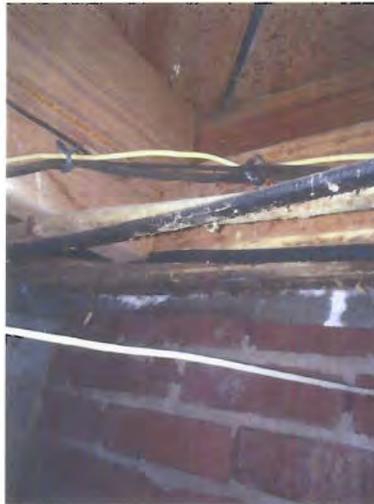
TERMITE DAMAGE/ACTIVITY TO FOUNDATION SILL

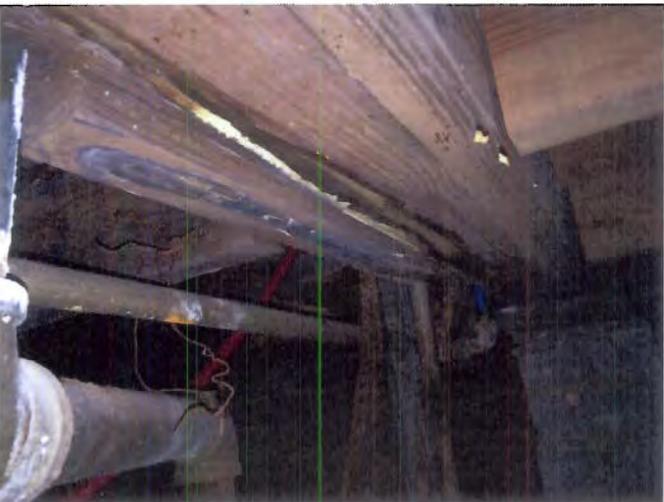
WATER DAMAGE BELOW BATHROOM

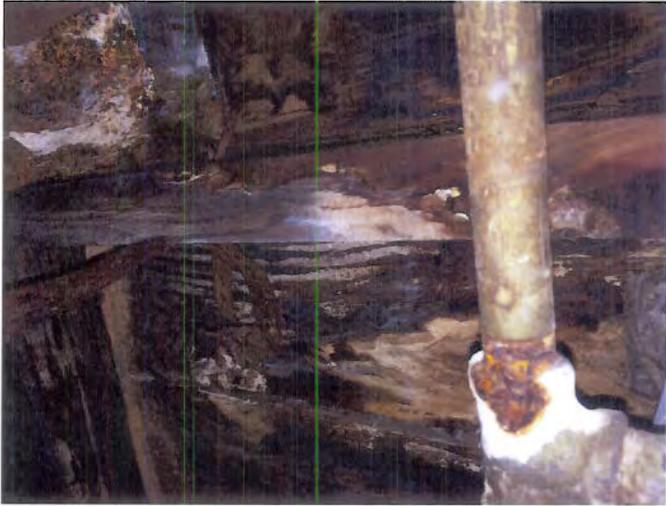
WATER DAMAGE BELOW BATHROOM

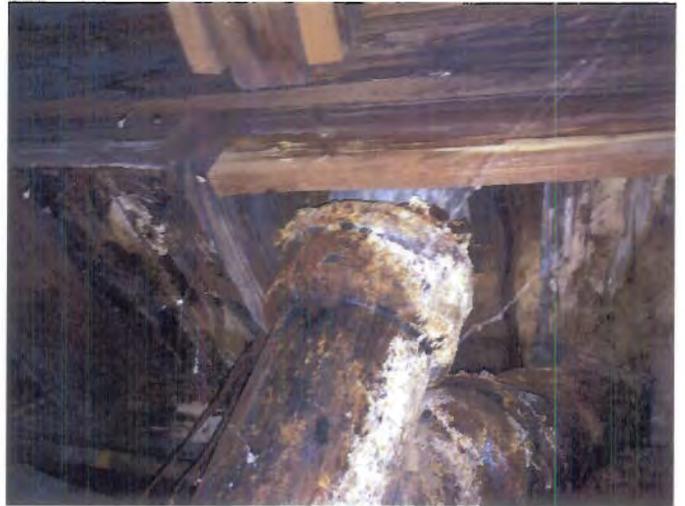
WATER DAMAGE BELOW BATHROOM

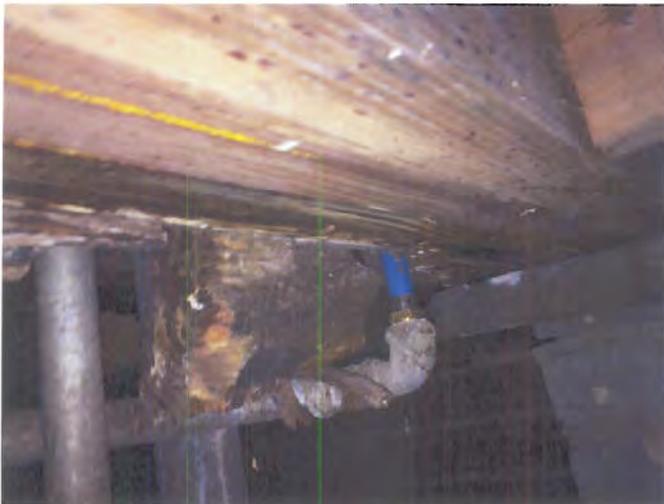
WATER DAMAGE BELOW BATHROOM
