## D/DRC Case

335 S. Edisto Avenue

**DESIGN/DEVELOPMENT REVIEW COMMISSION  
DESIGN REVIEW DISTRICT  
HISTORIC AGENDA  
EVALUATION SHEET  
Case # 3**

**NATURE OF REQUEST:** Request Certificate of Design Approval for demolition

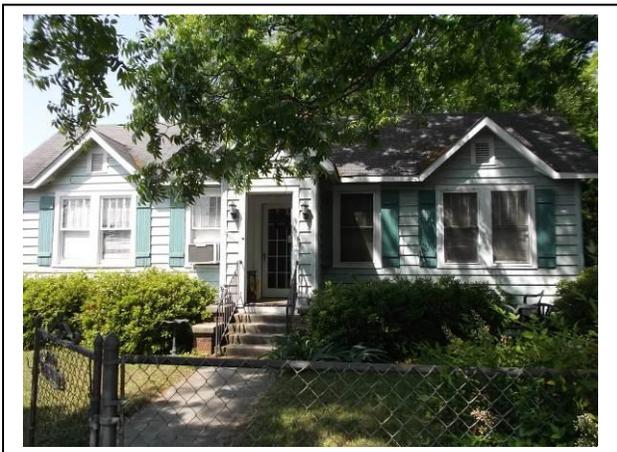
Central portion is failing addition

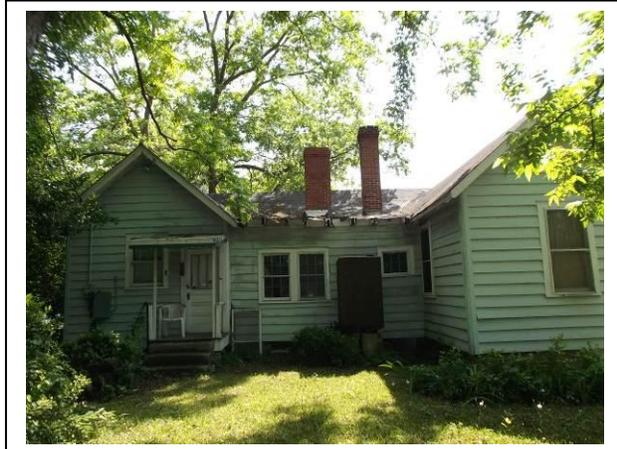
Worst area of siding disrepair, on left side

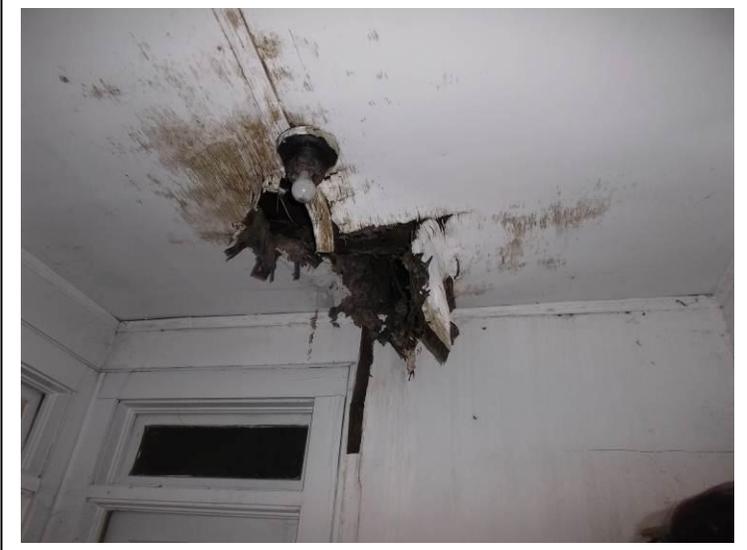
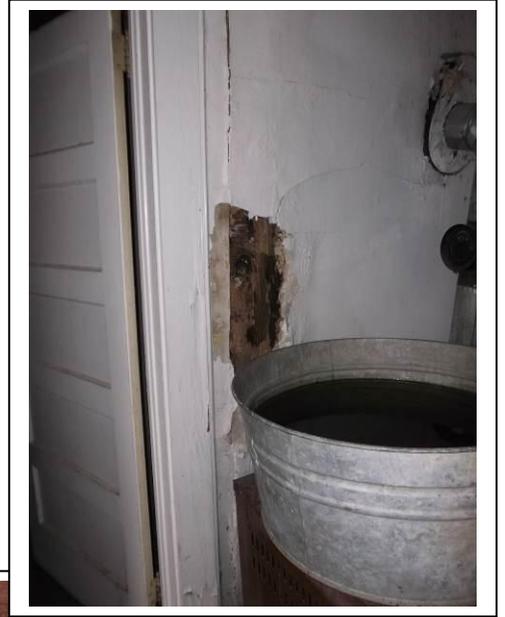
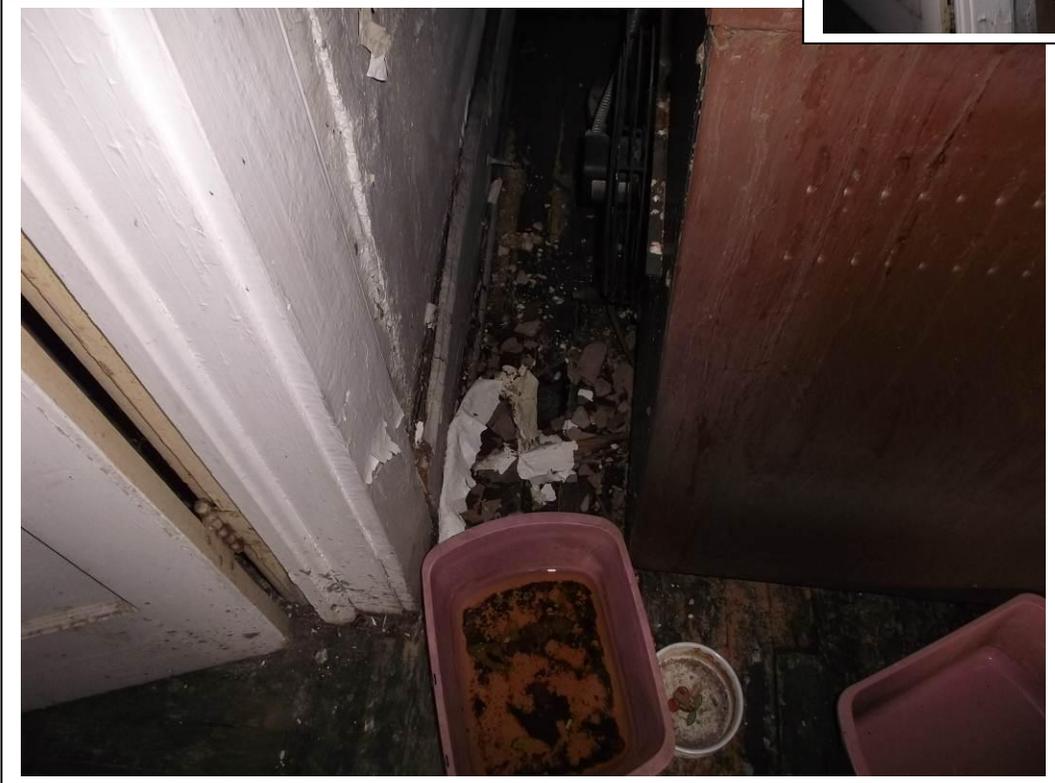
Hallway: The ongoing leak from the roof has left the ceiling (top image) damaged. A basin sitting on top of the oil furnace (top left) catches rain water. The water has damaged the floor in the hallway (bottom). Staff photos

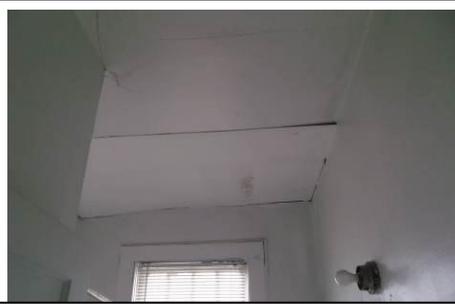
Bathroom ceiling, old repair

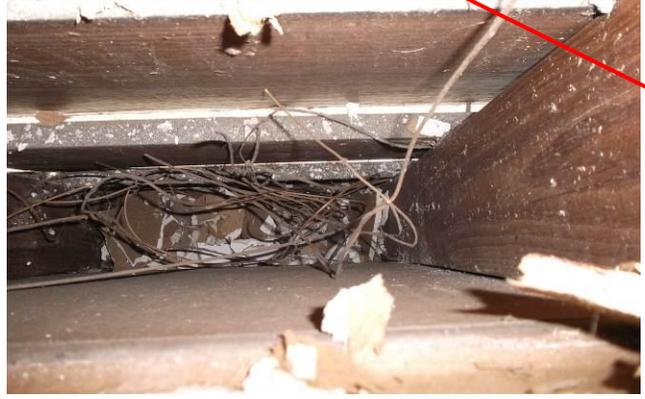
Looking into wall hole made by contractor, debris but no termite or water damage visible

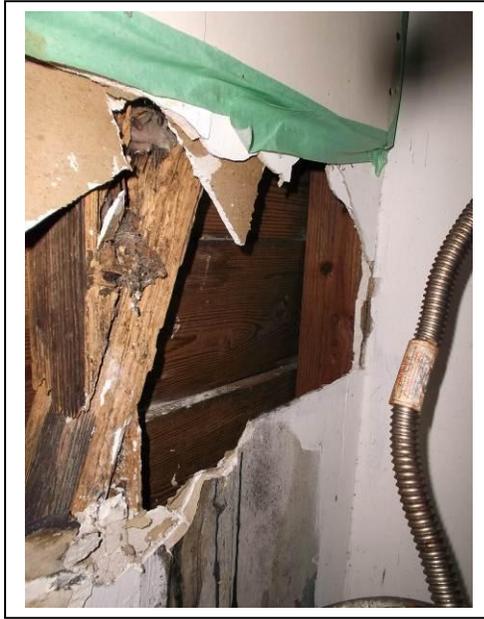
Above: One water damaged stud between two intact studs in kitchen, at water heater, in newly created hole. Staff photo

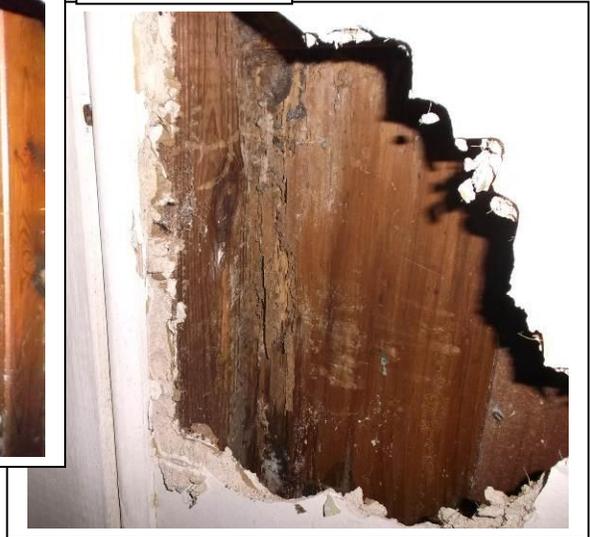
Left: Image of collapsed roof in addition  
Above: Adjacent wall to addition showing termite damage in stud

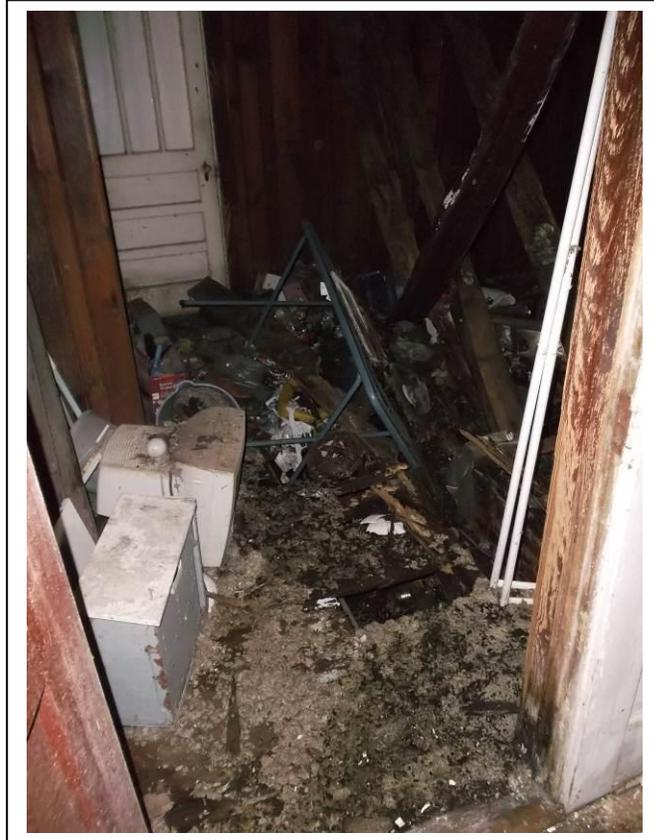
Collapsed floor in addition

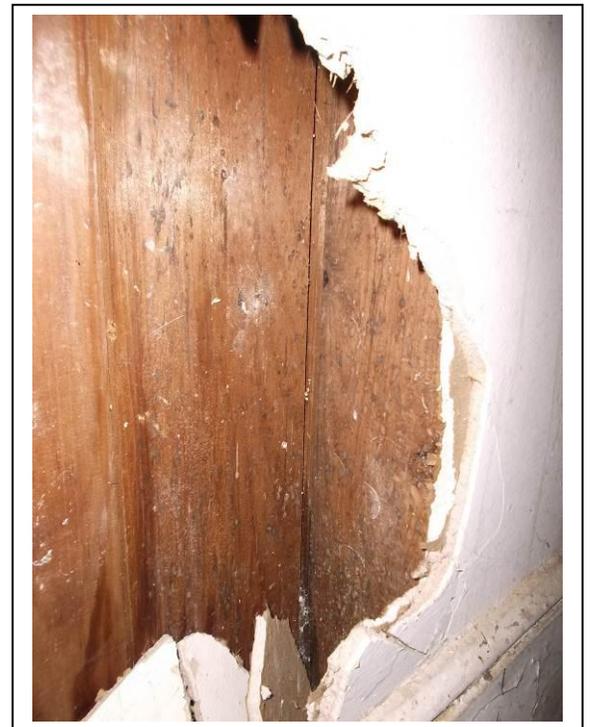
Sound stud and wall adjacent to collapsed addition

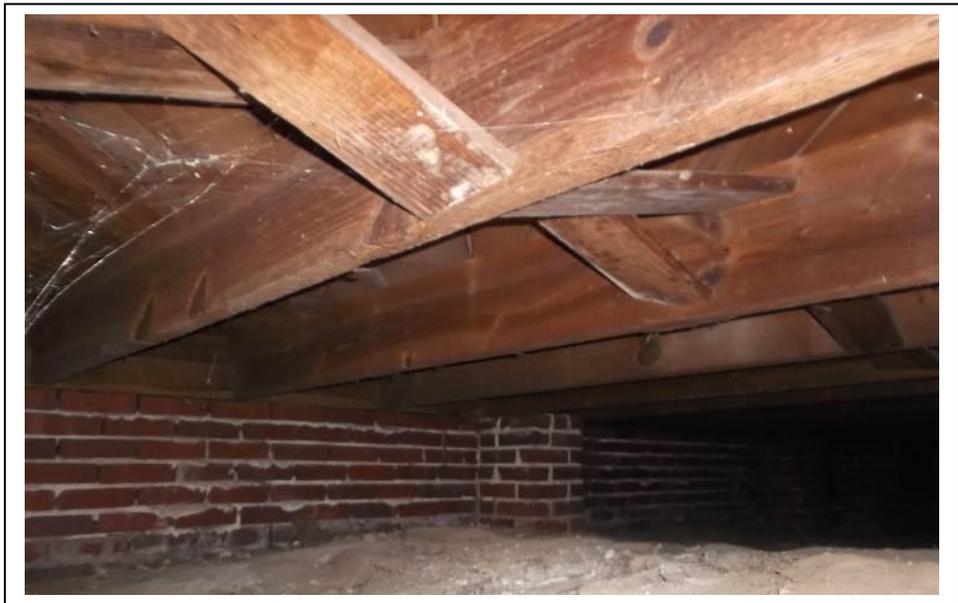
Below: view under the floor showing intact joists, bracing and subfloor

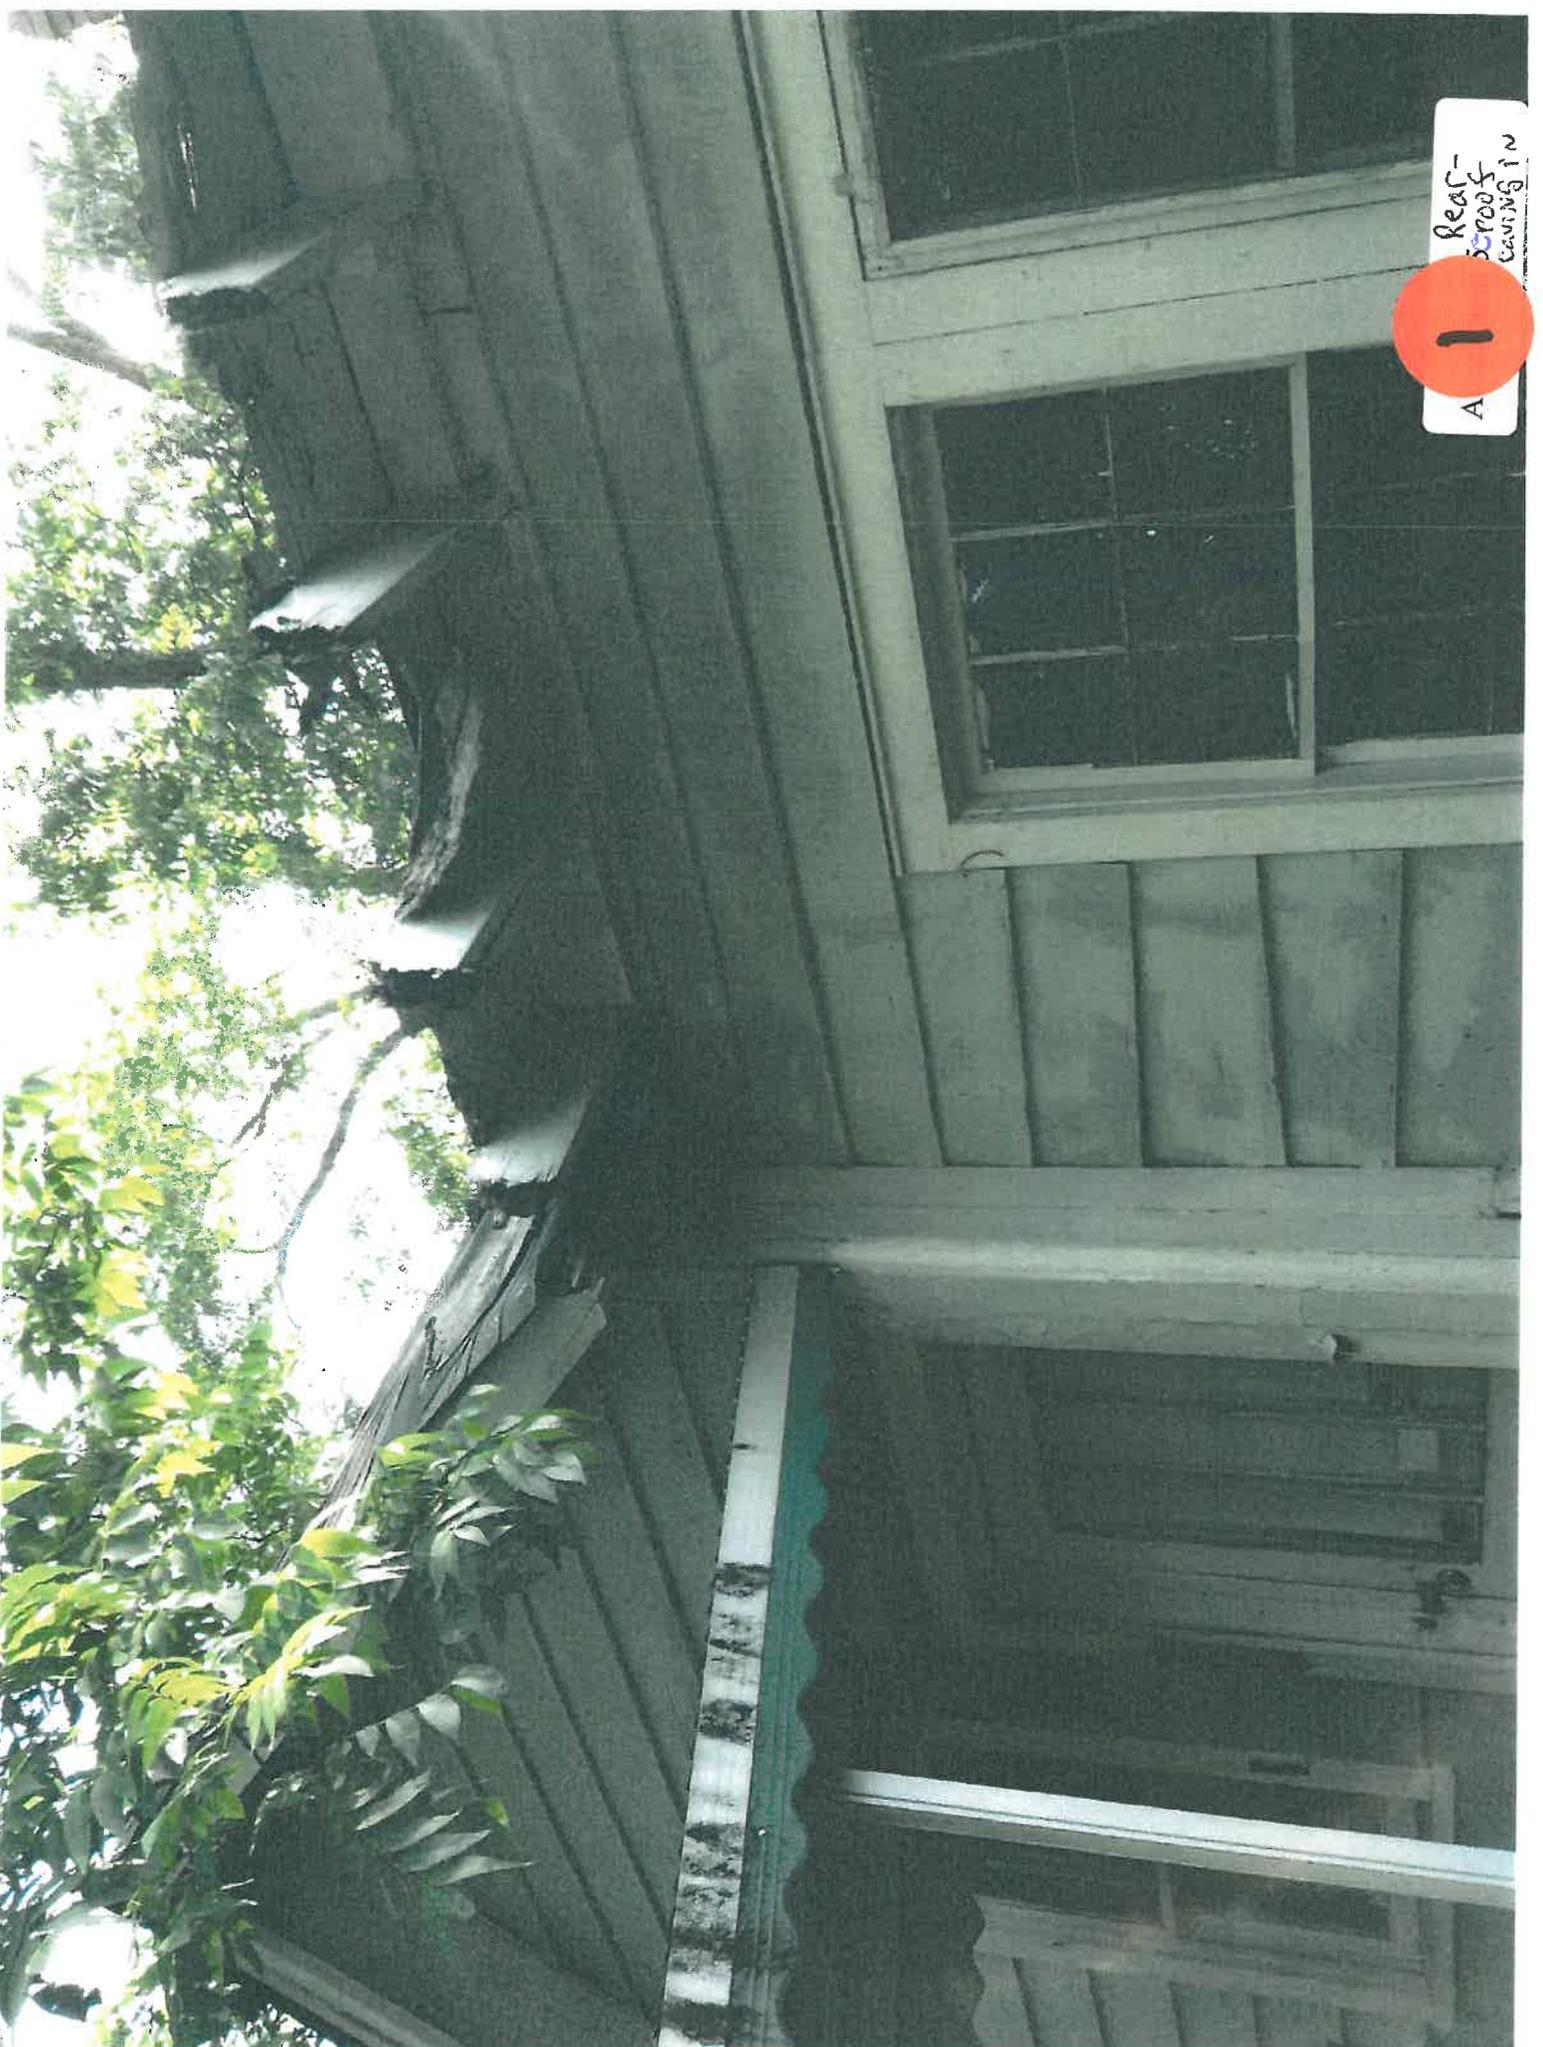
1 rear-roof screening in

Rear addition

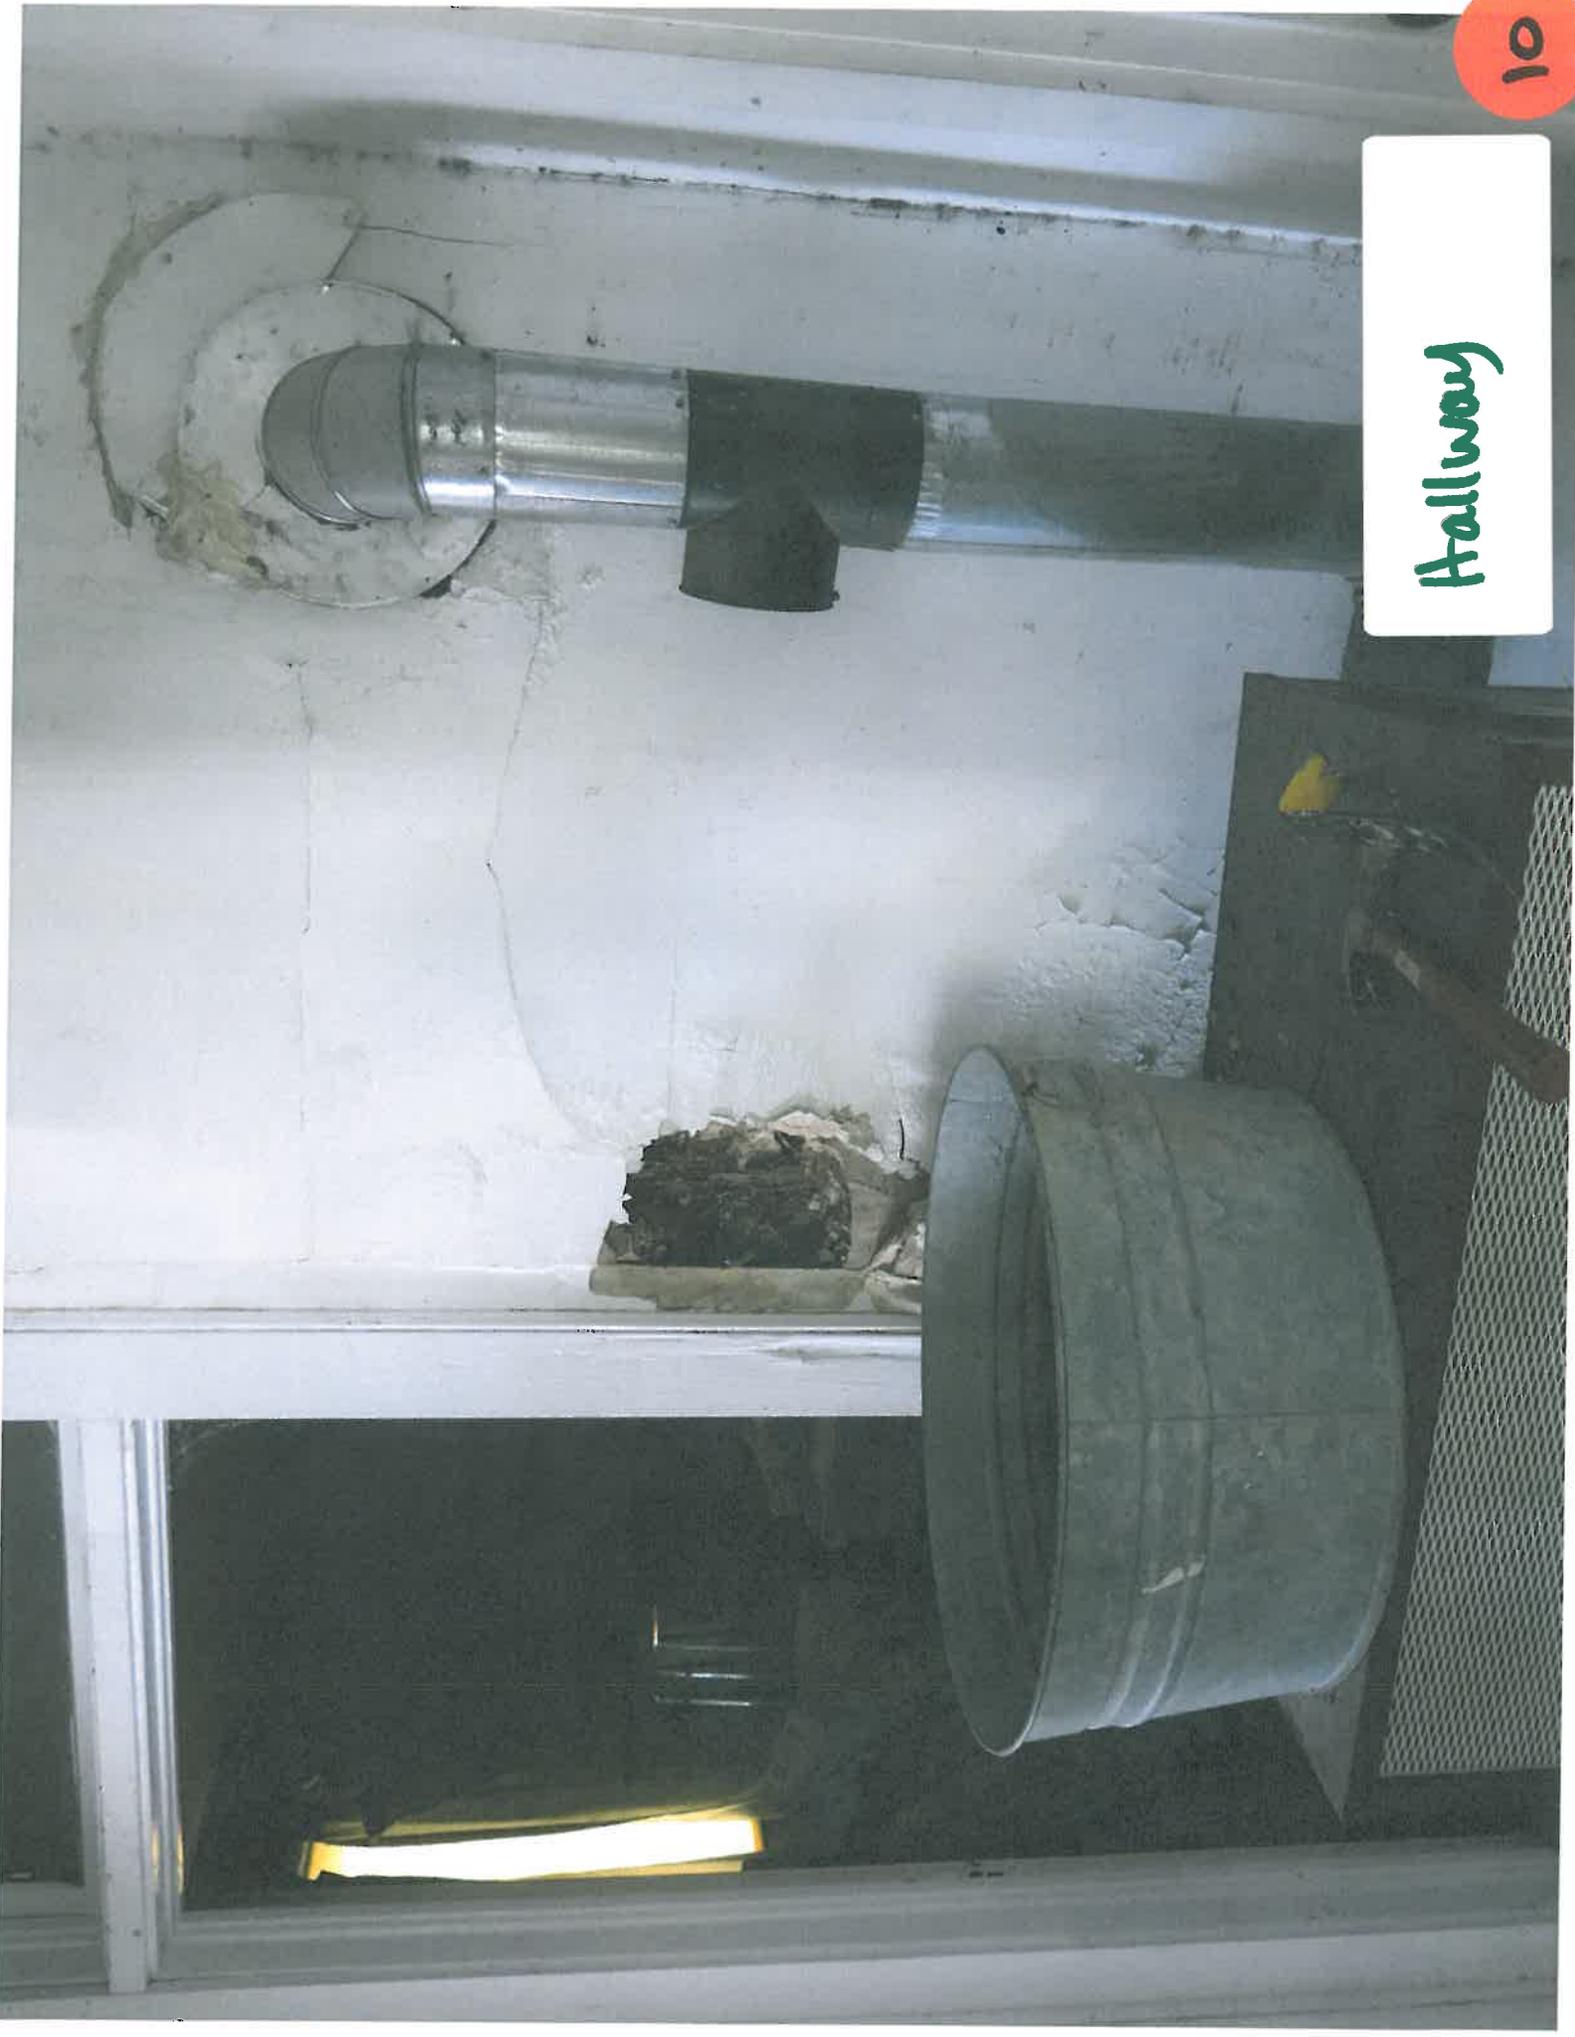
Hallway wall  
close up

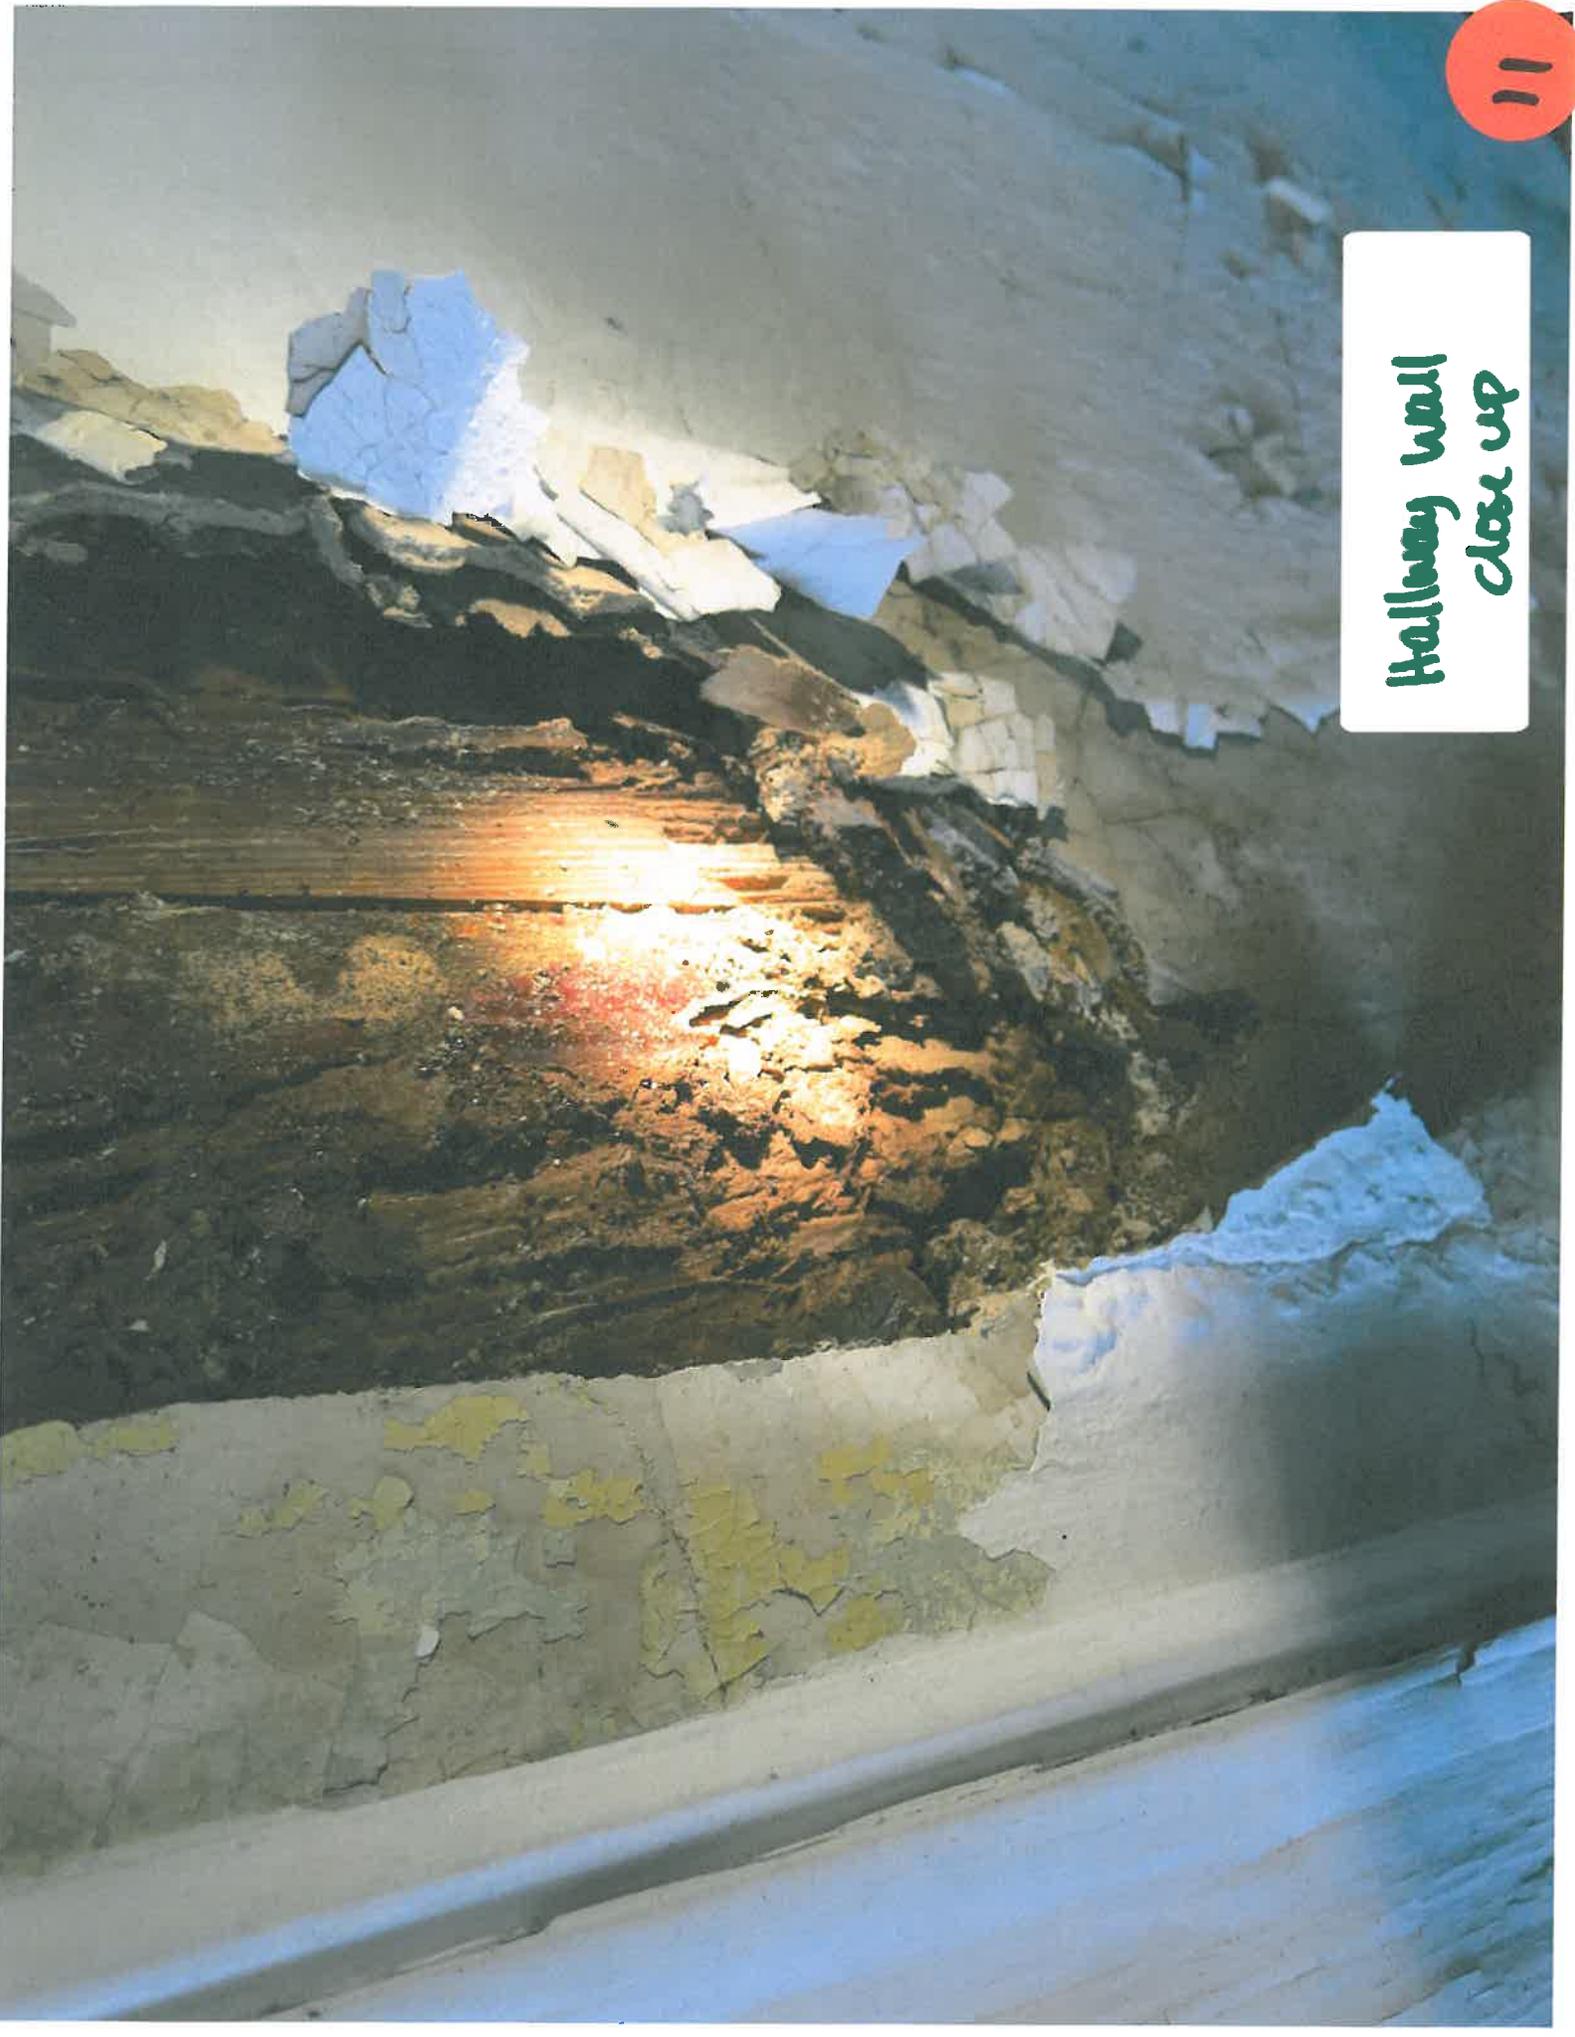
Hallway wall  
close up

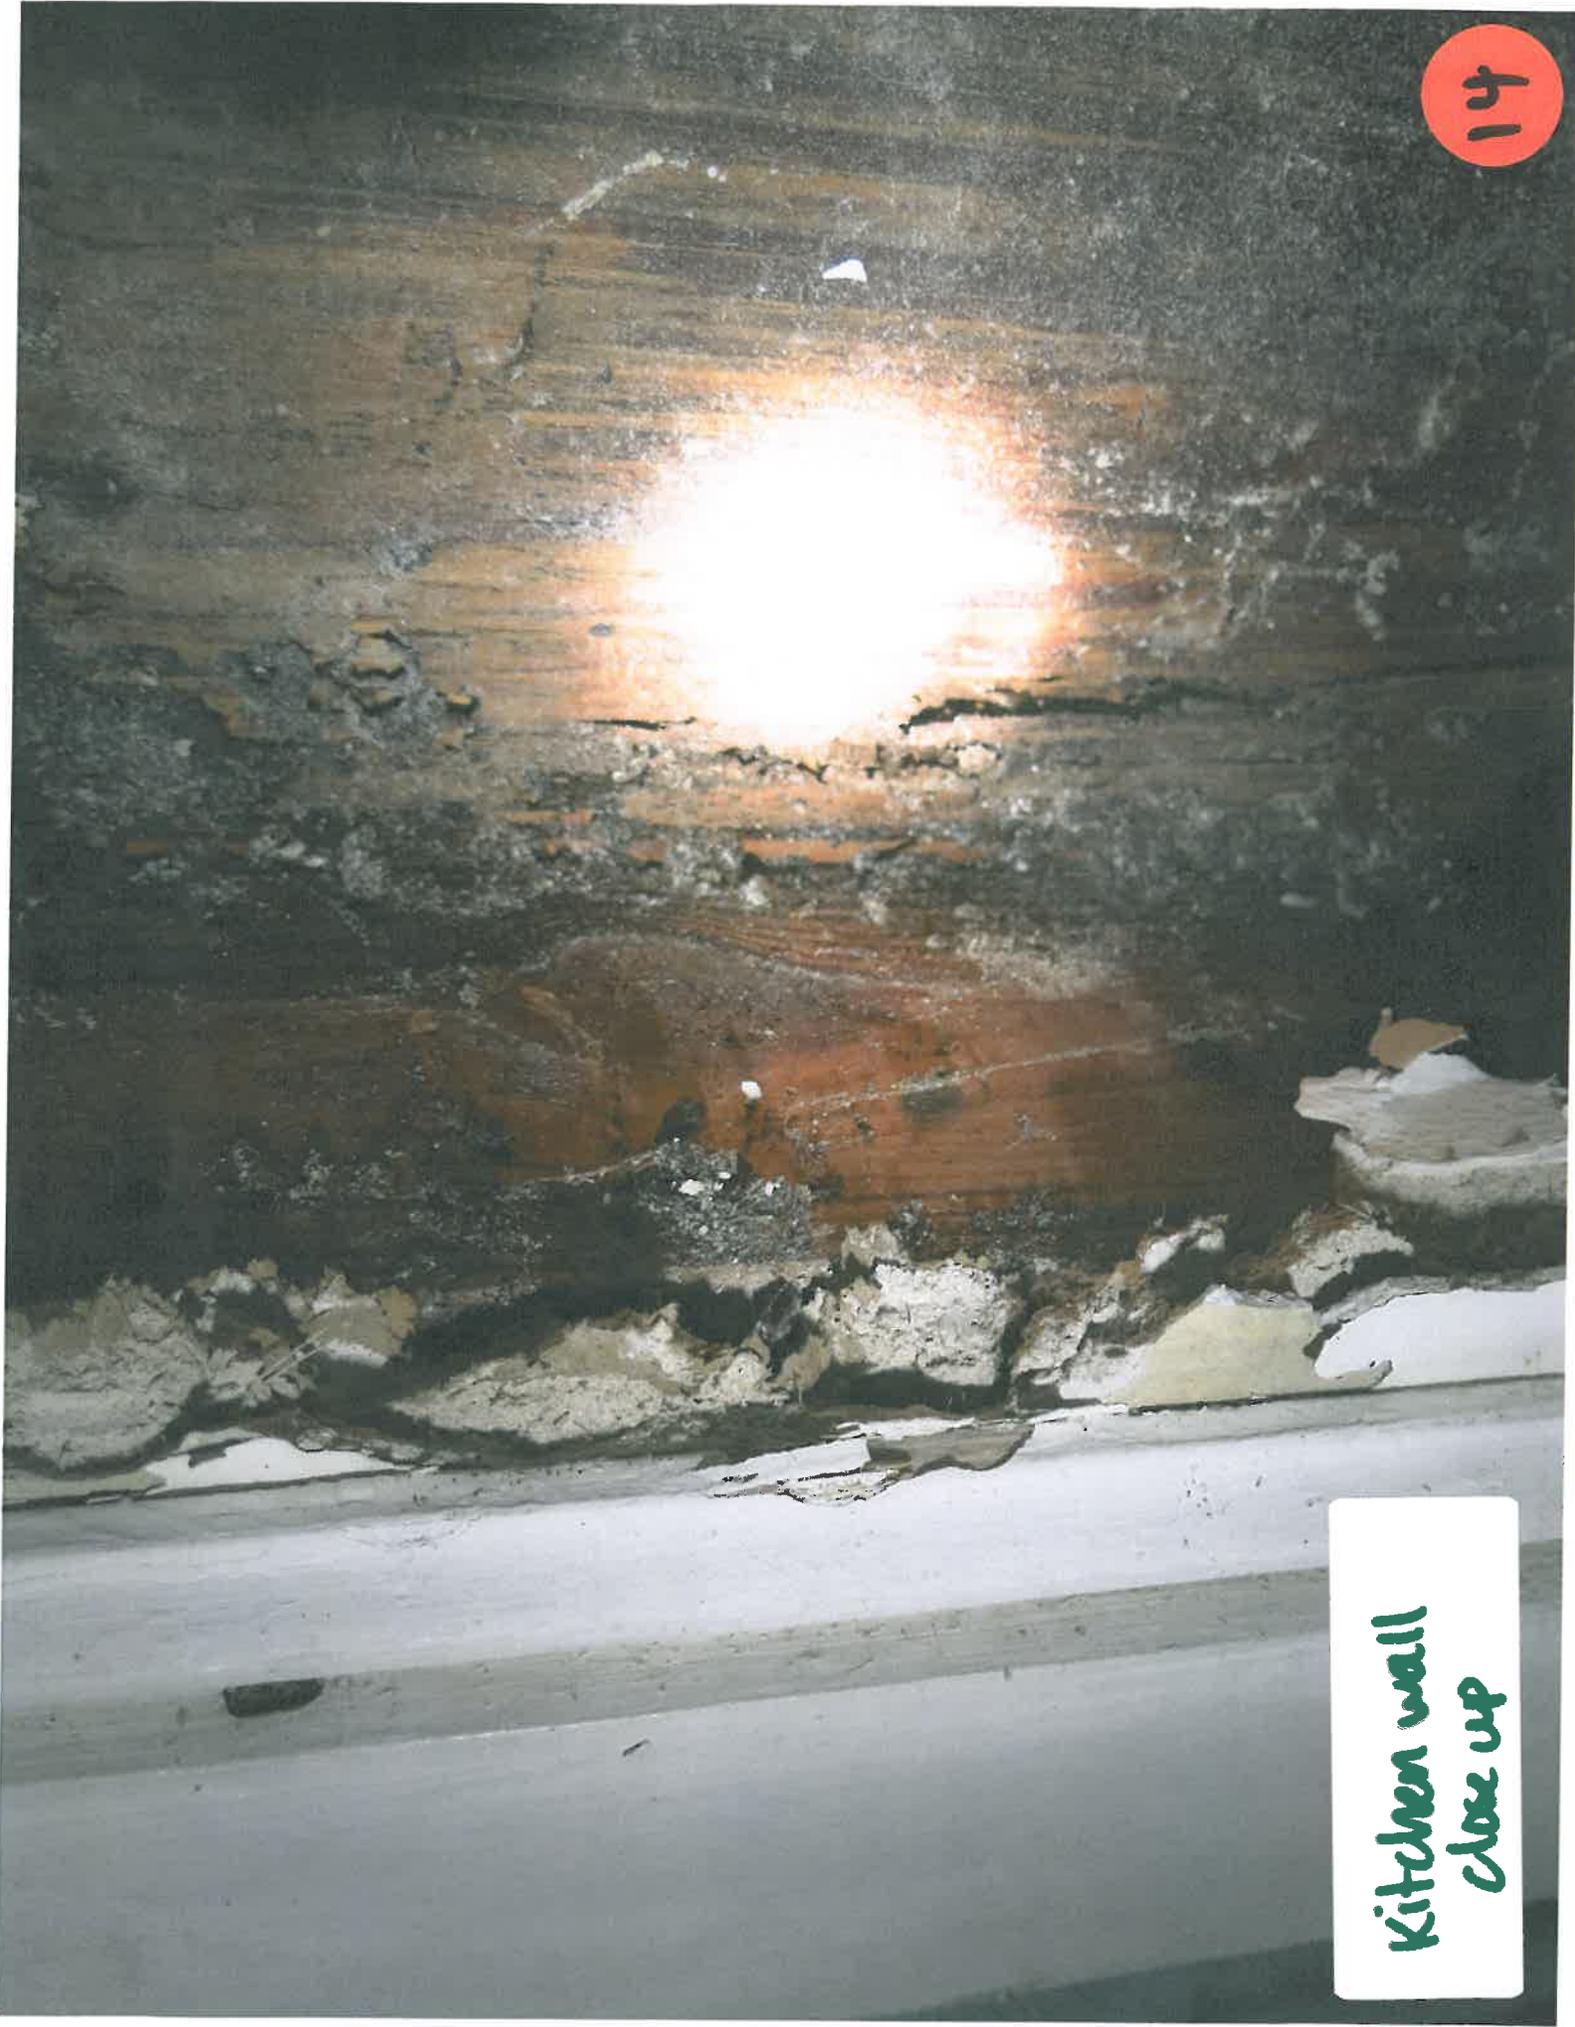
Kitchen wall  
close up
