D/DRC Case

1811 Pickens Street

DESIGN/DEVELOPMENT REVIEW COMMISSION
DESIGN REVIEW DISTRICT
HISTORIC AGENDA
EVALUATION SHEET
Case # 1

NATURE OF REQUEST: Request Certificate of Design Approval for exterior changes

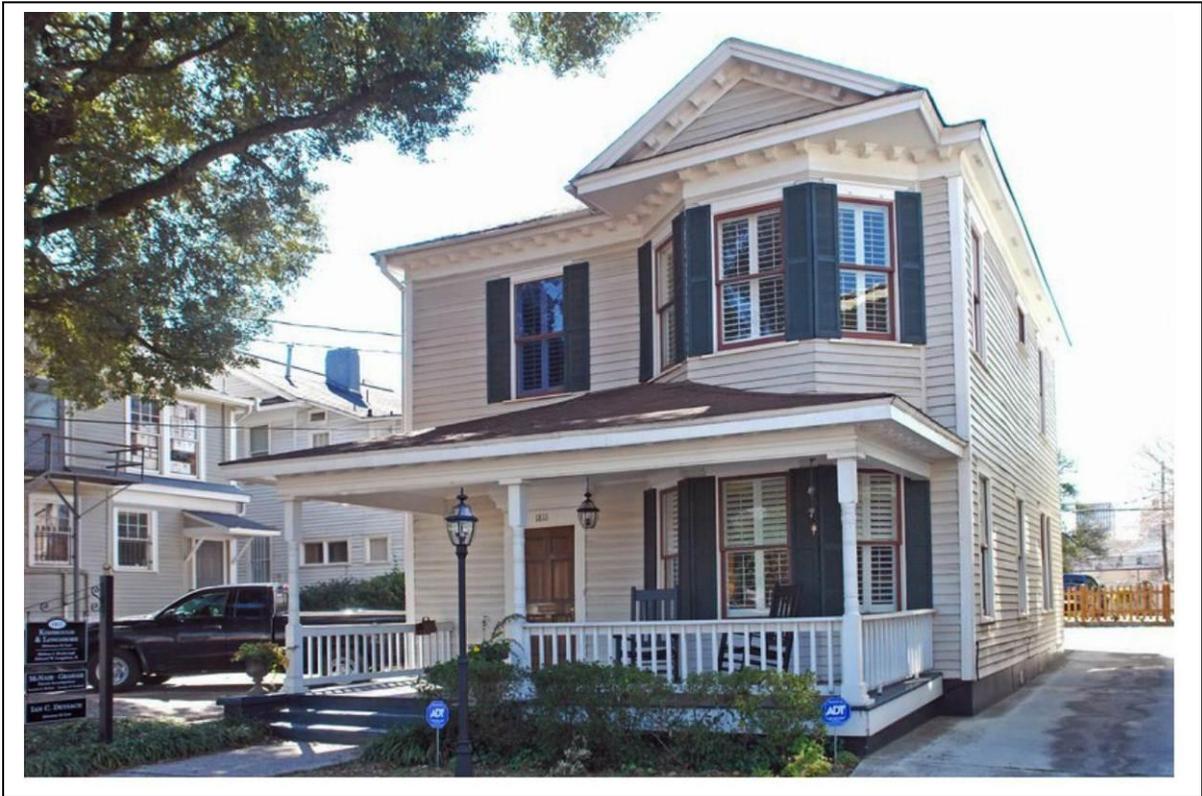
Before Image (from www.Inimg.com)

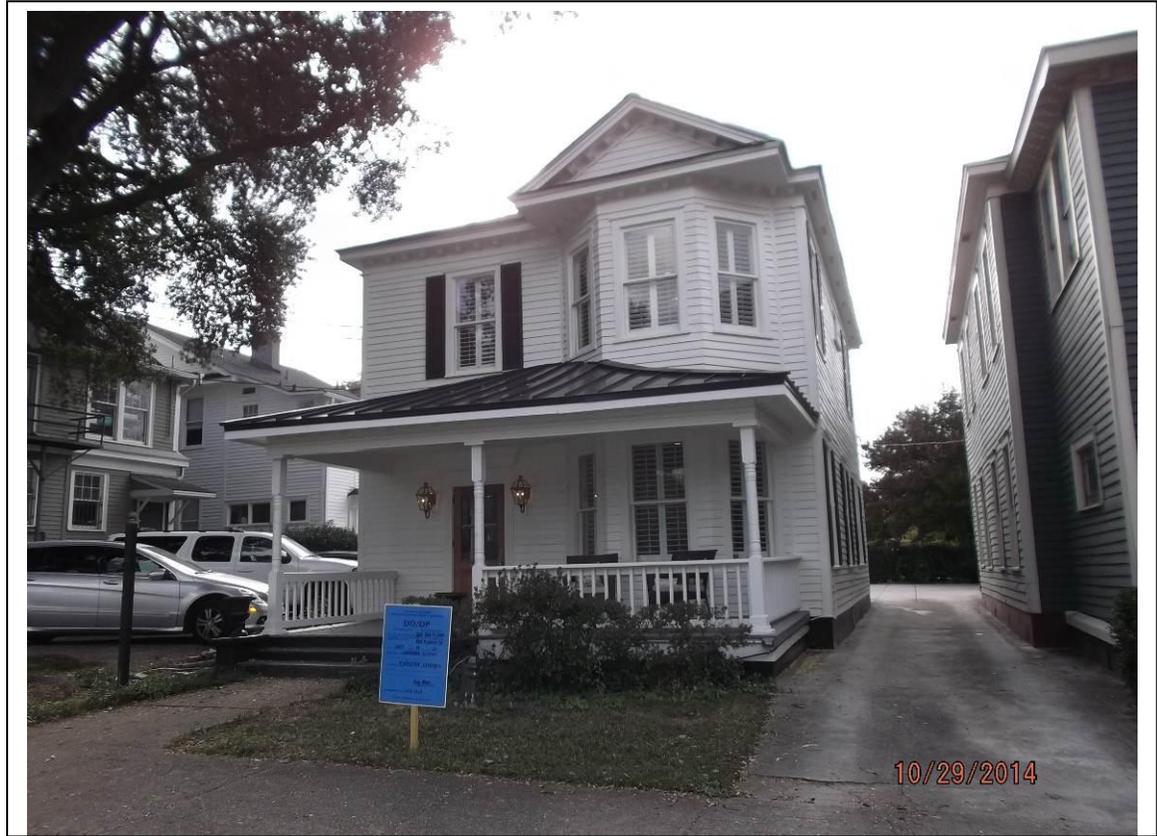
Current Image, staff photo

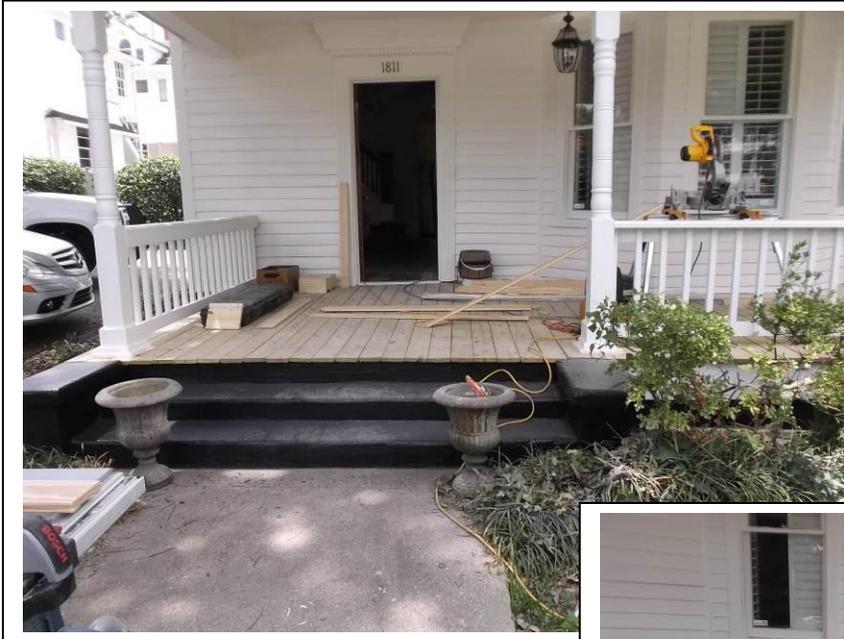
There is no historic precedent for using deck boards as a front porch floor. Deck boards are for decks; they are marketed as such and are commonly understood to be for decks. Similarly, porch flooring is marketed as such and features the traditional tongue and groove interlocking edges, much like an interior wood floor. The sidewalk (public right of way) on this street is very close to the building so the porch floor is very evident as an alteration to the front of the house. The deck boards are much wider than traditional porch flooring and they have gaps between them.

While Staff does not know what was on the porch floor immediately preceding its recent wholesale replacement, it is another example where the complete loss of the original material should generate replacement with a new material that matches the old in “design, color, finish, texture and other visual qualities and, where possible, materials.” Wood porch flooring to match historic patterns is still widely available today, so it is possible to meet this ordinance with modern materials.

Staff photos of porch floor immediately after replacement

Staff recommends replacement of the porch floor with appropriate porch flooring within 60 days in order to comply with Section 17-674(d) of the City Ordinance. Appropriate porch flooring would be approximately 3 to 4 inches wide and 3/4 inch thick.

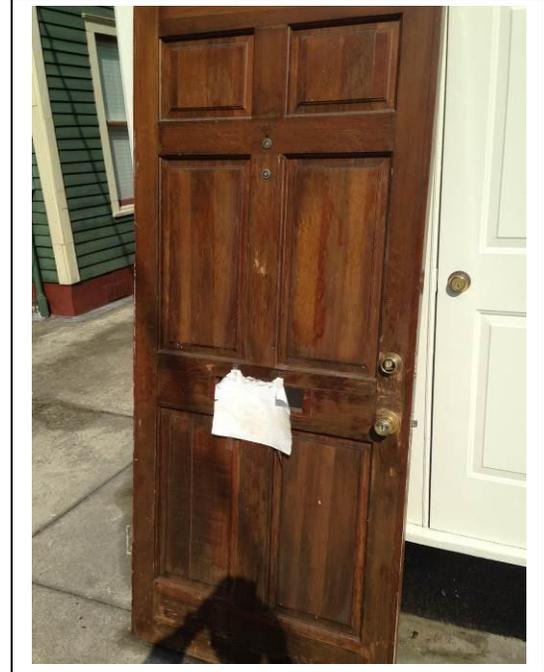
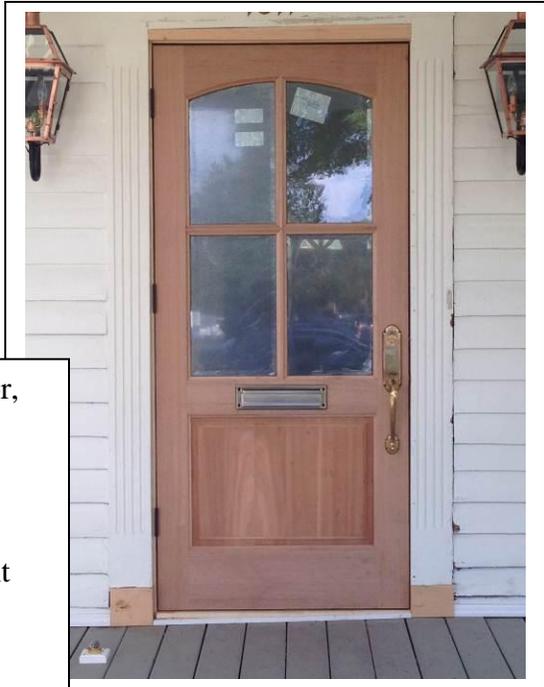
The door installed is not a typical front door design for a 1910s Folk Victorian style home nor does it replicate the original door; therefore it could be considered conjectural. In looking at two images from the early 1980s (one is included at the end of the evaluation, the other is on file at the State Archives), it is apparent that the door on the house at that time had a lattice work panel detail on the bottom half with a rectangular piece of glass on the top half. Staff has located this same door in a catalog from 1910, which is close to the latest possible construction date of 1913 for this building.

In looking at several door catalogues from the 1910s it is apparent that none of the doors featured an arch top nor did they feature muntins in the glass. Rear doors sometimes had muntins, but not the front doors. Patterns within this district and in other houses from the 1910s reveals that local patterns followed the same trends as those found in the catalogues;

glass was rectangular with no muntins. The door that has been installed is a change that is not in keeping with this guideline.

The door is a distinctive feature that had previously been missing from the home. The c. 1980s door that was in the house was clearly not original. When that door was removed, replacement by a new door appears to require a door that matches in “design, color, finish, texture” etc. to meet this ordinance. If the Colonial door had not been removed then there would have been no review needed as there would have been no exterior change. The new door fails to match the original door, which appears to be intact in early 1980s images. The new door has an arched glass inset with muntins; both the arch shape and the muntins are not typical of doors of the era and the door in general does not meet this ordinance as it does not match the old design.

New door, installed without approval

Applicant photo

Staff recommends removal of the new door within 60 days, with a replacement door to match the original in order to meet Section 17-674(d) of the City Ordinance, or they may reinstall the recently removed Colonial door. If they reinstall the Colonial door then there is no exterior change to review.

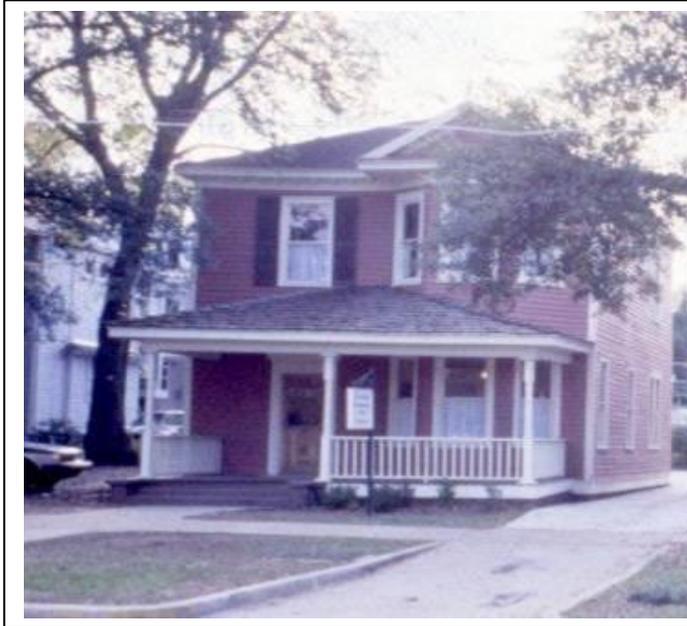
Slide from early 1980s, City of Columbia collection, with inset showing close up of what was likely an original door, removed in the 1980s

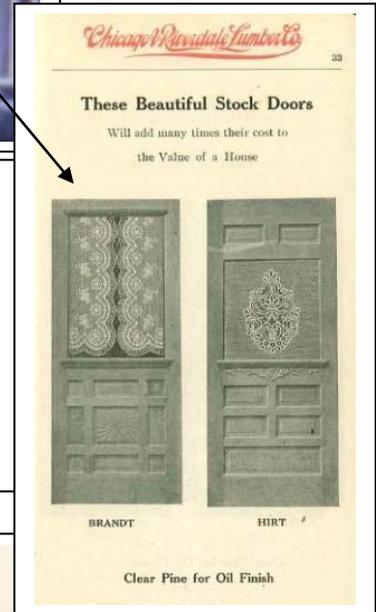
A 1910 catalog features a very similar door to the one shown on this c. 1913 house (Lumber Millwork, cat. 31, www.archive.org)

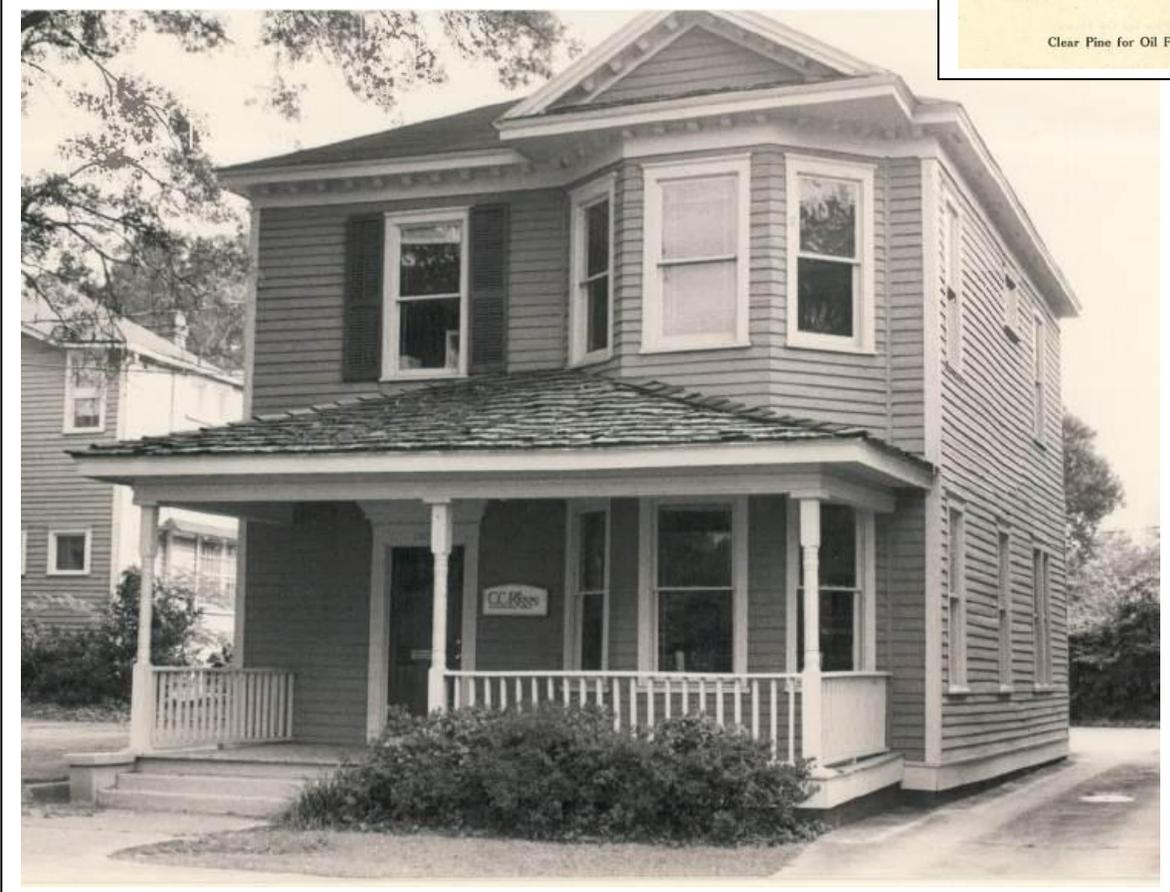
1992 Survey Photo, City of Columbia collection
