**DESIGN/DEVELOPMENT REVIEW COMMISSION
DESIGN REVIEW DISTRICT
HISTORIC AGENDA
EVALUATION SHEET
Case # 3**

ADDRESS: 1628 Calhoun Street

NATURE OF REQUEST: Request for Certificate of Design Approval for demolition.

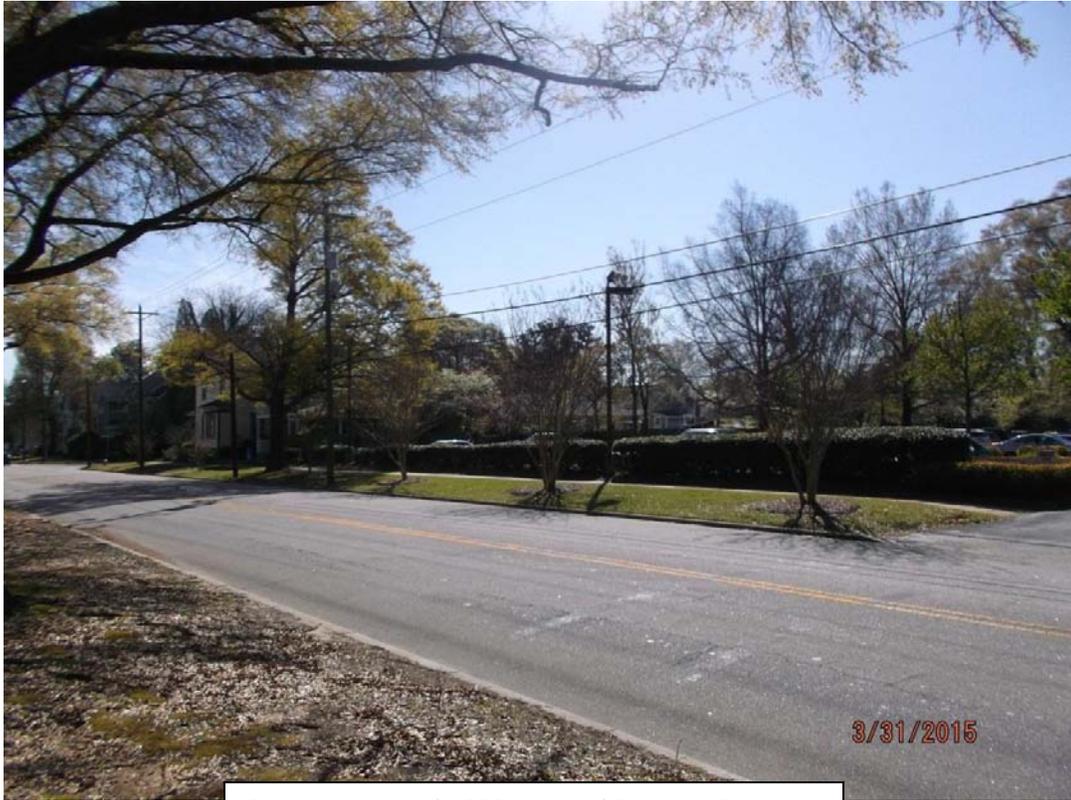
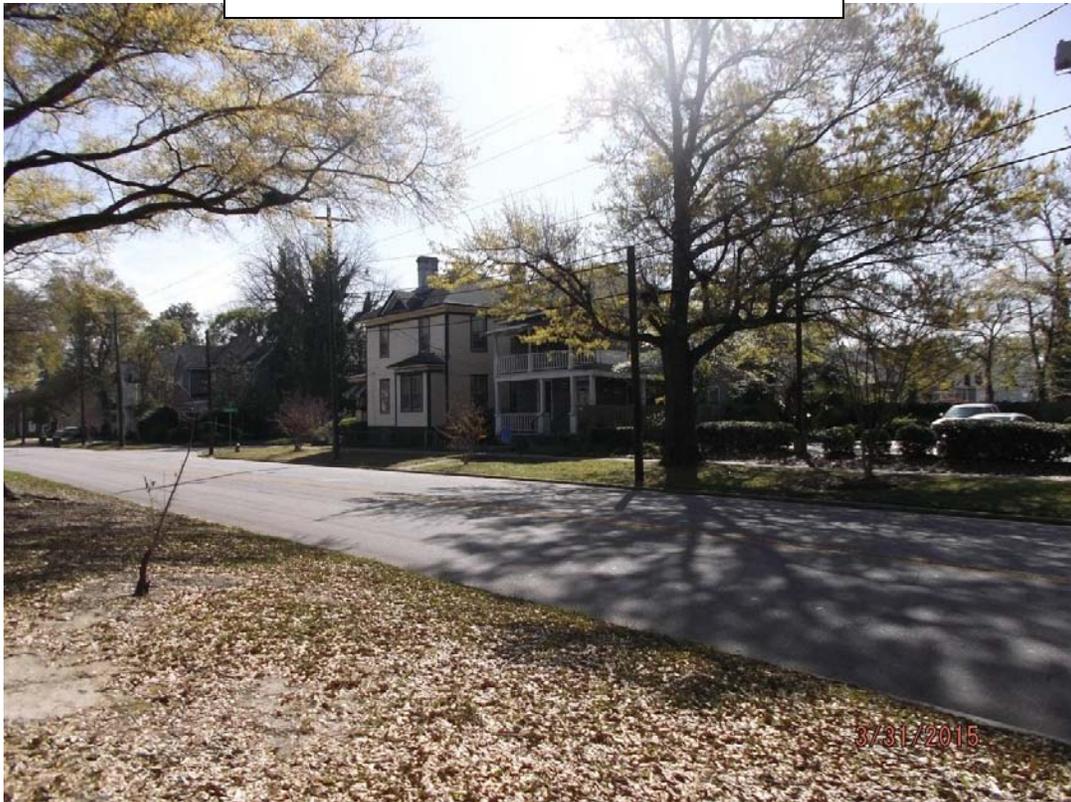
Current views of 1600 block of Calhoun Street

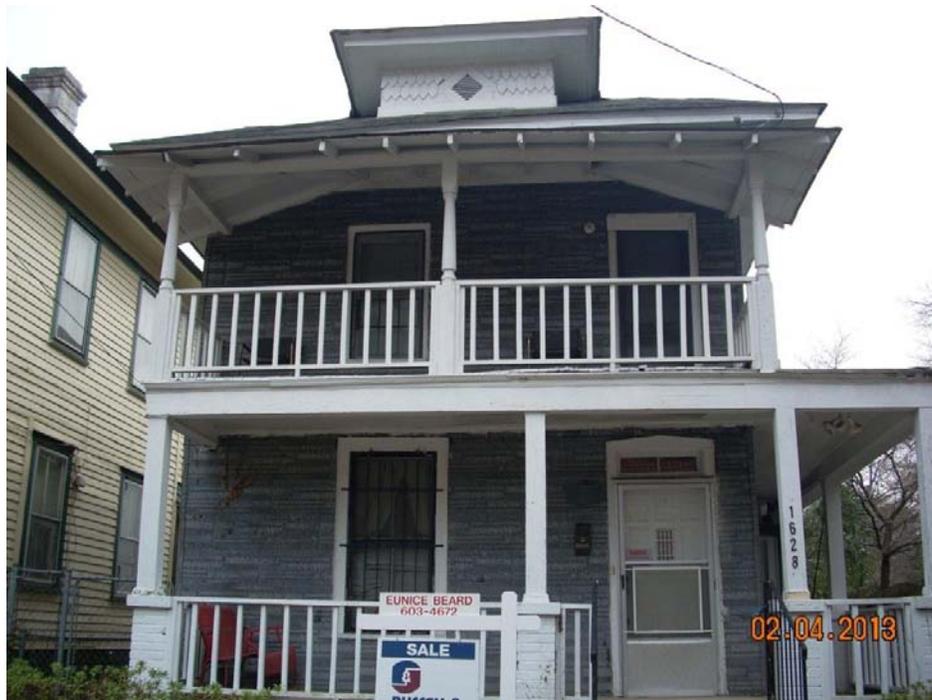
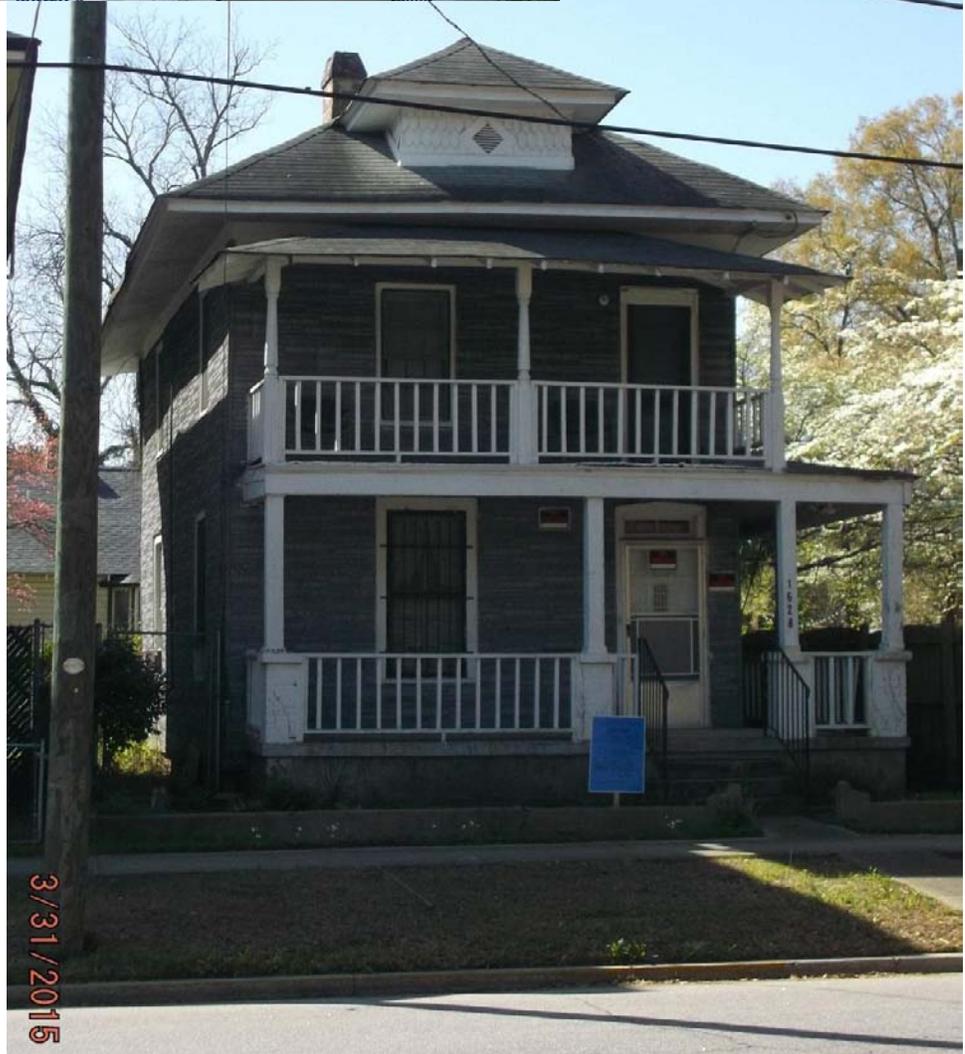
Left: Image from 2013

Below: Image from 2015, showing the building has not been altered in two years

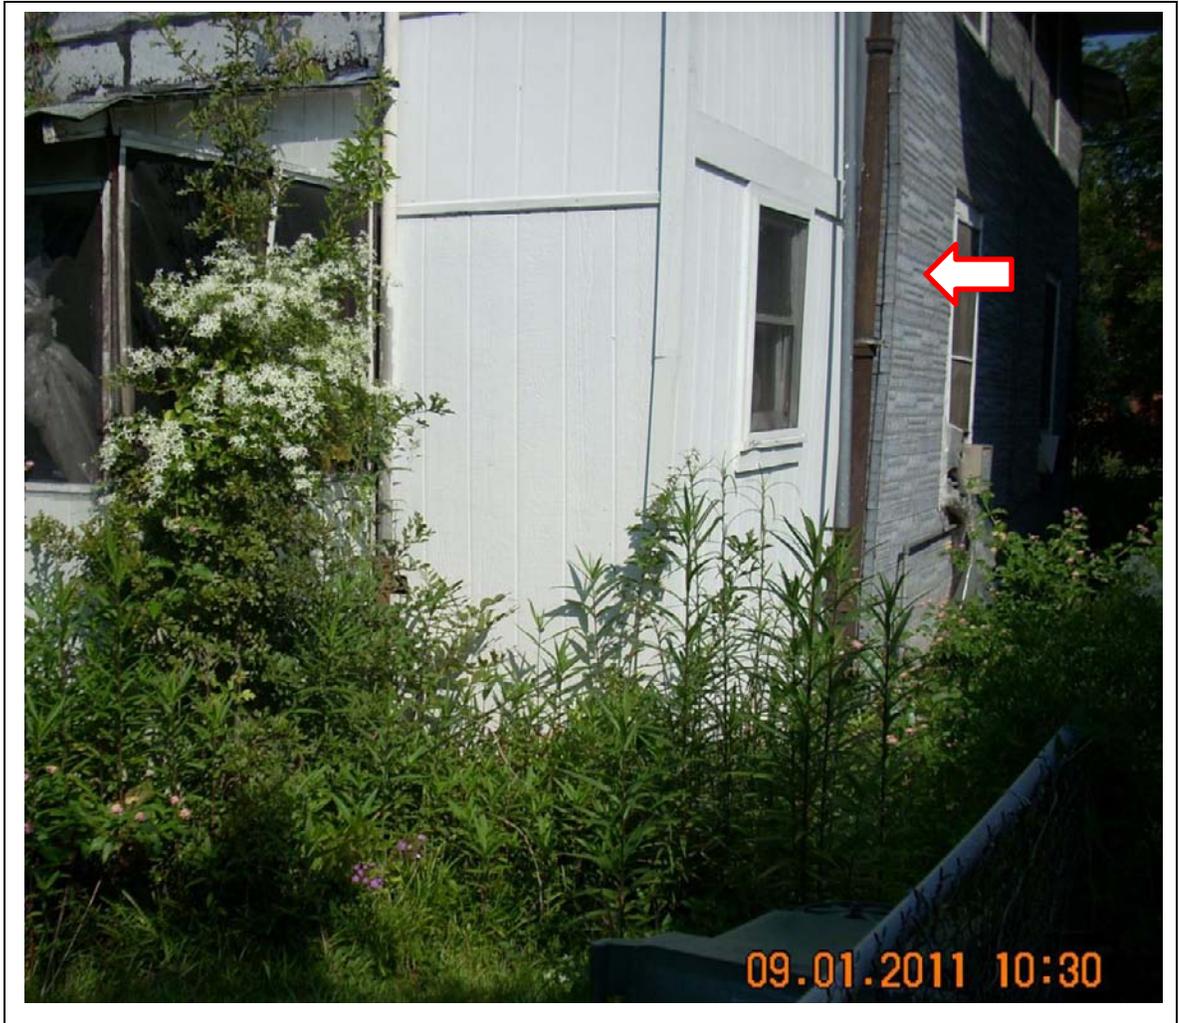
Staff agrees with the engineer's observation of a slight bulge in the southeast (left rear) corner of the original house, but disagrees with his assumption that "this means that the floor structure has released its connection to the wall." This bulge has existed since at least 2011 and may be due to a number of reasons, including swelling of the wood siding underneath due to water leakage from the vent pipe hole in the eave above. As there is no gap opening in the asphalt siding at the slight bulge, it is possible the deformity predates the application of the asphalt siding.

2011 City photo with arrow showing slight bulge in southeast corner, though there is no gap opening in the asphalt siding. Foreground shows overgrown yard that initiated a property maintenance code violation for a previous owner.

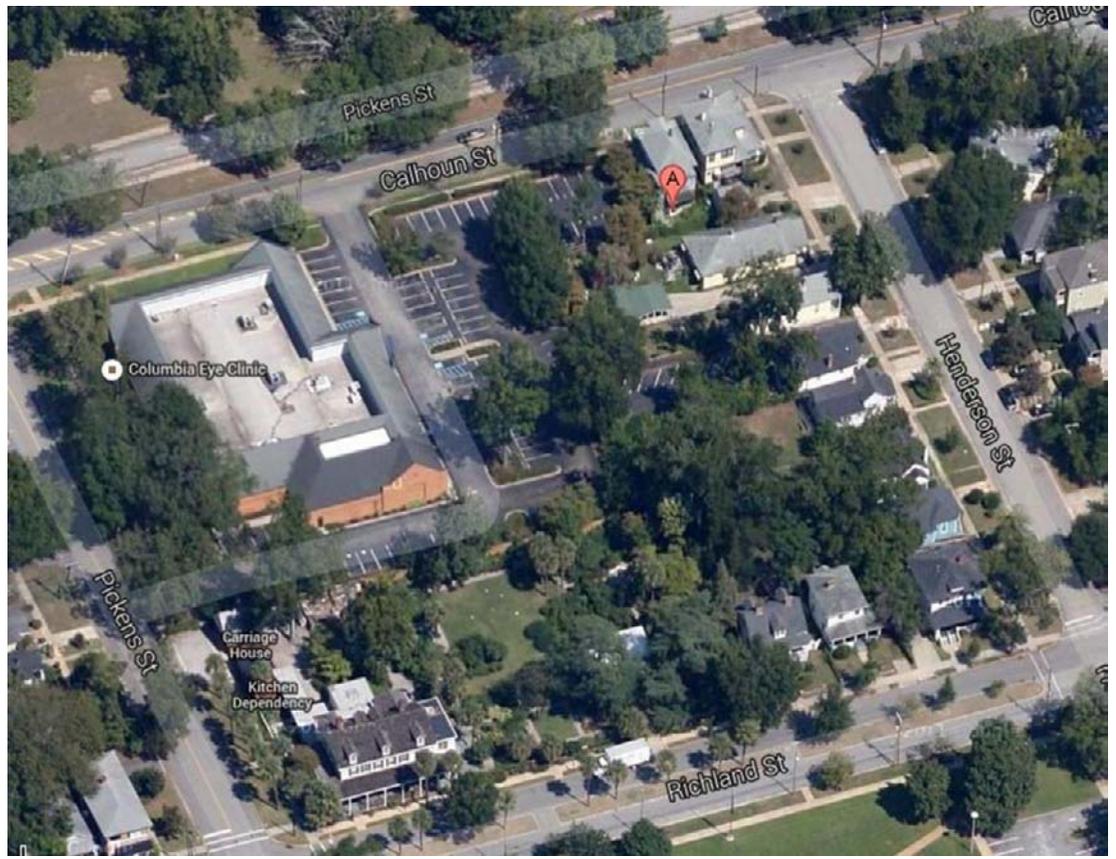
A modern view shows 1628 Calhoun Street (labeled "A"). It sits alone facing Calhoun but is integral to the district that continues to the east and south as seen in the many historic buildings shown along Henderson and Richland Streets. *(Google image)*

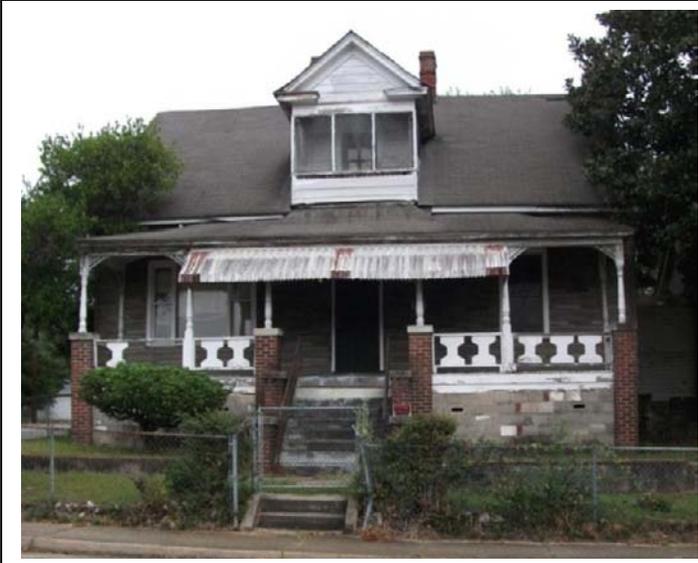
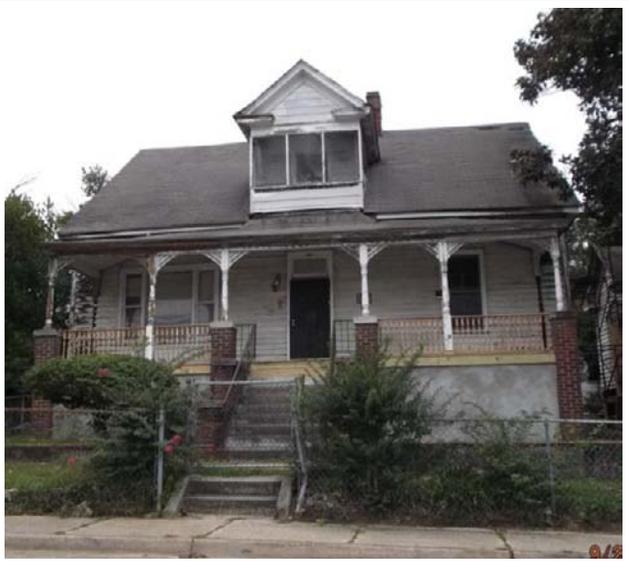
Although the building has been covered in asphalt siding, it is likely that its removal would reveal wood siding, as staff has seen some wood siding in an area where the asphalt is missing. The removal of similar asphalt siding was recently done in Lower Waverly at 928 Pine Street and in Arsenal Hill at 1711 Wayne Street, revealing intact wood siding.

The removal of asphalt siding at 928 Pine Street revealed largely intact original wood siding underneath.

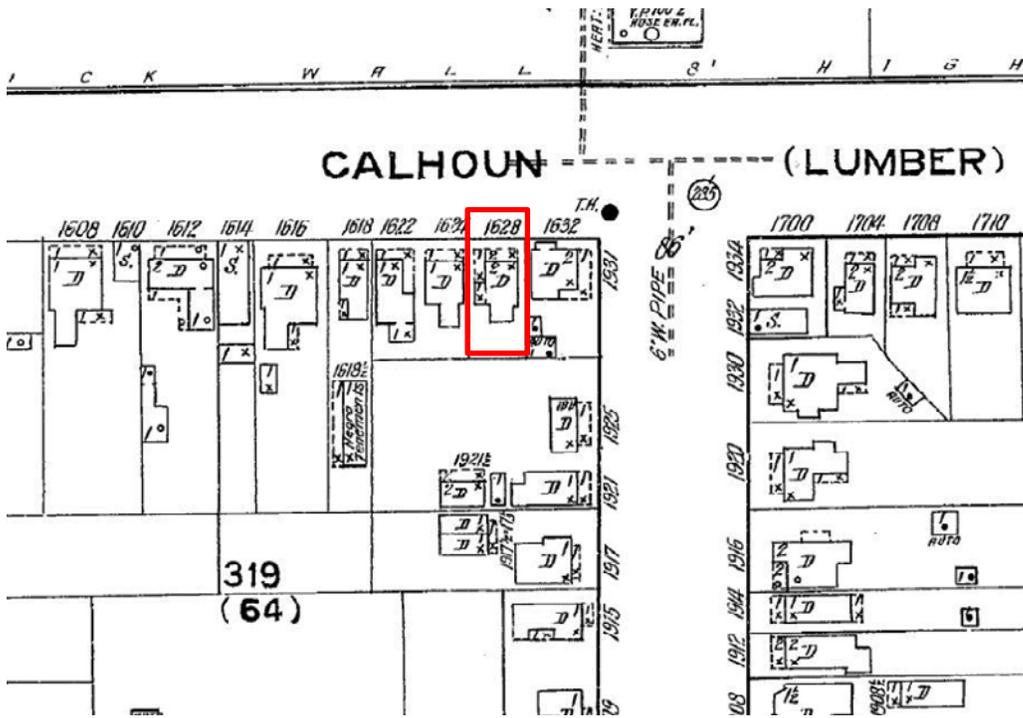
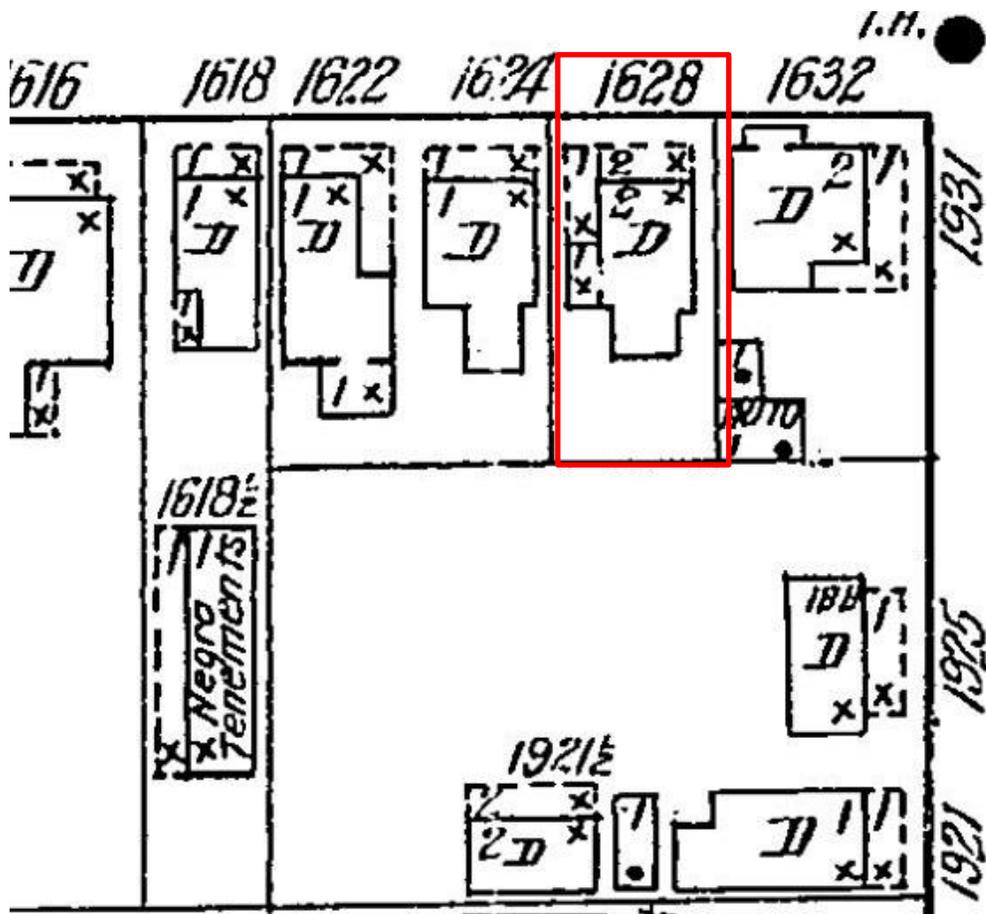
1918 Sanborn Map (both) shows the dense development along the 1600 block of Calhoun Street

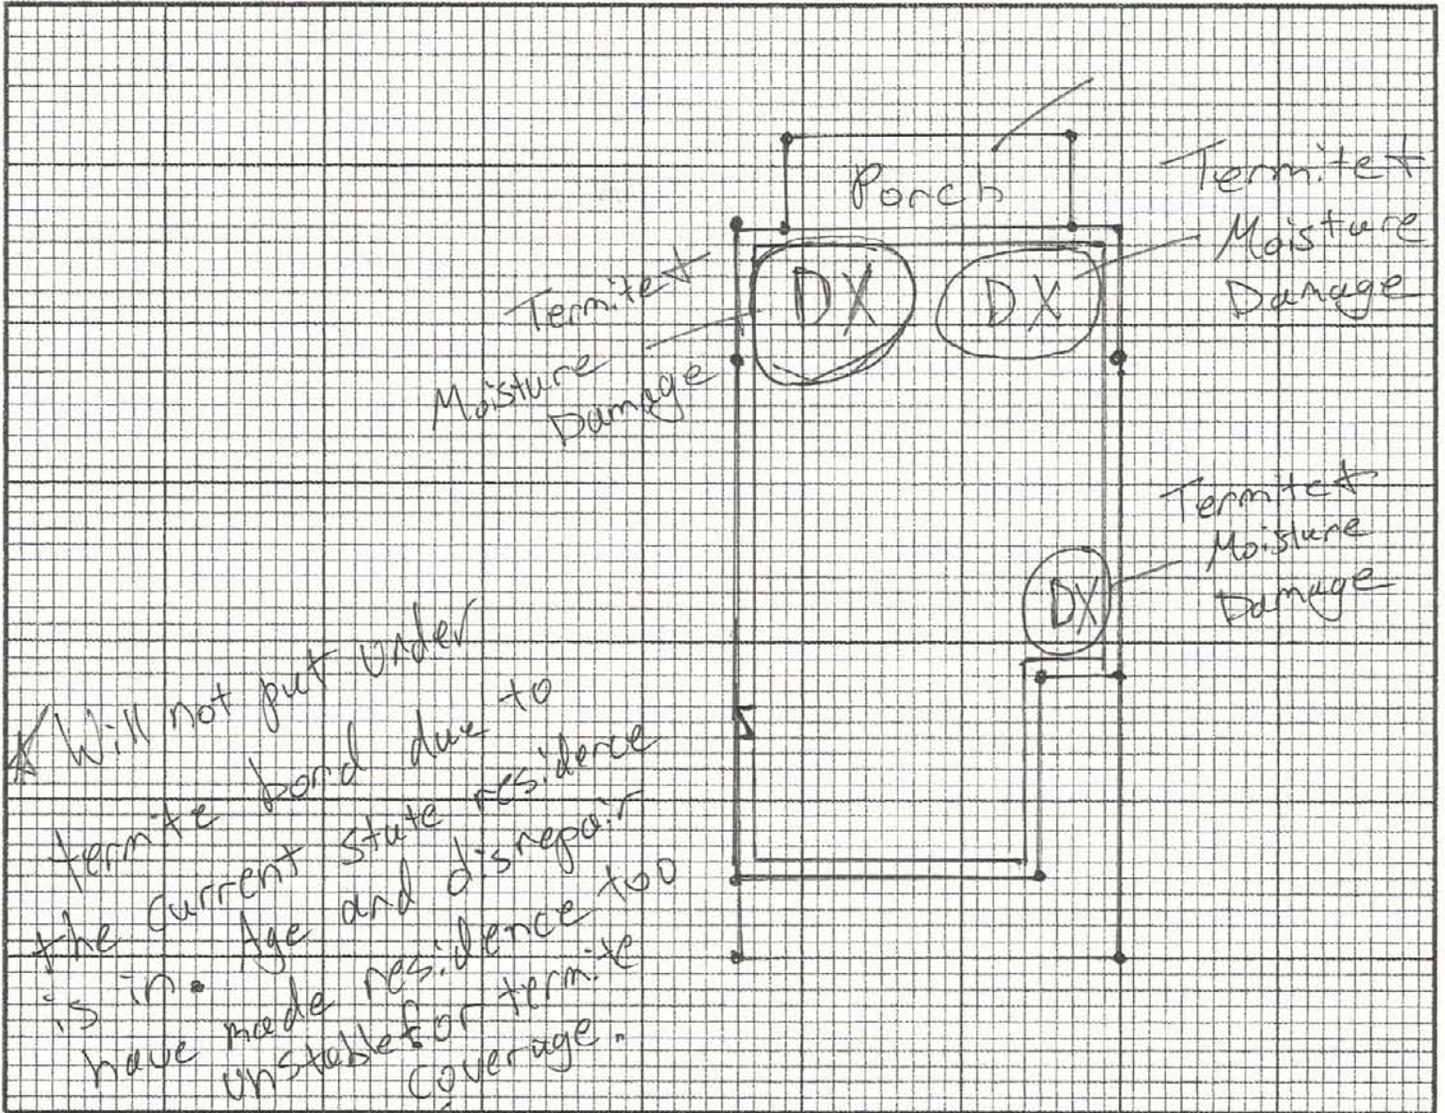
INSPECTION GRAPH

The applicant has also provided a termite letter that shows some isolated areas of moisture and termite damage. As with any property that does not have the termite damage repaired, the property is listed as “unsuitable for termite coverage.” Many termite companies require the damage to be repaired before they will issue bonds.

Inspector's Statement of Visible Activity See graph.
By Kyle Lewis Date 4/7/15

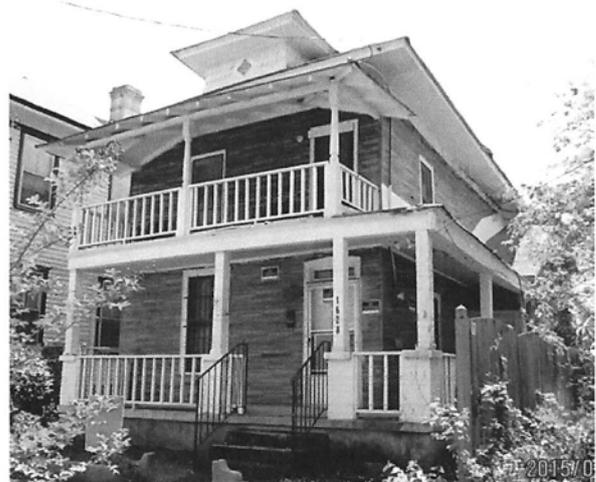
While looking from the front right (see photo) it appears that the structure may be salvageable; however, closer investigation clearly reveals otherwise. Upon entering the lower level, the front room seems to be somewhat structurally sound, but that is where it ends. The next room back has a sagging and shaky floor structure (this is approximately mid depth of the house), and the back room has a floor structure that I would class as partially failed due to the amount of drop in some areas, especially the back right.

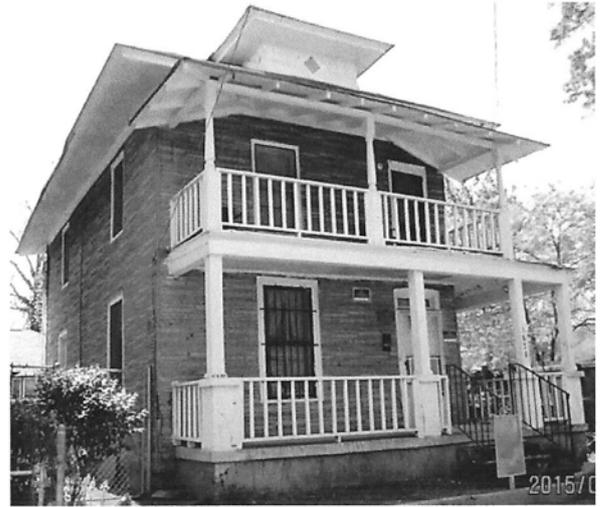
From the outside one can see that the left exterior wall is no longer planer and appears to be bulging slightly toward the back half. This could be the result of the second floor structure rotating as the edge drops, thus pushing out on the wall as it wedges downward. This means that the floor structure has released its connection to the wall.

A view of the rear provides a clearer idea of the level of structural distress and deterioration in this building. The portions closest to the chimney appear to have maintained their elevation, but the dropping of the structure to each side is clearly evident. Extensive deterioration of the roof can be seen at the back right corner (upper left in adjacent photo), as well as along the back fascia. This has allowed water to enter the wall cavity which would have resulted in rot, thus contributing to the dropping of the floor structure as the wall deteriorated to a point where it could no longer support the load.

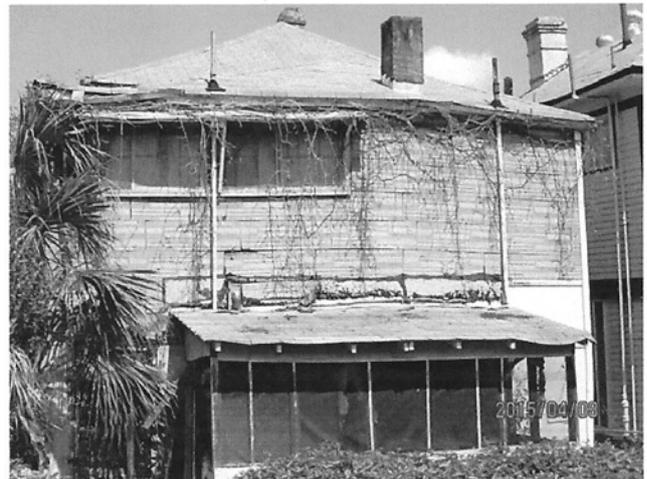
Overall, there is obvious structural failure in portions of this residence; obvious severe wood rot in portions; floors that have severely deflected; floors that have partially collapsed; exterior walls that are failing; and, based on my observations, possible failure of some of the interior foundation support (or the structure resting immediately thereupon) toward the back section.

It is my professional opinion that the level of deterioration of this structure is such that repair is not feasible. It would in effect be predominately remove & replace the majority of the existing structure, along with reinforcing a considerable portion of what little would be left of the original. It must be noted that before anyone attempts to remove any items from the back portion of this structure (upstairs or downstairs) that temporary shoring should be put in place to help support the second floor so that it does not collapse.
