Wales Garden Architectural Conservation District

**DESIGN/DEVELOPMENT REVIEW COMMISSION
DESIGN REVIEW DISTRICT
HISTORIC AGENDA
EVALUATION SHEET
Case #2**

ADDRESS: 1731 Heyward Street

NATURE OF REQUEST: Request Certificate of Design Approval for exterior changes and preliminary certification for the Bailey Bill.

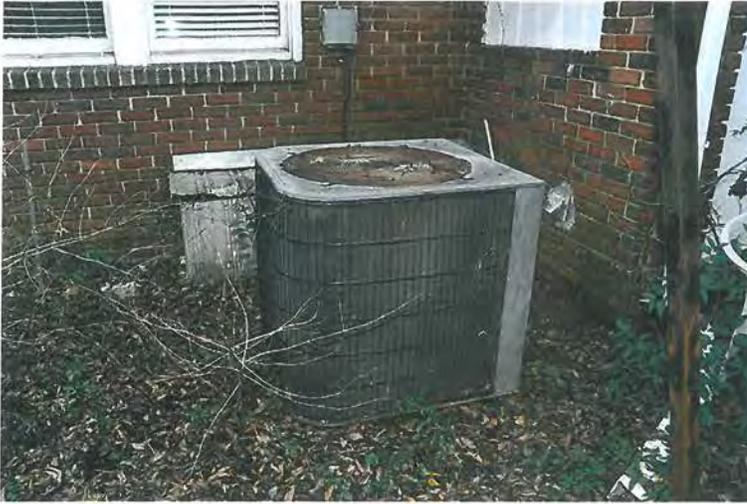
CONDITION OF
ELECTRICAL
HVAC
PLUMBING

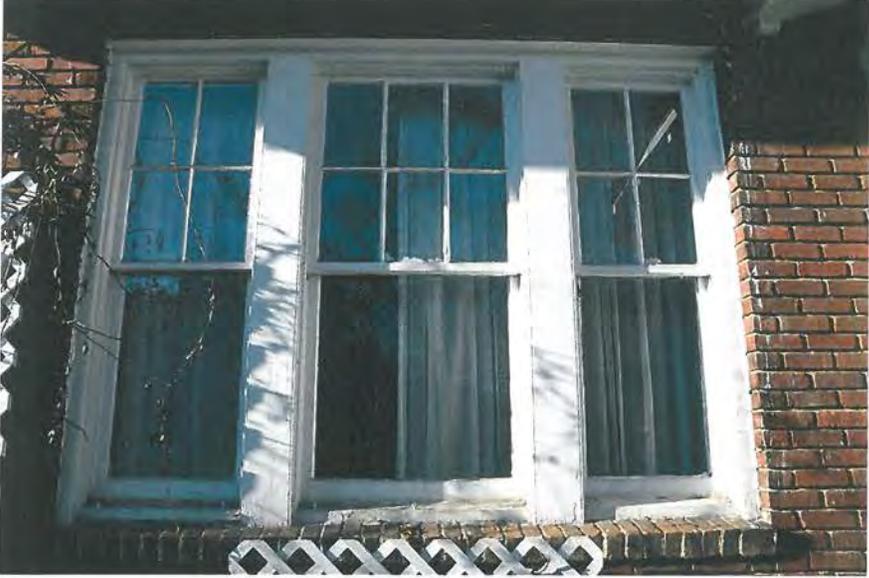
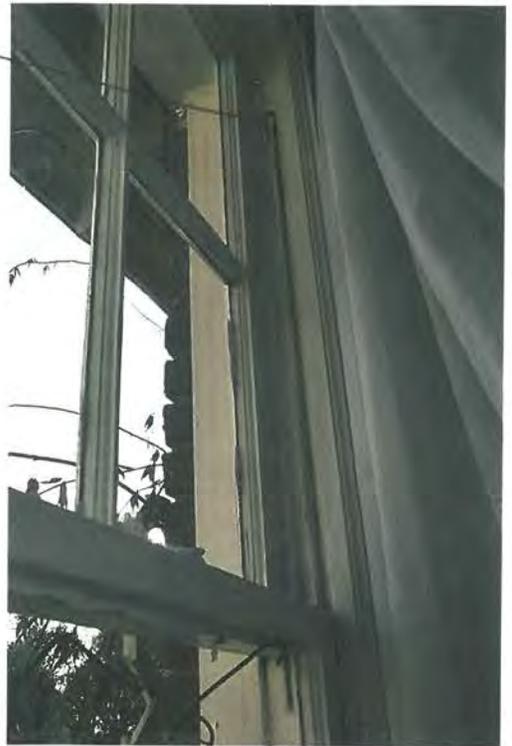
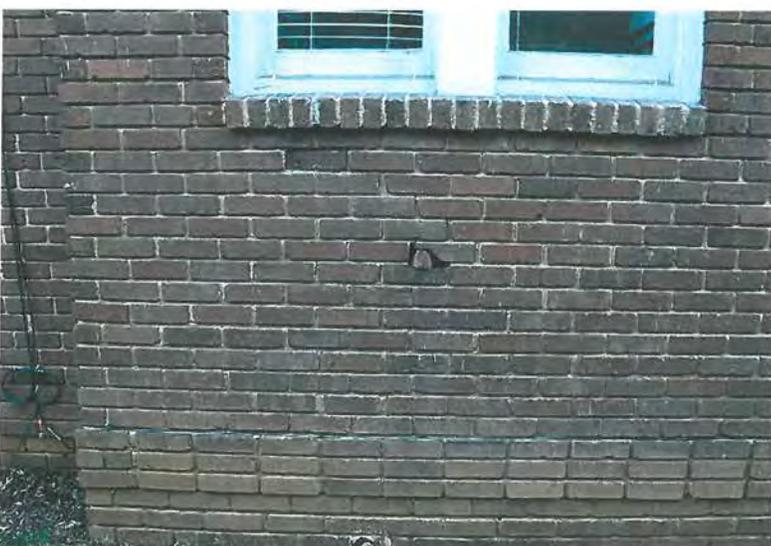
← EXAMPLE
OF
BRICK REPAIR
NEEDED.

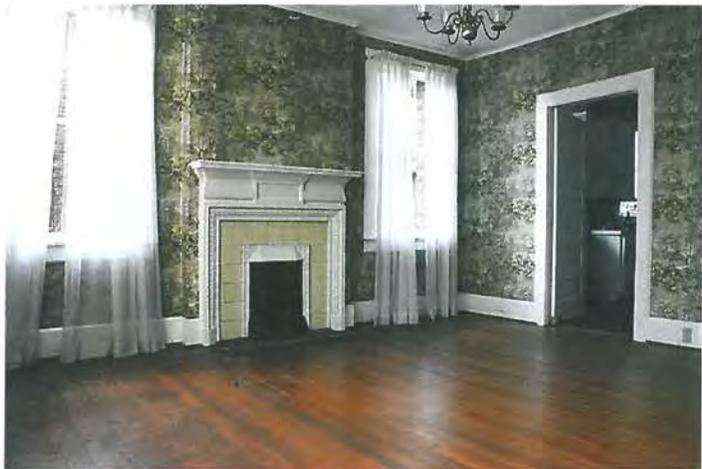
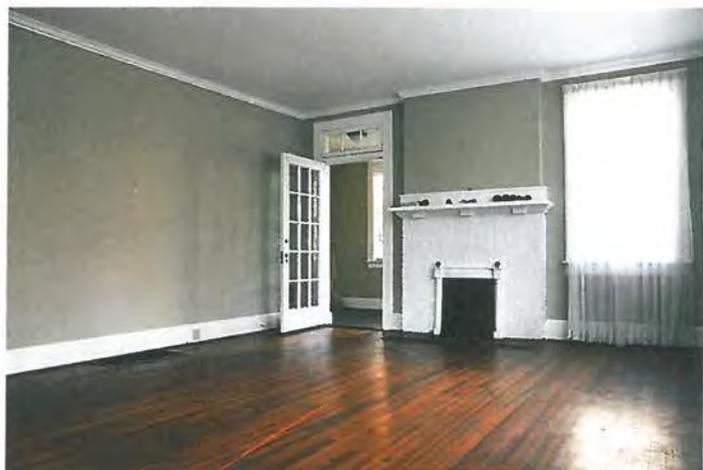
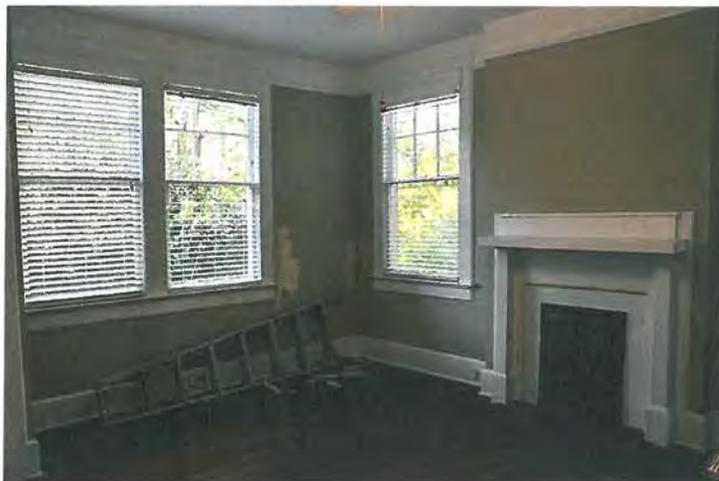
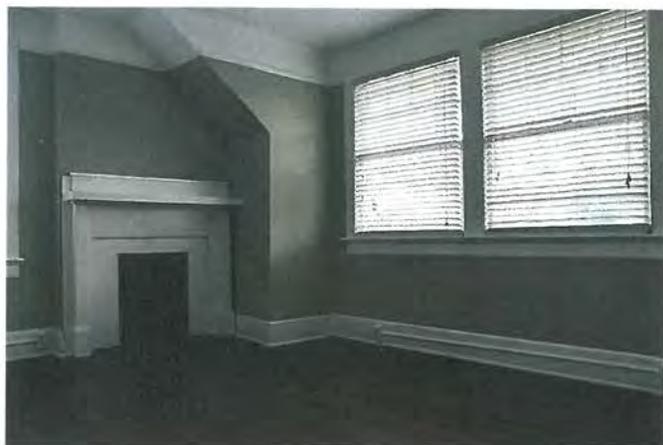
Et 6 of 6

FIREPLACES
TO REPAIR CHIMNEY

Architectural feature <u>CHIMNEY</u> Approximate date of feature <u>1925</u> Describe feature and its condition <u>ROOF</u> <u>4 of 6 ORIGINAL FIREPLACES REMAIN.</u> Photograph No. <u>Ex 6</u> Drawing No. _____	Describe work and impact on feature <u>BRING CHIMNEYS TO CURRENT CODE TO ALLOW HOMEOWNER TO ENJOY & USE</u>

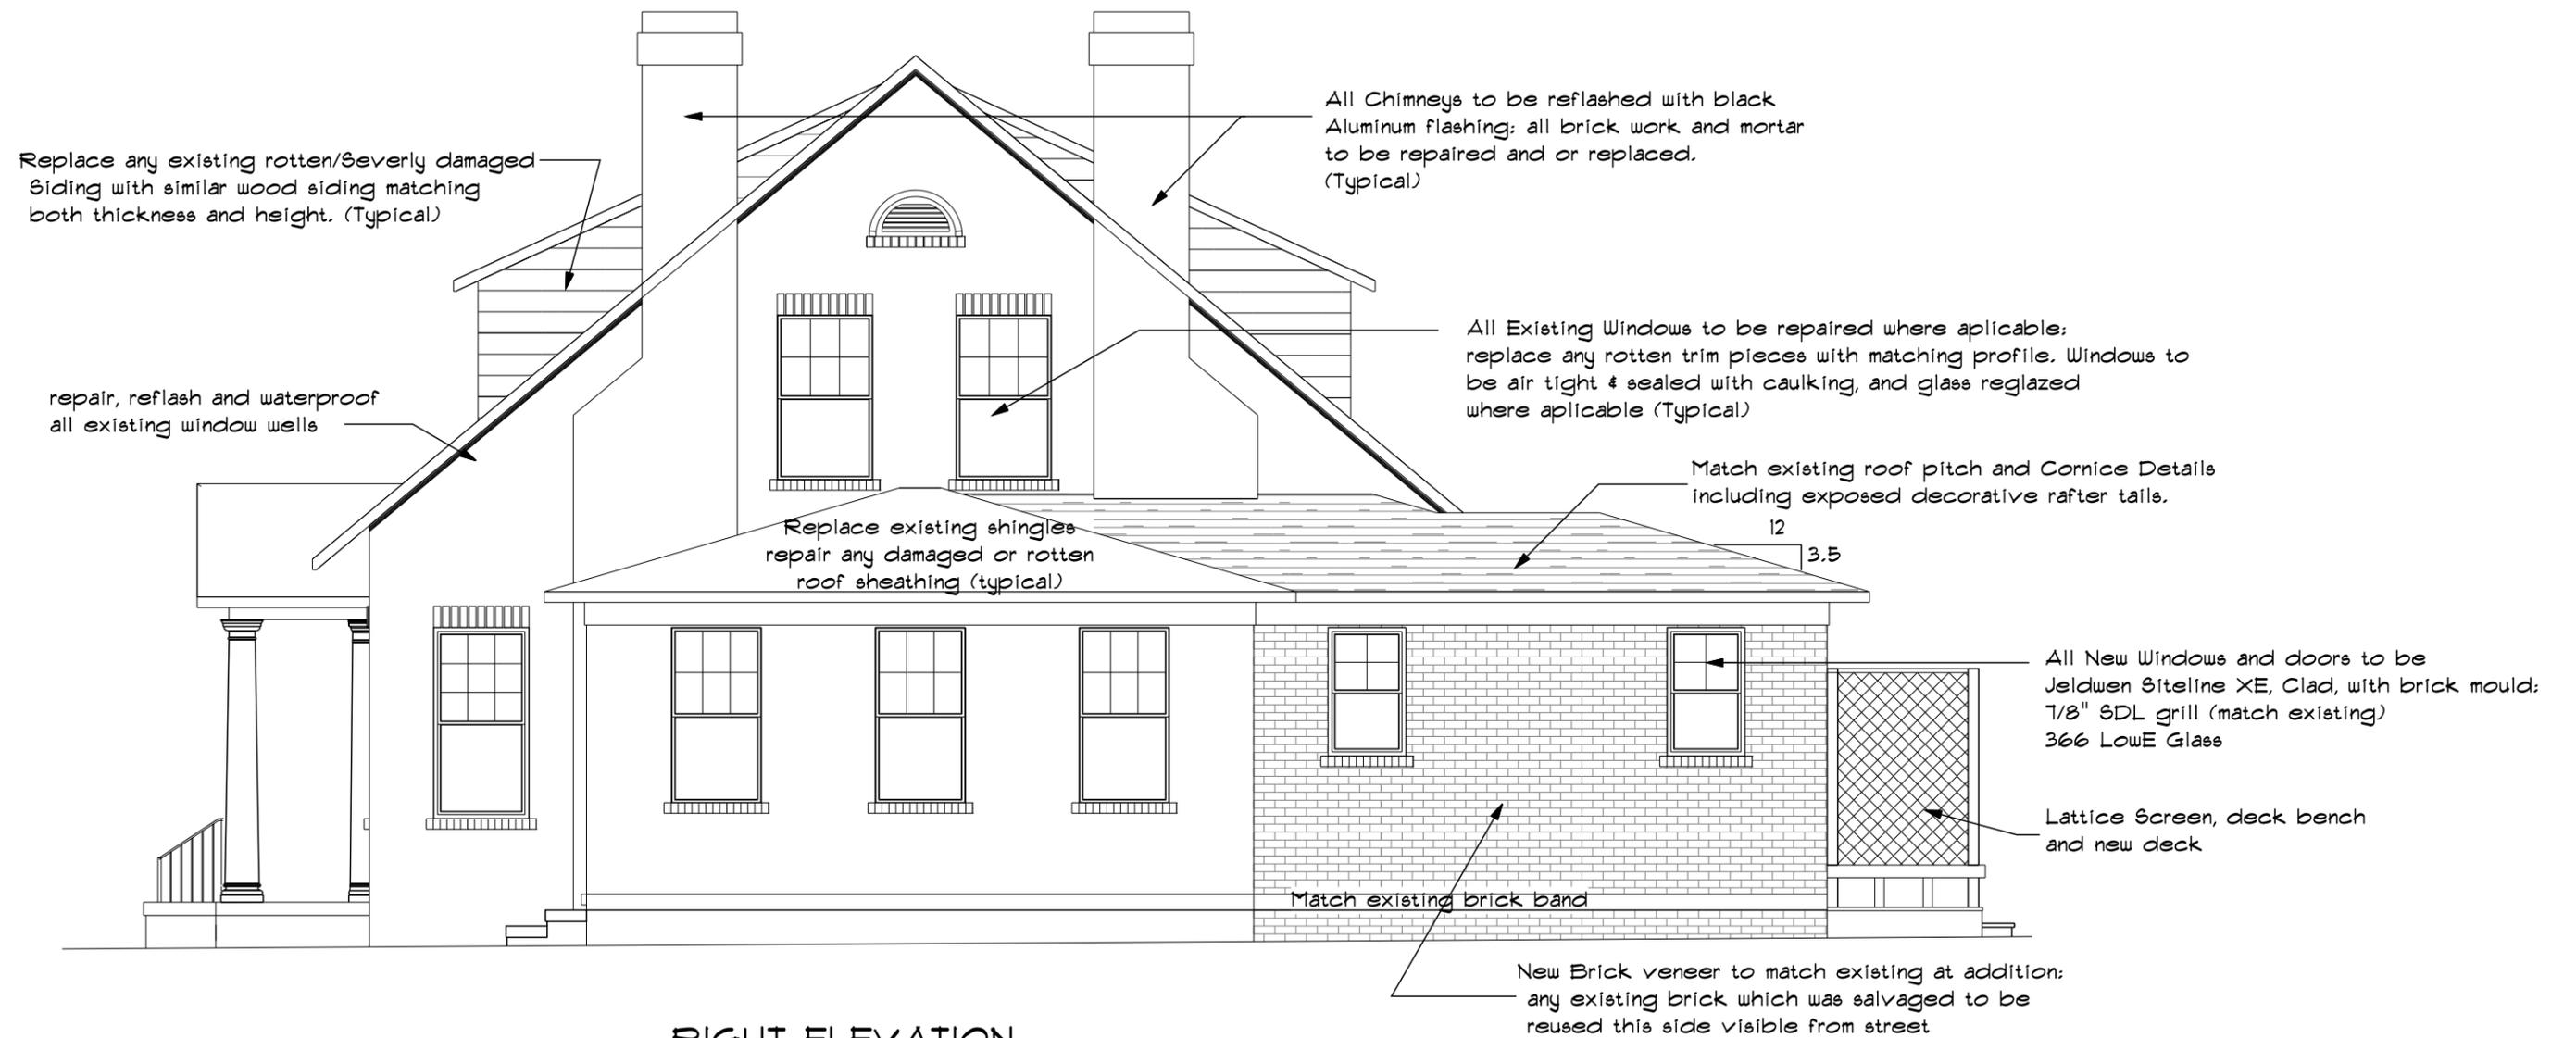
RIGHT ELEVATION

The proposed aluminum-clad SDL windows on the visible portion (right side) of the addition are much smaller and feature a different pane configuration than the original windows. The width of the SDL grids for the proposed windows is 7/8" which is wider than the 5/8" muntins of the existing windows. Staff recommends making the size, pane configuration, and muntin width of the proposed windows consistent with

- *The two windows on the right side of the addition shall be 6/1 wood or aluminum-clad windows with 5/8" muntins/grids and shall be consistent with existing window sizes on the side wing.*
- *All details deferred to staff*

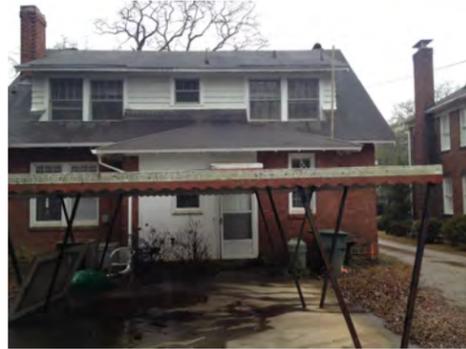
remove existing carport
