## D/DRC Case

1300 Summerville Avenue

**Cottontown/Bellevue Architectural Conservation District**

**DESIGN/DEVELOPMENT REVIEW COMMISSION  
DESIGN REVIEW DISTRICT  
HISTORIC AGENDA  
EVALUATION SHEET  
Case # 4**

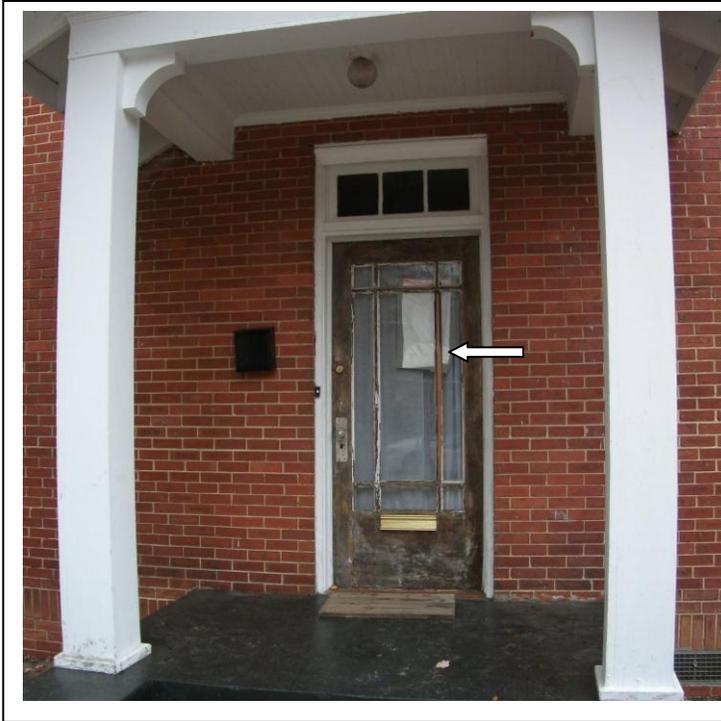
Damaged muntin indicated by arrow

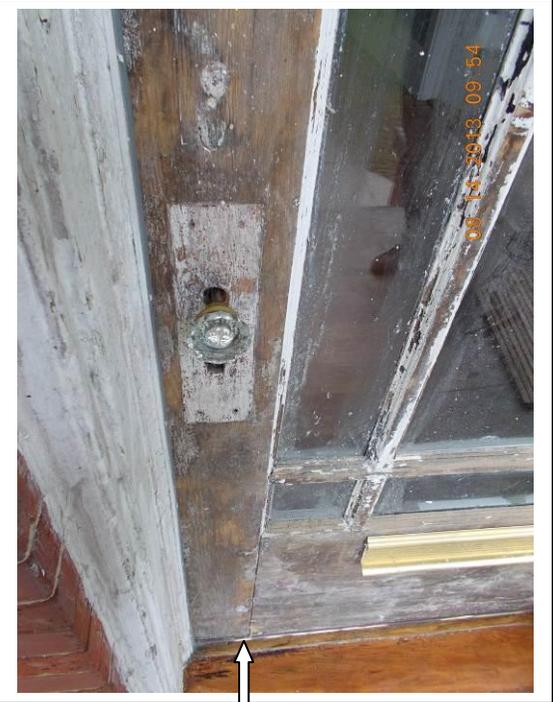
Image above from 2013 shows non-original doorknob and slight separation of vertical joint at the bottom of the door

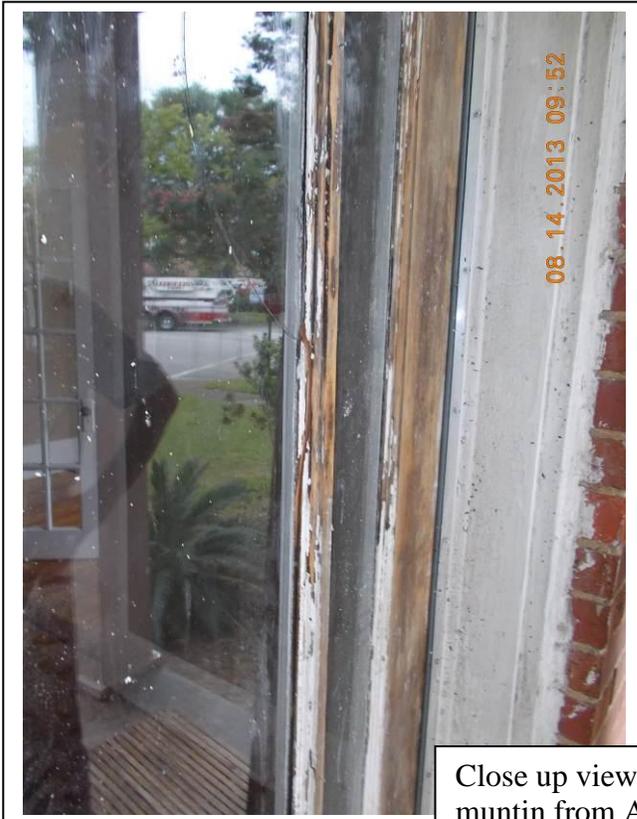
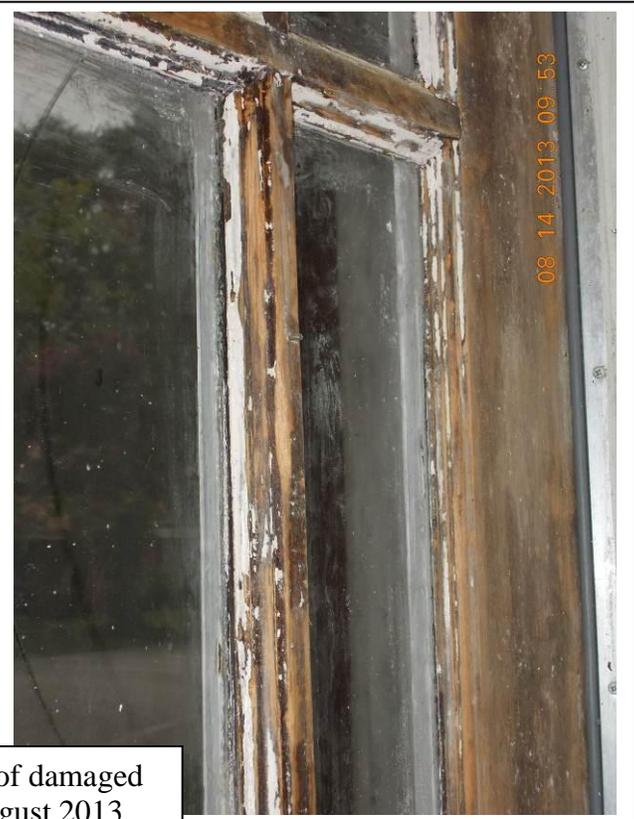
Close up views of damaged muntin from August 2013

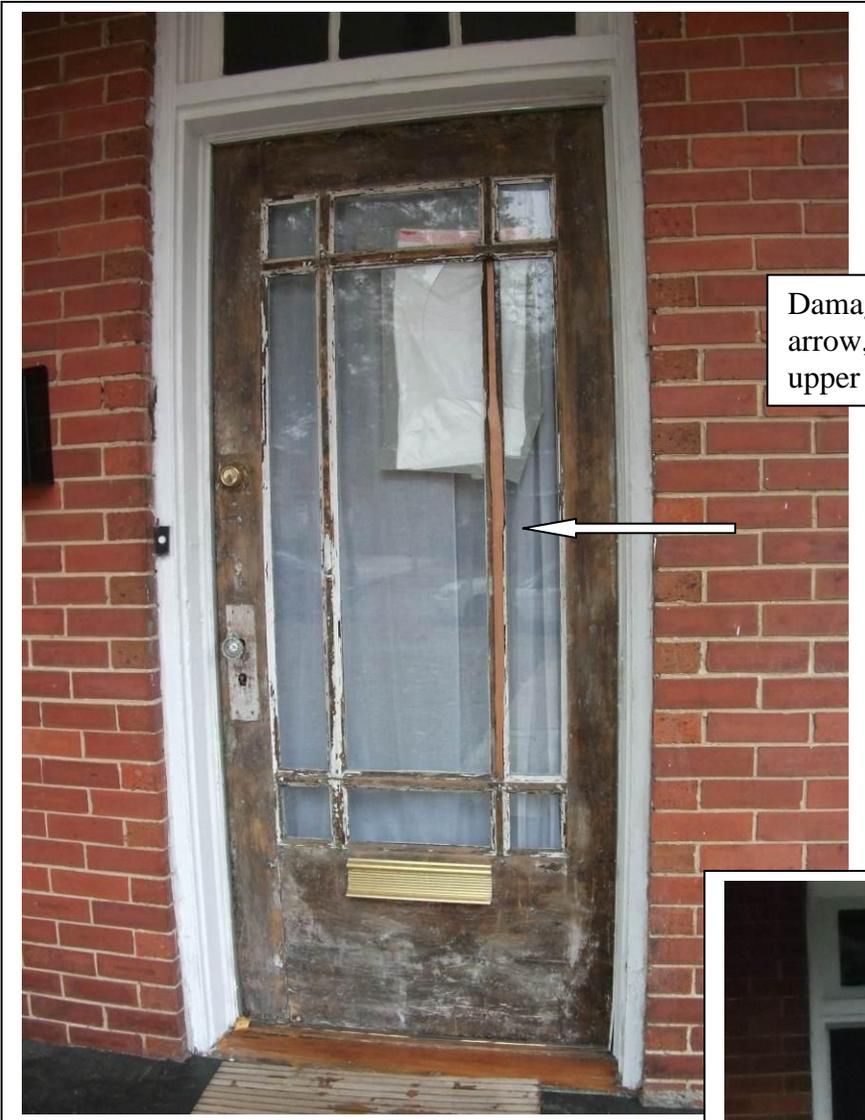
Damaged muntin indicated by arrow, central pane is broken in upper right corner

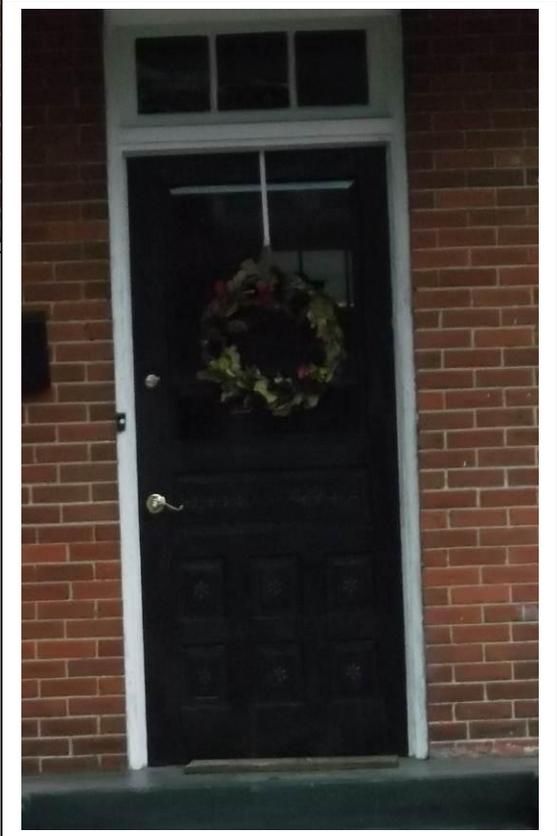
New Door

The door is not missing or deteriorated beyond repair. The proposed door does not closely match the original, nor is it of a compatible contemporary design, as it is a half-glass instead of a  $\frac{3}{4}$  glass door, does not mimic any of the muntin detailing, and features multiple raised panels and carving, instead of the flat, plain bottom of the original door.

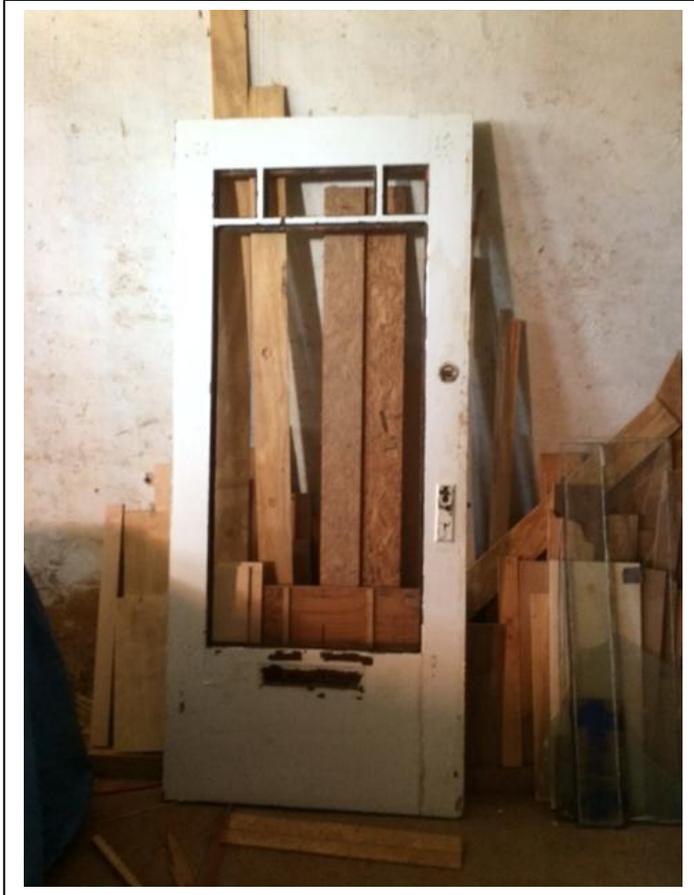
The door appeared to be very repairable when viewed by Staff. The owner has taken the door out to be repaired and has indicated that the door “fell apart.” The door was being used and appeared sturdy when viewed by staff, and a current photo supplied by the applicant shows that the stiles and rails are intact on the door, while the muntins and glass have been removed (please see attached). Repairing this door is possible and would meet the guideline; replacing the door does not meet this guideline.

**Left: Image by applicant showing current condition of the door**

Staff finds that the door previously on the building is likely original and therefore the proposal does not meet Section 7-1 of the guidelines. Staff recommends that the request for a Certificate of Design Approval for a new door be denied and recommends a time frame within which the applicant shall repair and reinstall the original door.

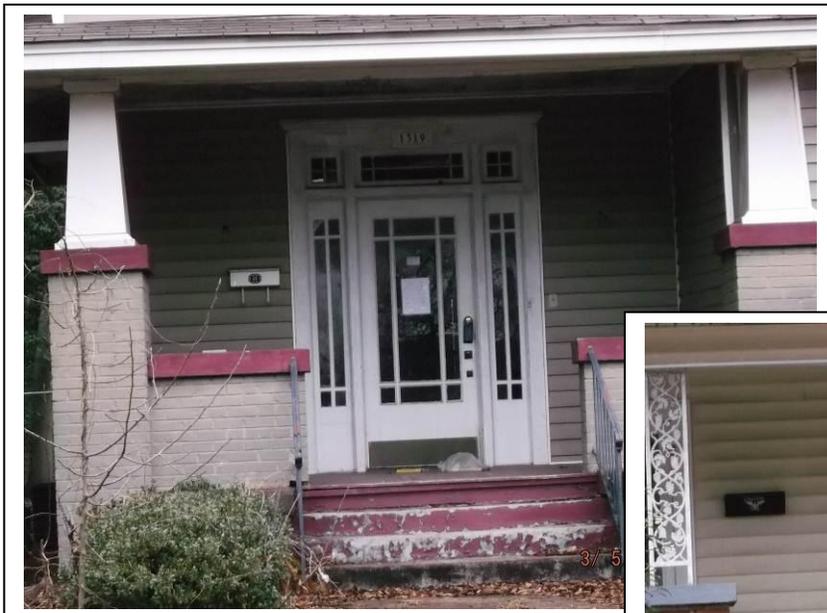
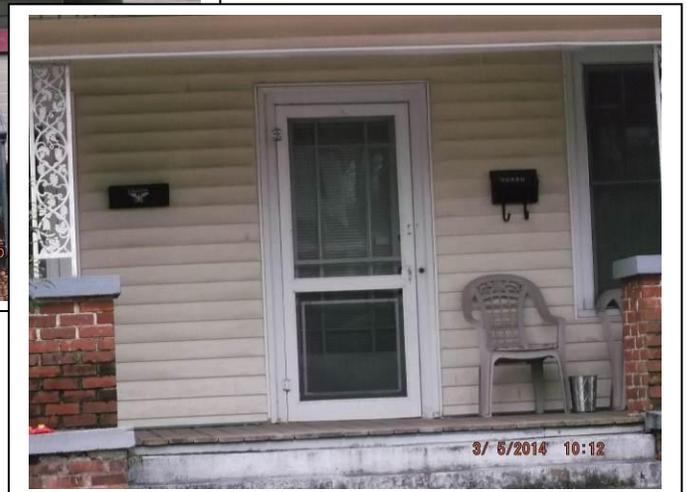
The applicant has questioned the fact that the door was original to the front of the house and has provided some information regarding that in an attached statement. Staff has identified three houses on the same 1300 block of Summerville Avenue with the exact same front door and would suggest that the applicant's information is not sufficient to prove that this is not the original front door (please see attached letter and images). The glass doorknob offered as proof of the building's original location in the interior is clearly not original to the door as there is the shadow of an escutcheon plate, and the gap around the door can be explained by wood shrinkage or changes to the door to accommodate weatherstripping that might have been removed. This can easily be remedied by adding a thin piece of wood to the door jamb to minimize the gap. Staff has noted a variety of thicknesses in exterior doors of historic buildings, so the measurement presented does not seem to exclude the possibility of this being an original exterior door.

**Below: Two of the three houses within the same block that have the same front door**
