D/DRC Case

3402 Earlewood Drive

Pending Certification for Bailey Bill

DESIGN/DEVELOPMENT REVIEW COMMISSION
BAILEY BILL APPLICATION
HISTORIC PROPERTY
EVALUATION SHEET
Case #2

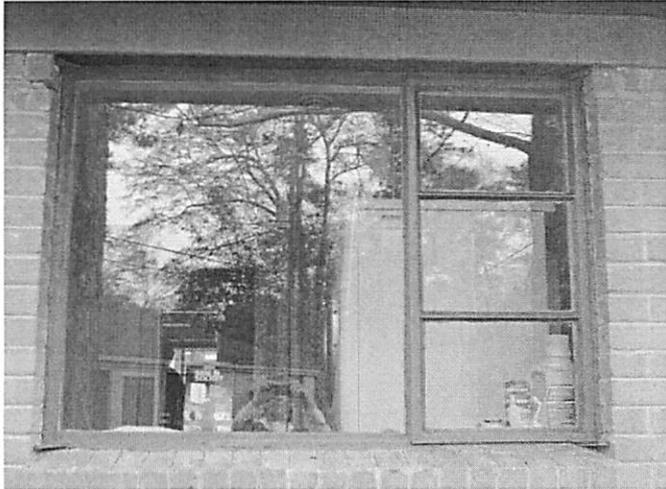
window "G"- missing muntins will be replaced

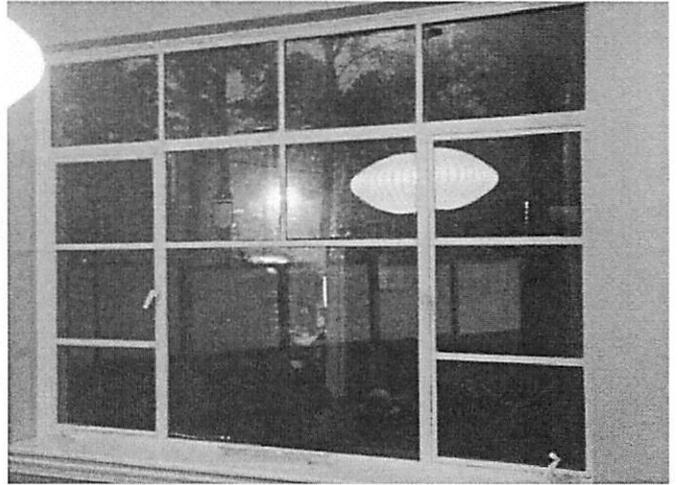
window "H" – missing muntins will be replaced

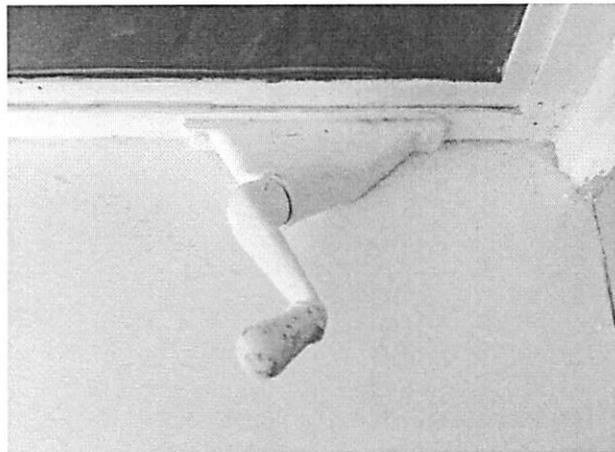
rusted hardware

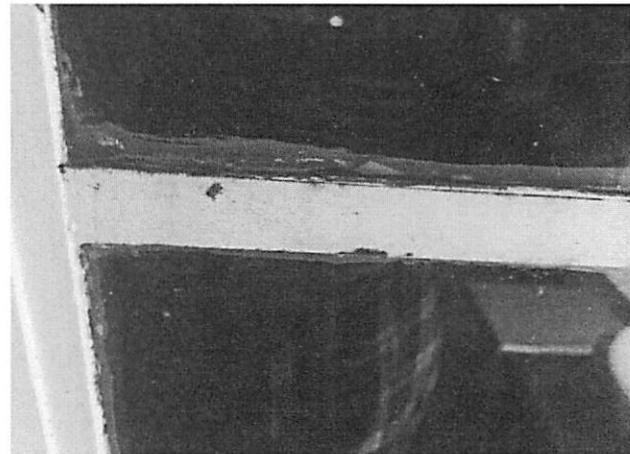
rusted muntins

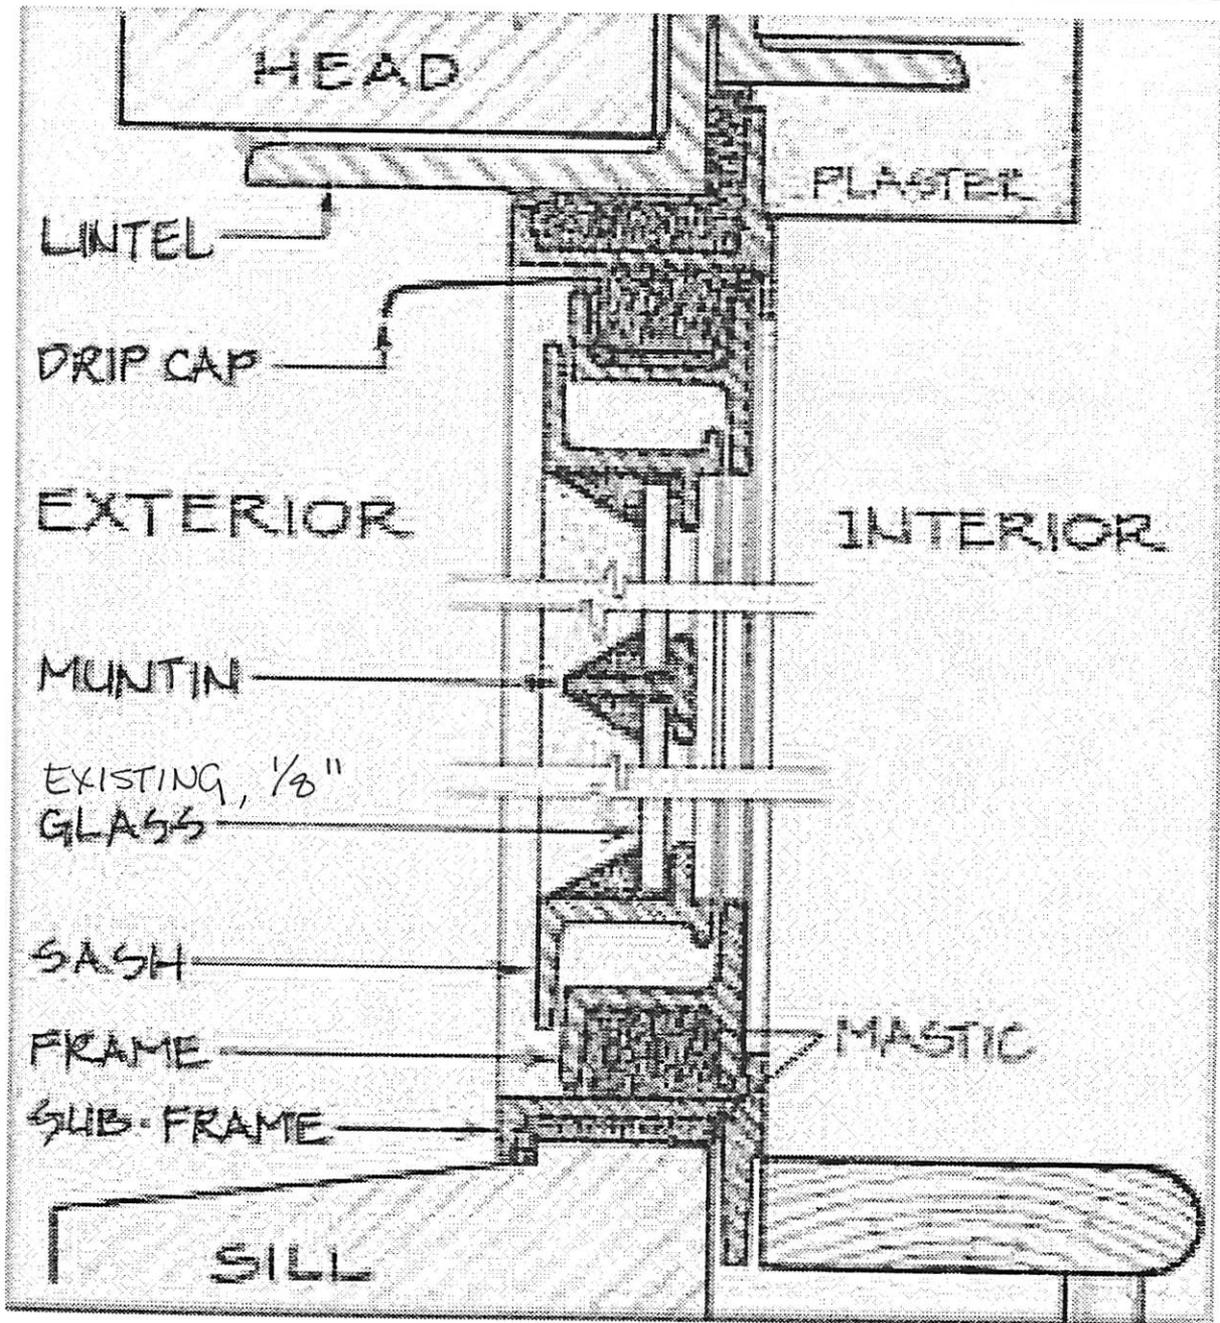
Existing window with 1/8" glass.

Total depth of window sash is 1".

Existing section through 1/8" glass; exterior relief of 1/2"
