D/DRC Case

3326 Kline Street

Melrose Heights/Oak Lawn Architectural Conservation District

DESIGN/DEVELOPMENT REVIEW COMMISSION
DESIGN REVIEW DISTRICT
HISTORIC AGENDA
EVALUATION SHEET
Case # 1

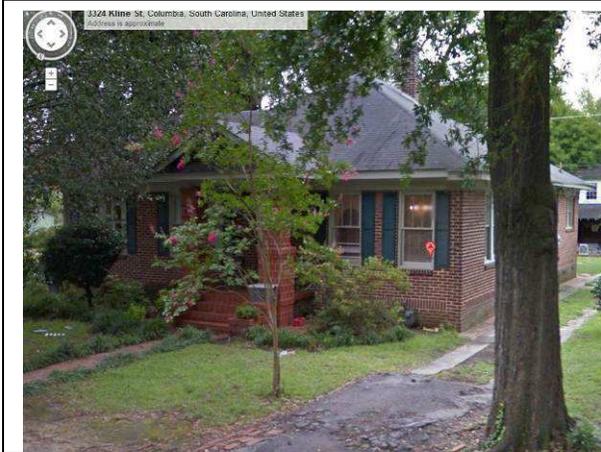
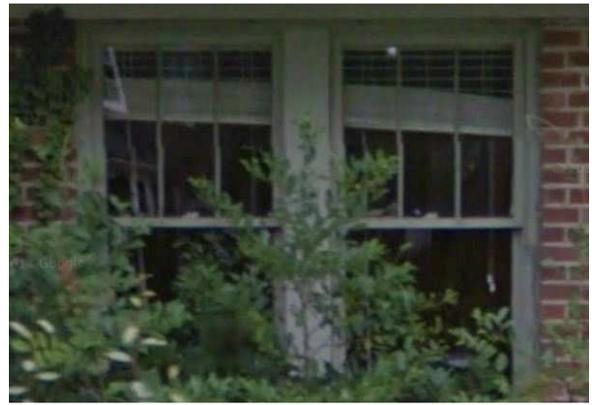
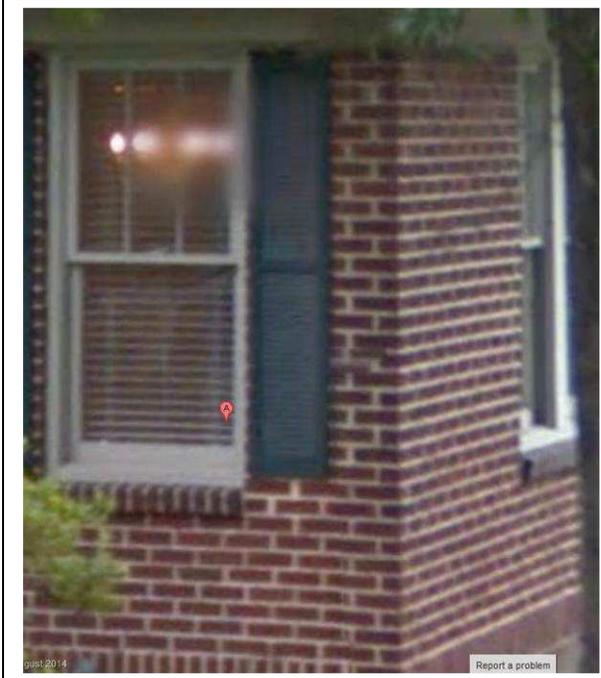
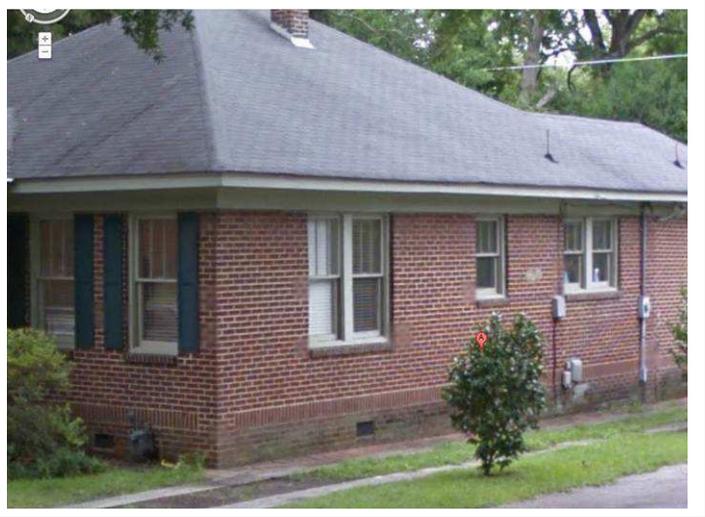
Staff was unable to look at the original windows in person but the images from the Google streetview appear to show intact 3/1 windows. There are no violation notices on file from the City indicating that they had found the building or its windows to be in disrepair.

Above and Left: August 2014 Google images

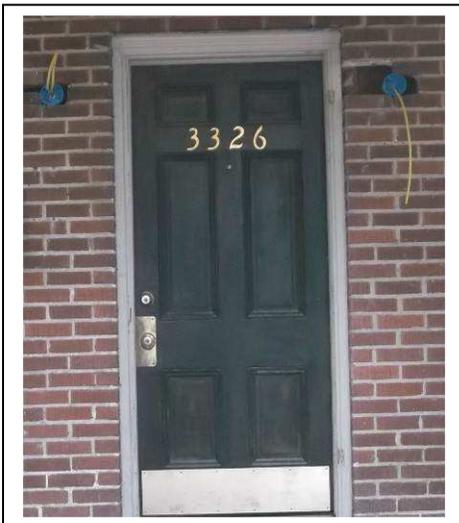
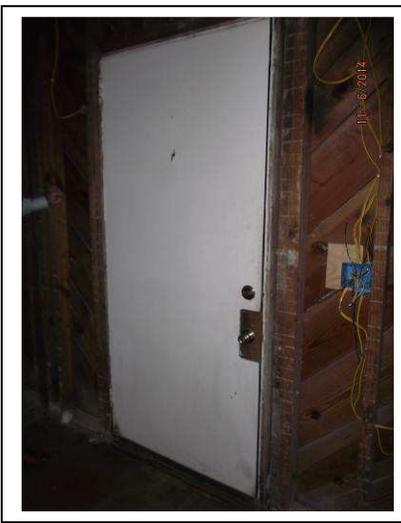
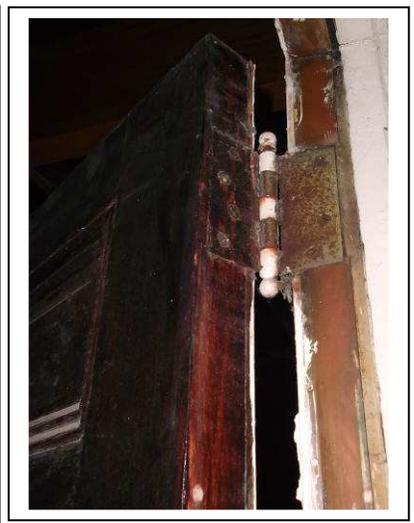
The door in the house appears to be original. It is a simple 6-panel, solid wood Colonial Door with historic hinges and no sign of new hinge holes. From the exterior the door is in very good condition. The interior has had a thin panel added. The owner does not like the panel and wants to replace the door with a replica. However, there is no indication that there is anything physically wrong with the door, and although staff suggested the owner remove the interior panel to investigate the condition of the door he has not provided any information regarding the condition of the door behind the panel. The door appears to be solid and in good condition.

While this door is not a unique or highly stylized door, it appears to be original and in good condition, and would merit retention based upon the guideline to “retain and repair historic...doors.”

Below: Recent staff images of door

Staff finds that the proposal affects items on the house that are visible to the public right of way and that the proposal does not meet Section 7 of the guidelines; therefore staff recommends that the request for Certificate of Design Approval be denied.

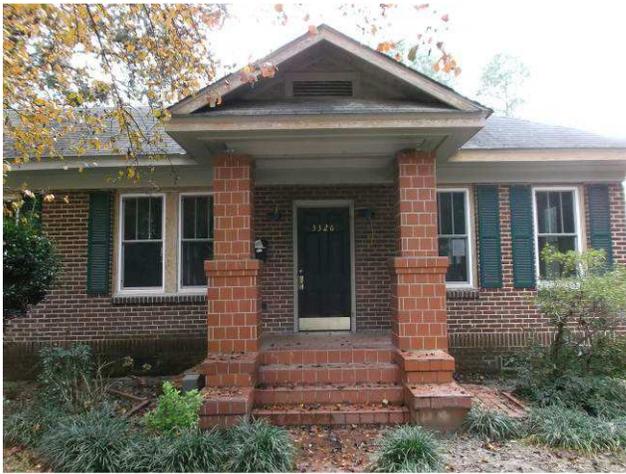
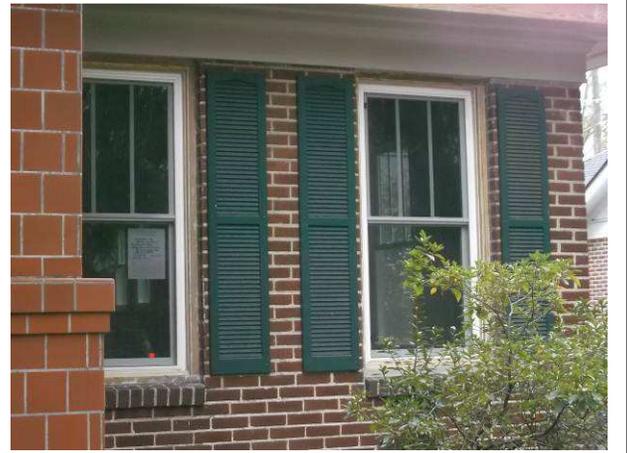
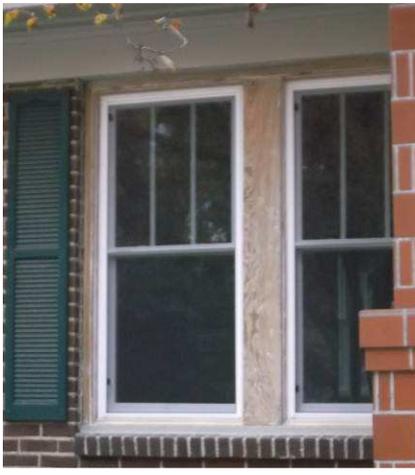
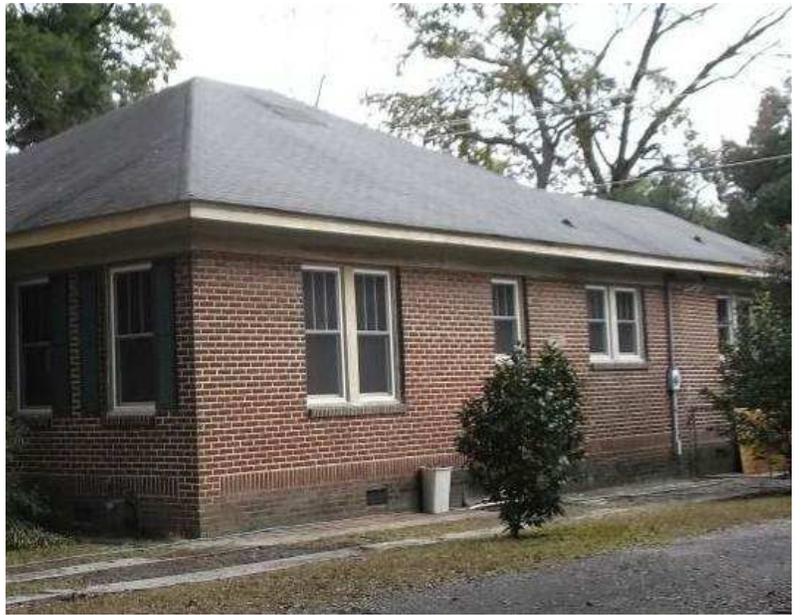
The vinyl windows that were installed do not match the material, glazing, reflective quality and detailing of the original windows. They feature integrated screens that obscure the windows somewhat from view, but they are clearly not the original wood windows. Their GBG detail allows for a solid sheet of glass in front of the false muntins, which creates a different reflective quality than is seen in true divided lite windows. The rails and stiles of the vinyl sashes are very uniform in size and therefore do not replicate wood window details. The vinyl window inserts also create more framing around the glass sashes than originally existed since they are built as an independent unit with their own jambs. Finally, the vinyl material does not replicate historic wood windows in material. Therefore, the proposed vinyl windows do not meet this guideline.

Current images by staff

Note that this house is on a corner and a majority of the windows are visible. The public right of way is extremely close.

Staff further recommends that the vinyl windows be removed within 60 days and that they be replaced with windows in keeping with Section 7 of the guidelines: true-divided lite, wood, double-hung sash windows with single-pane glass of a 3/1 configuration matching the details of the wood windows that were removed from this home.

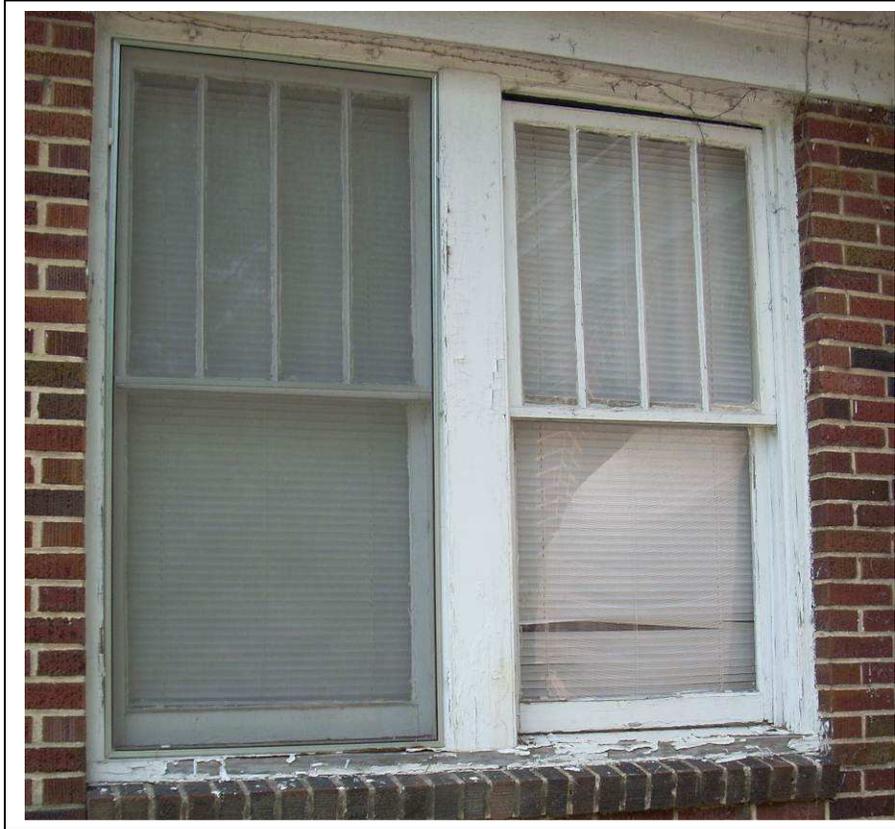
Left: Staff photo of a **different house** with a similar window configuration

Note that even with a screen the window's details and dimensions are obvious

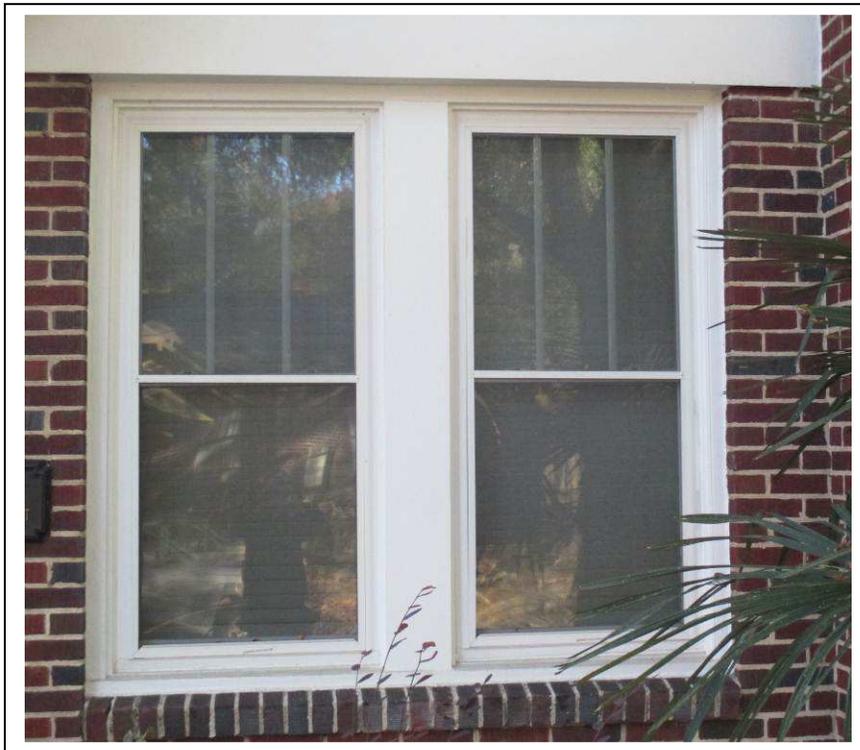
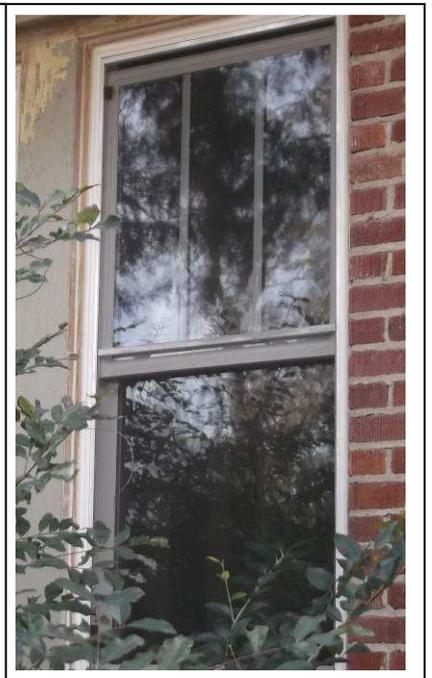
Below: Images of the new vinyl windows in **3326 Kline** show how different they appear from the wood windows at left
