D/DRC Case

1116 Woodrow Street

Melrose Heights/Oak Lawn Architectural Conservation District

DESIGN/DEVELOPMENT REVIEW COMMISSION
DESIGN REVIEW DISTRICT
CONSENT AGENDA
EVALUATION SHEET
Case # 2

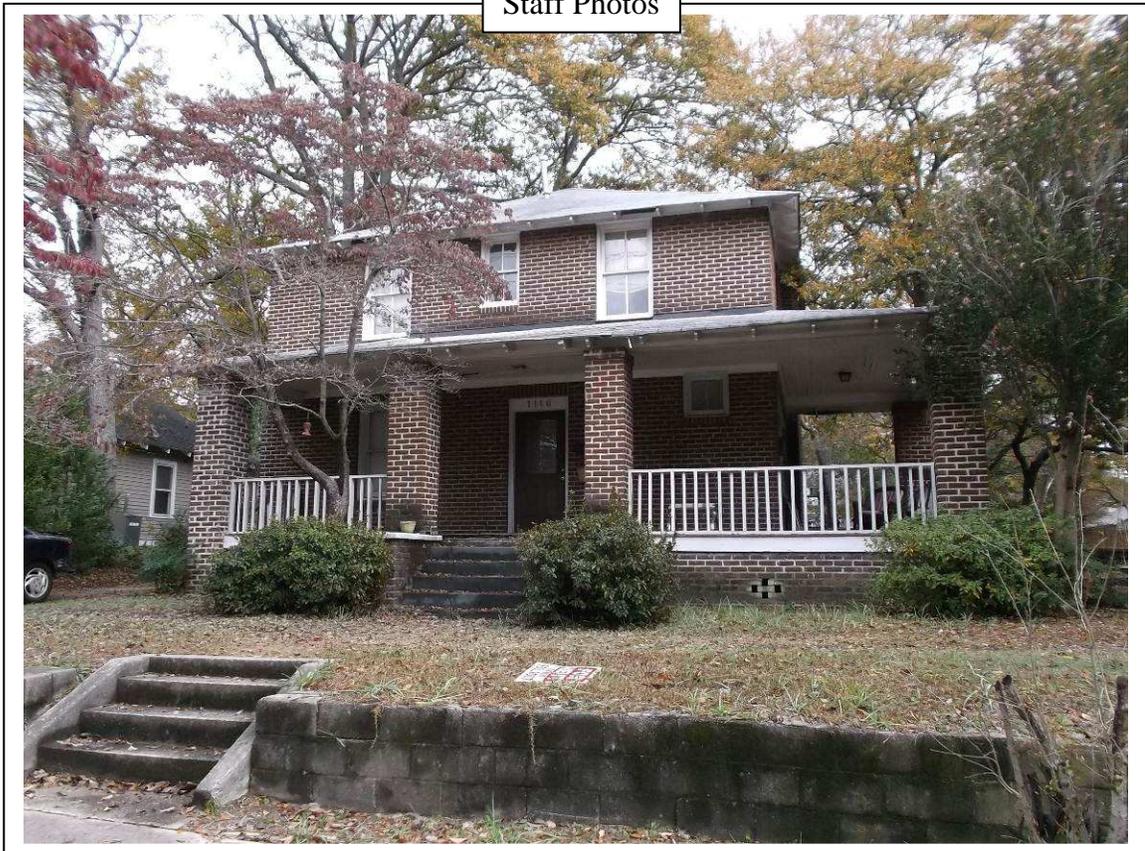
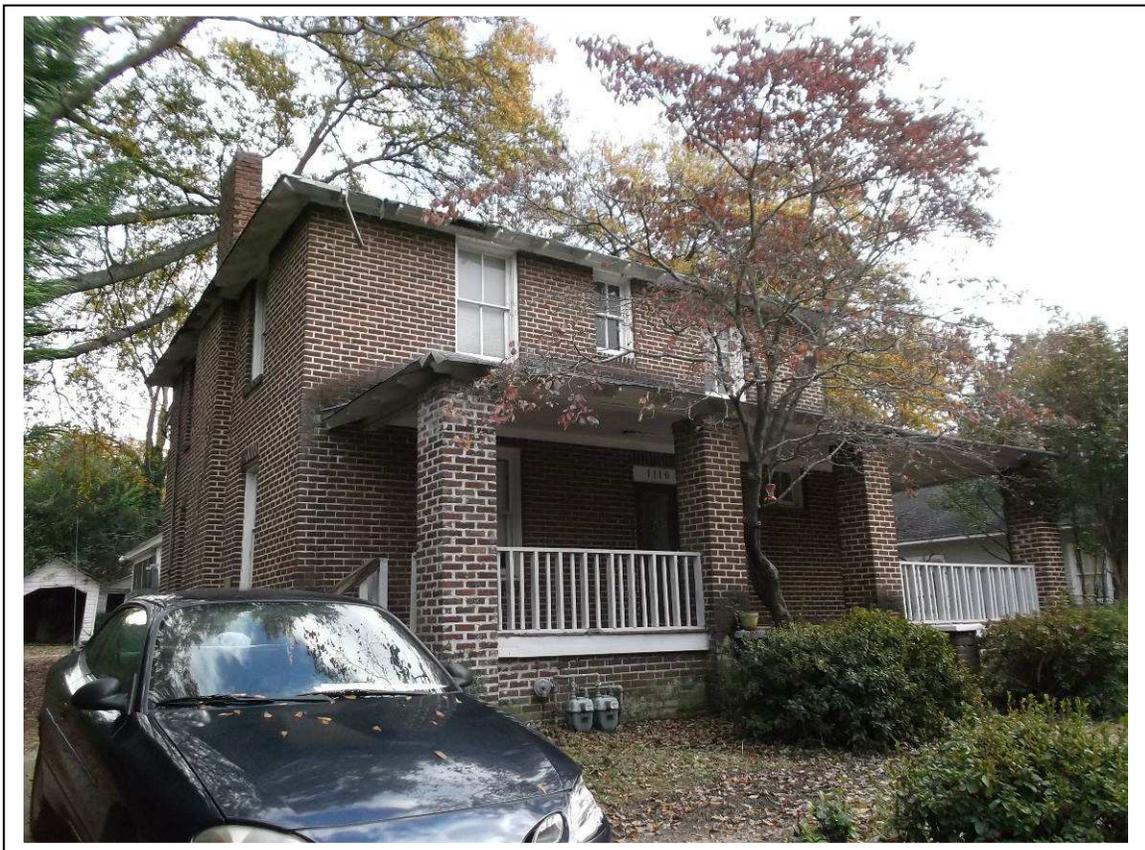
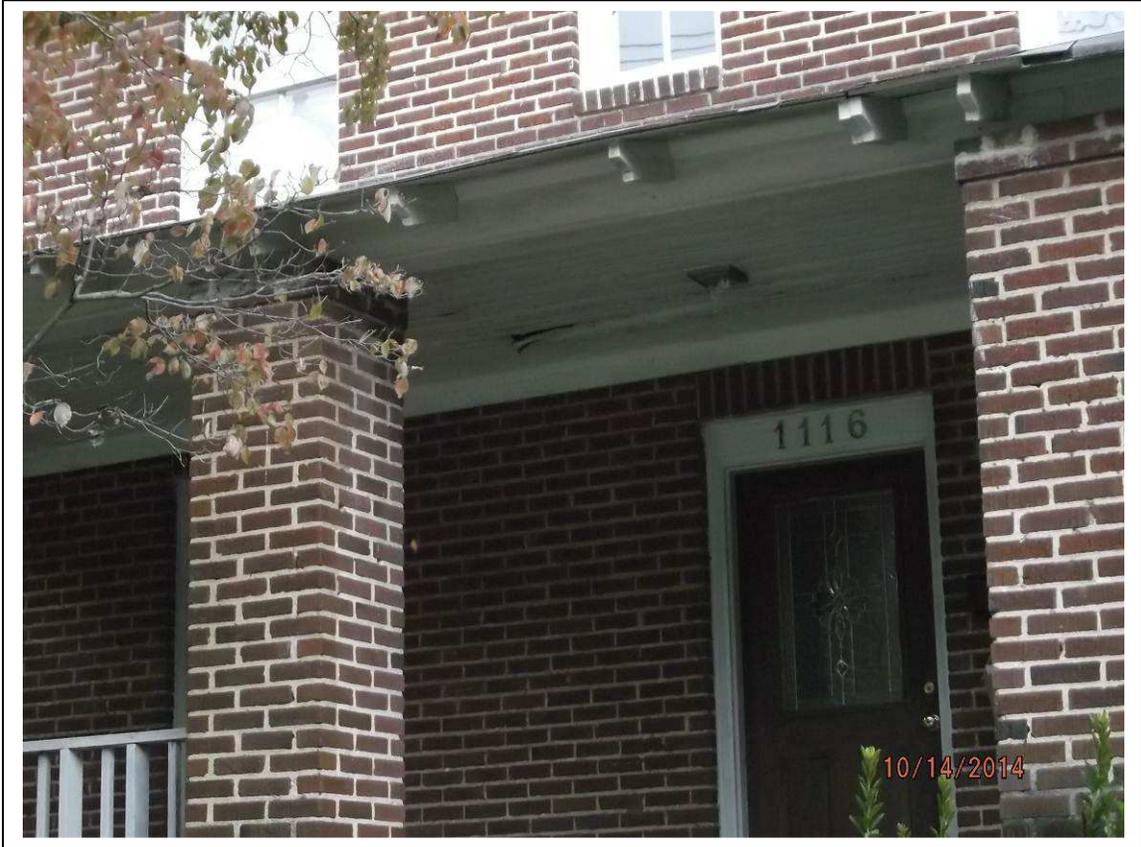
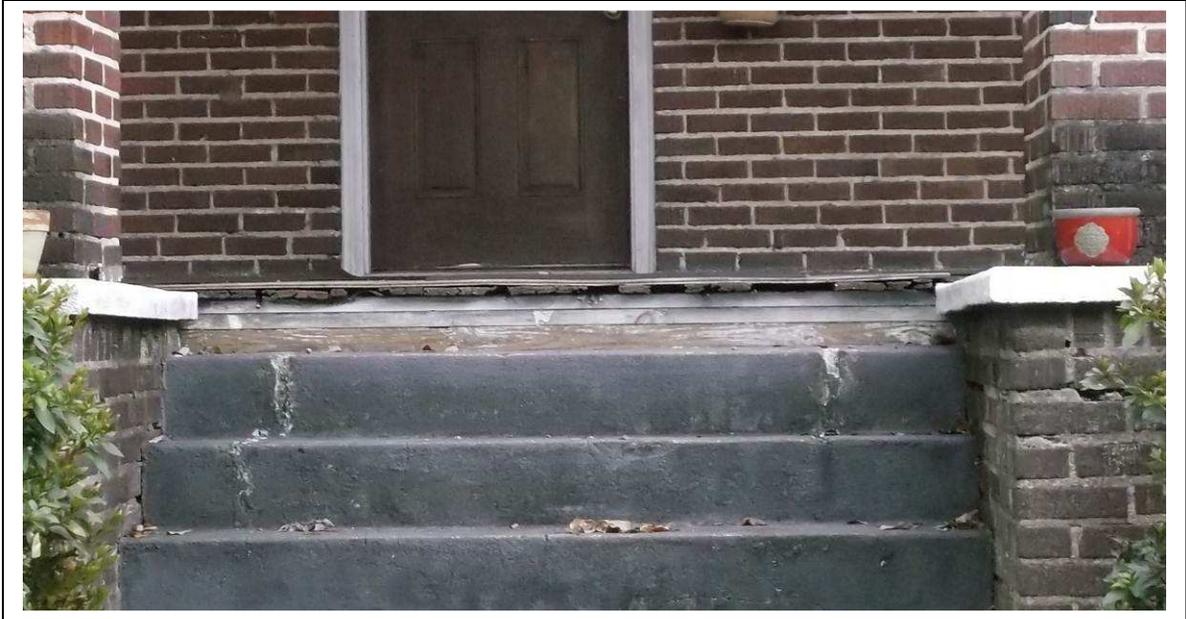
Staff Photos

The porch flooring is somewhat deteriorated due to the water and termite damage in the floor joists, and part of the porch floor has previously been replaced. The proposal is to replace the porch floor with the exact same kind of flooring, which is the typical tongue-and-groove 1"x3" dimensional wood.

The historic character will be retained and preserved. There is some removal of historic material on the porch floor and a few pieces of the porch ceiling due to damage. The porch floor has already been compromised by new infill pieces and rot. The beadboard porch ceiling will be carefully repaired with replacement of only a few boards that show disrepair.

Staff photos of porch ceiling and porch floor in disrepair

The brick chimney is deteriorated along the top few courses but they will be rebuilt and the chimney will be repointed. The porch flooring is deteriorated and will be repaired in kind with the exact same type of flooring.

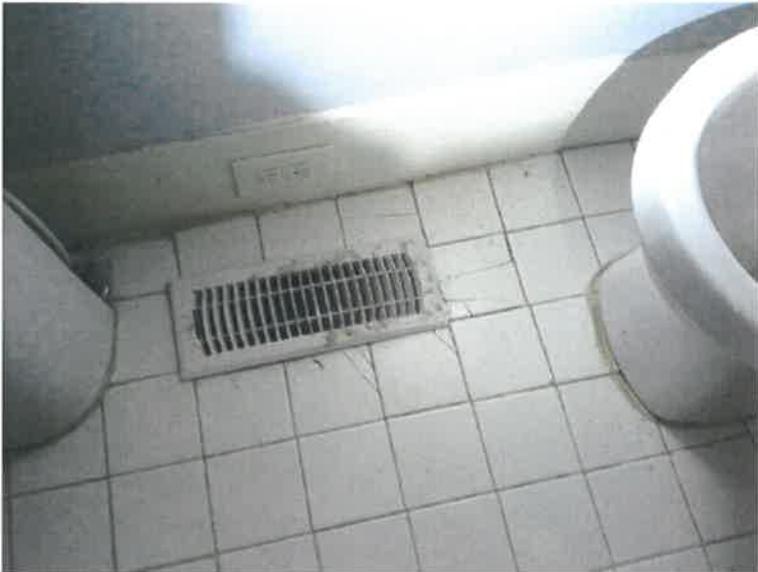
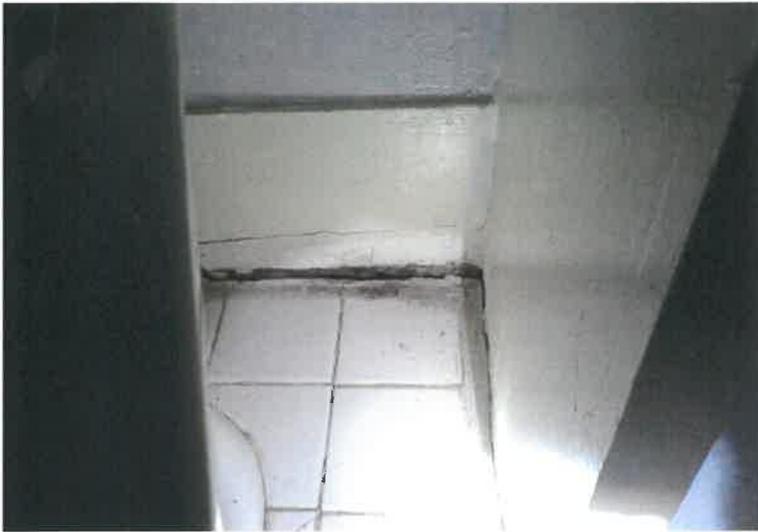
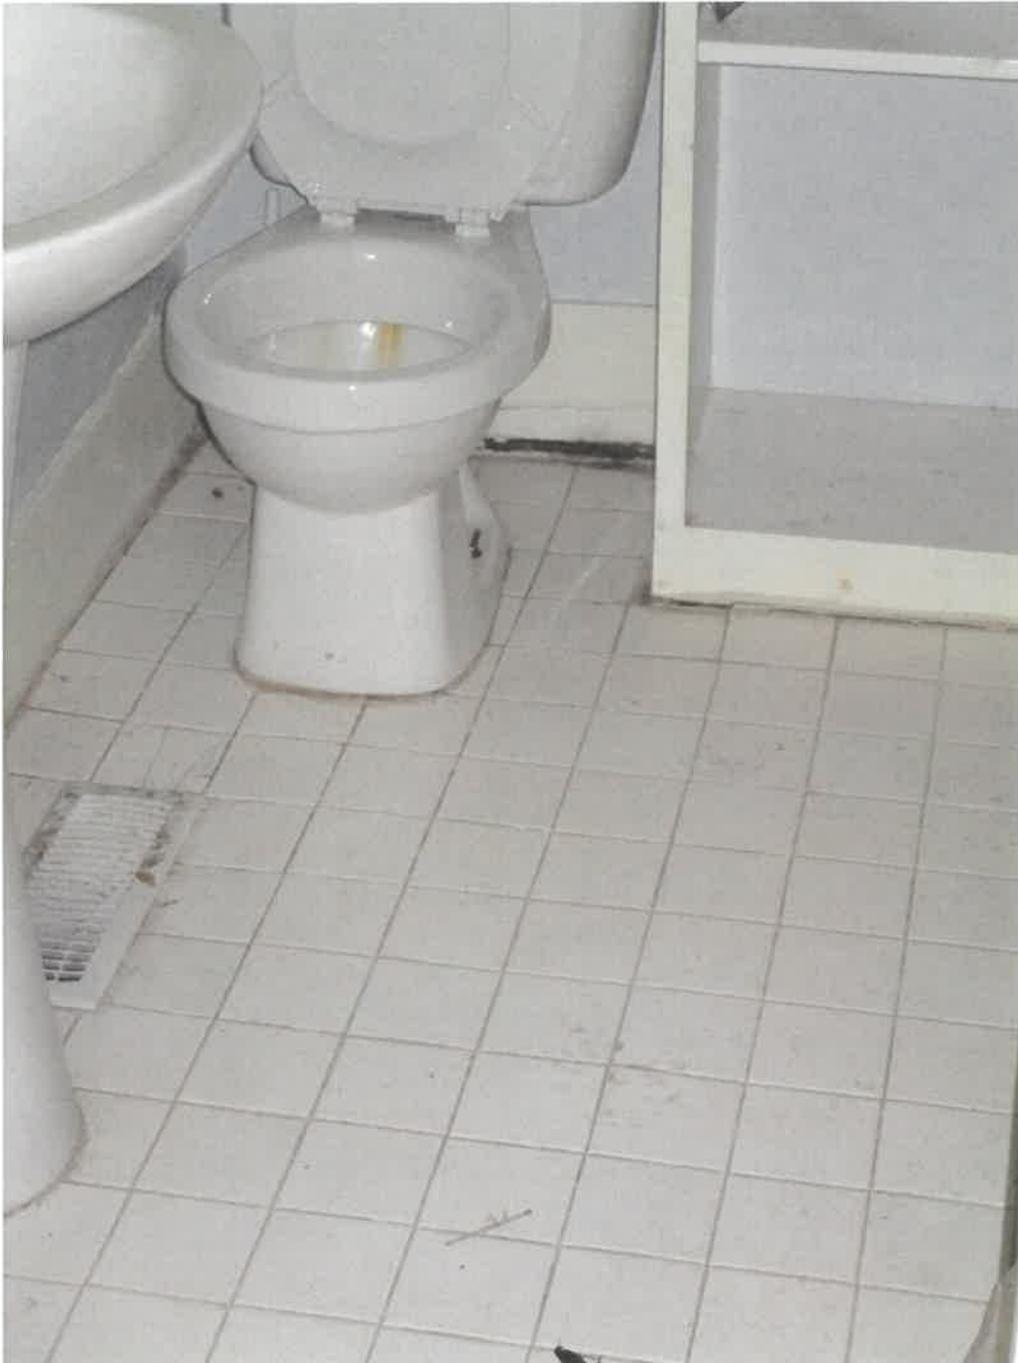
Picture #19

<p>Architectural feature <u>Right Rear Bathroom</u> Approximate date of feature <u>Unknown</u> Describe feature and its condition</p> <p>Subflooring and structure under the bathroom is rotten. Tile flooring is loose and cracked</p> <p>Photograph No. <u>19 - 21</u> Drawing No. _____</p>	<p>Describe work and impact on feature</p> <p>Demo bathroom to repair sub structure. Update plumbing / electrical as needed. Replace subfloor and tile.</p> <p>This will increase structural integrity of bathroom, improve safety, lengthen useful life of the house, and improve aesthetic of bathroom</p>
<p>Architectural feature <u>Plumbing</u> Approximate date of feature <u>1930</u> Describe feature and its condition</p> <p>Much of the plumbing is original galvanized piping which often corrodes over time. A leak was observed under the hall bathroom.</p> <p>Photograph No. <u>22 - 23</u> Drawing No. _____</p>	<p>Describe work and impact on feature</p> <p>Repair leak and replace galvanized piping where possible.</p> <p>This will prevent future leaks, increase water flow, and prevent structural damage due to rot. Also, will increase useful life of the house.</p>
