D/DRC Case

1218 Daly Street

Melrose Heights/Oak Lawn Architectural Conservation District

NATURE OF REQUEST: Request Certificate of Design Approval for exterior change

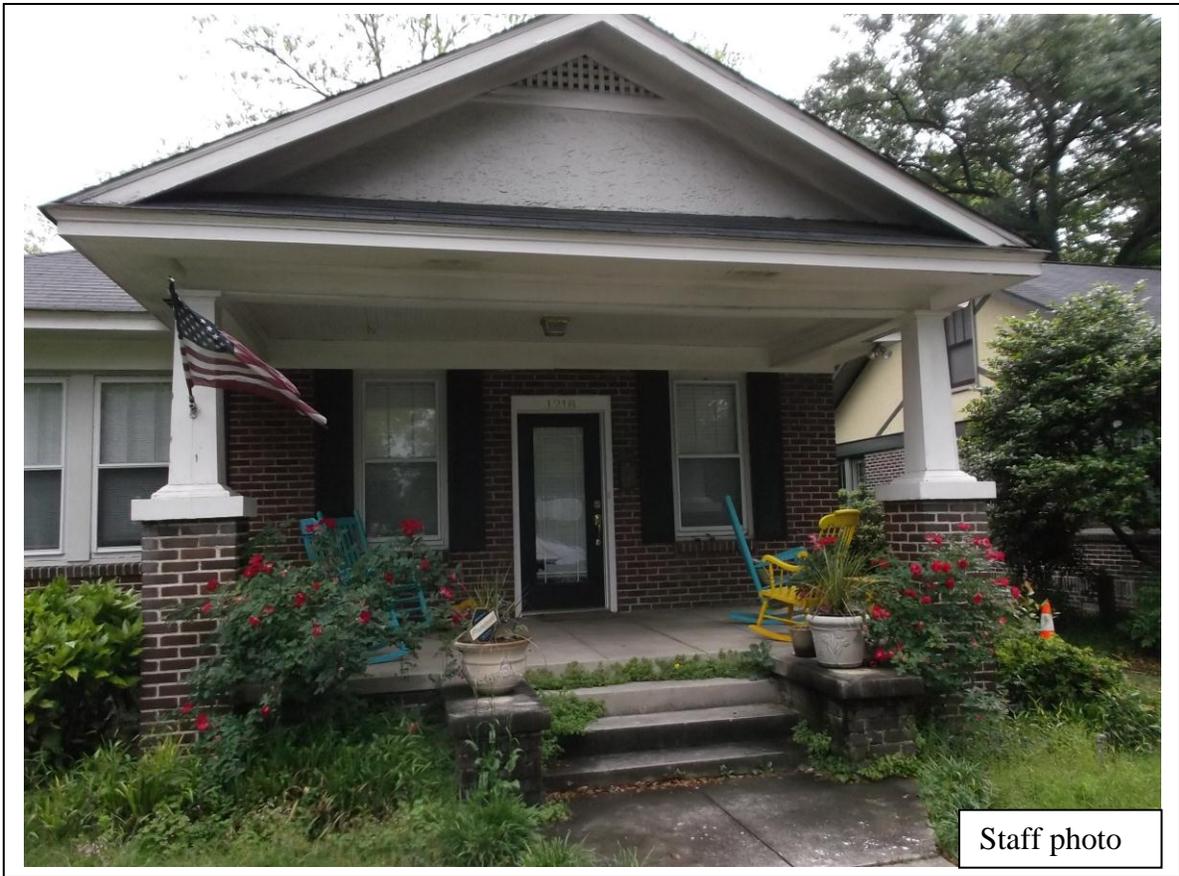
Staff photo

This guideline indicates that the door should have been repaired rather than replaced. Staff was not able to see the door prior to its replacement but its protection from the elements by the front porch suggests that rot should have been minimal. The door that was recently installed appears to have been a pre-hung, meaning that it required the removal of original trim in the opening. Finally, the new door appears to be a few inches shorter than the original, which has resulted in the addition of a sort of lintel above the door that is not reflective of the original trim design on the house.

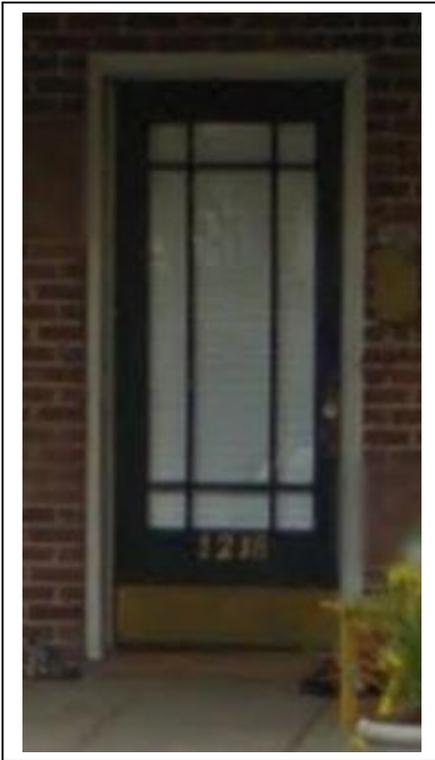
Had the door been deteriorated then a door that “closely” matches the original is necessary to meet this guideline. The applicant has indicated that the door is “as similar to the original as possible,” and while the muntin design in the glass does attempt to repeat the pattern found on the original door, it fails to replicate the exterior muntins found on the original glass and instead has a faux muntin sandwiched between the glass. This creates what appears to be a large span of uninterrupted glass, with the faux muntins largely invisible in the reflective glare on the glass. The faux muntins also are much narrower than what existed on the original door; they do not have the width or dimensions of the original. The bottom rail of the original door was also taller than that of the replacement door.

Original door, Google view

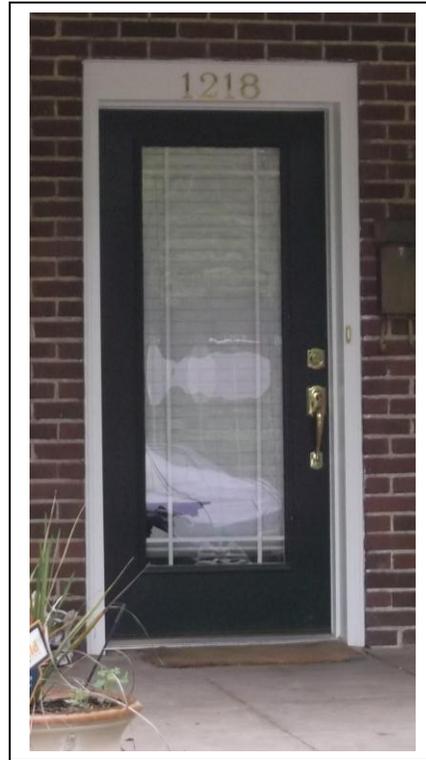
The replacement of the door and trim does not meet this guideline.

Staff finds that the door installed does not meet this guideline.

New door, staff photo

Staff finds that the proposal does not meet Section 7 of the guidelines and recommends the request for the new door be denied.

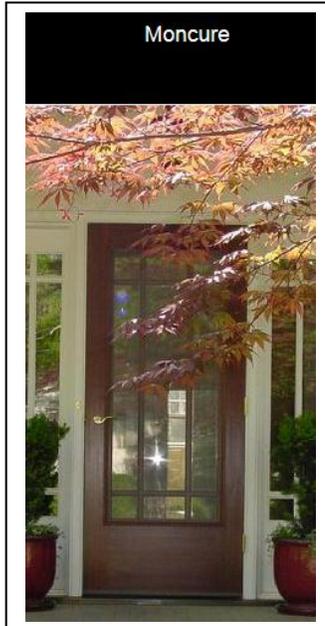
Southern Custom Doors, example of new door

Staff has found a few manufacturers who supply this door type in a contemporary design that is largely compatible with the original door in that they have the exterior muntins that better replicate the original door. Home Depot and door companies carry these doors.

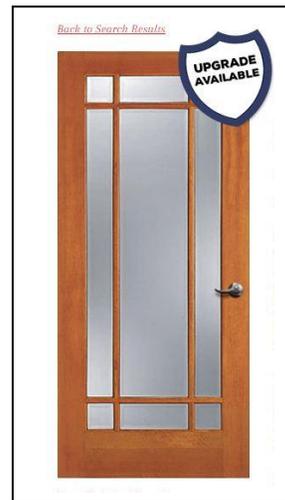
Simpson Door, example of new door
