## D/DRC Case

2211 Bull Street

Cottontown/Bellevue Architectural Conservation District

**DESIGN/DEVELOPMENT REVIEW COMMISSION  
DESIGN REVIEW DISTRICT  
REGULAR AGENDA  
EVALUATION SHEET  
Case #1**

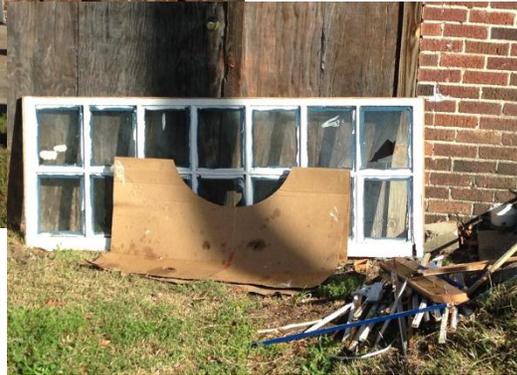
The current vinyl windows do not reflect the detailing, muntin profile, muntin depth or materials of the historic wood windows.

The new vinyl windows do not match the historic window's muntin profile, as the new windows have dividers between the glass. The vinyl material is not sympathetic to the original wood windows. If the applicant had gained a city permit for the window work, staff would have advised that any window replacement should be wood or aluminum clad.

Replacement and original window

*Per section VII of the Cottontown/ Bellevue Design guidelines, staff **does not recommend granting a Certificate of Design Approval** for the window replacement and recommends reinstalling the historic wood windows that were removed. If any new windows are required, staff will review and approve based on the design guidelines for Cottontown/ Bellevue. All details deferred to staff.*
