D/DRC Case

DESIGN/DEVELOPMENT REVIEW COMMISSION
DESIGN REVIEW DISTRICT
HISTORIC AGENDA
EVALUATION SHEET
Case # 2

ADDRESS: 1321 Lady Street, Owen Building

NATURE OF REQUEST: Request Certificate of Design Approval for exterior changes and preliminary approval for Bailey Bill

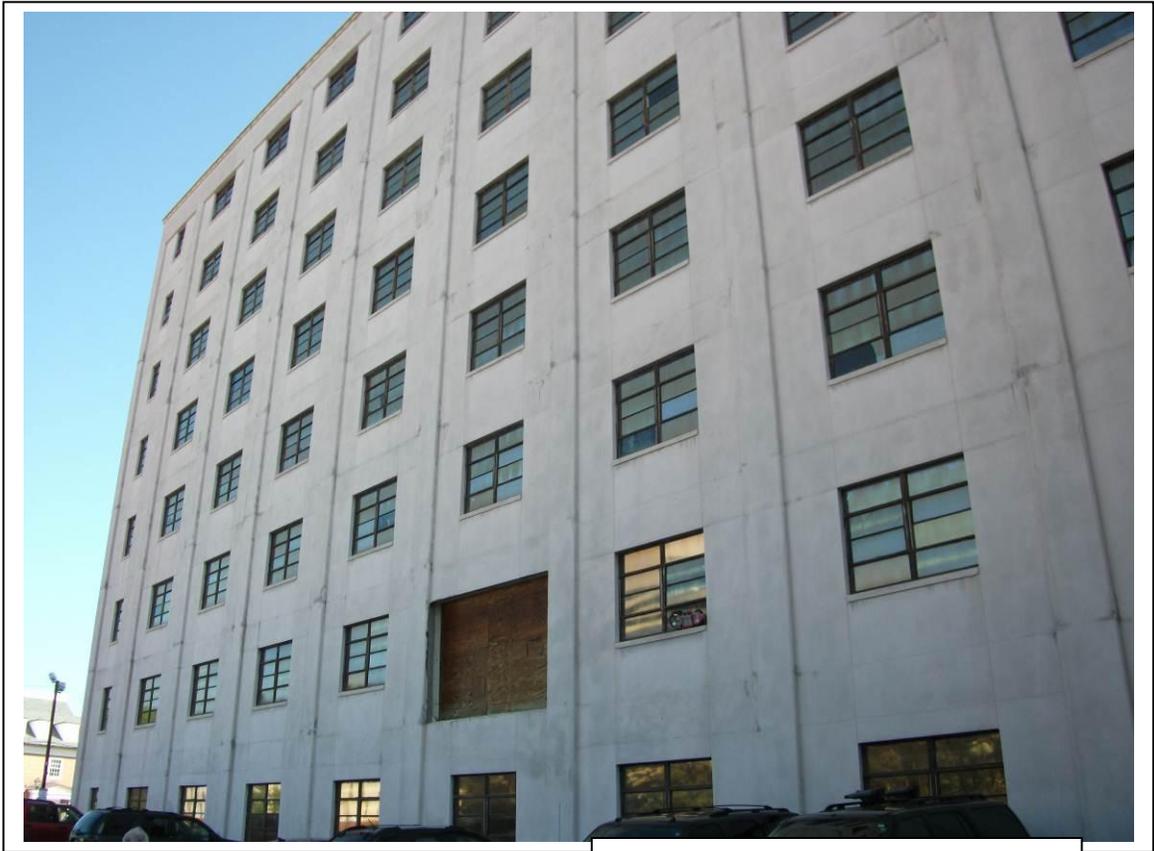
West side wall and window

Missing Windows: Two windows are proposed on the rear wall of the original building to replace two windows that were removed. There is evidence in this wall, which is painted brick, of two large windows. Window matching the original configurations of 8 panes will be placed in these locations as well as in a hole on the west side where a window was removed.

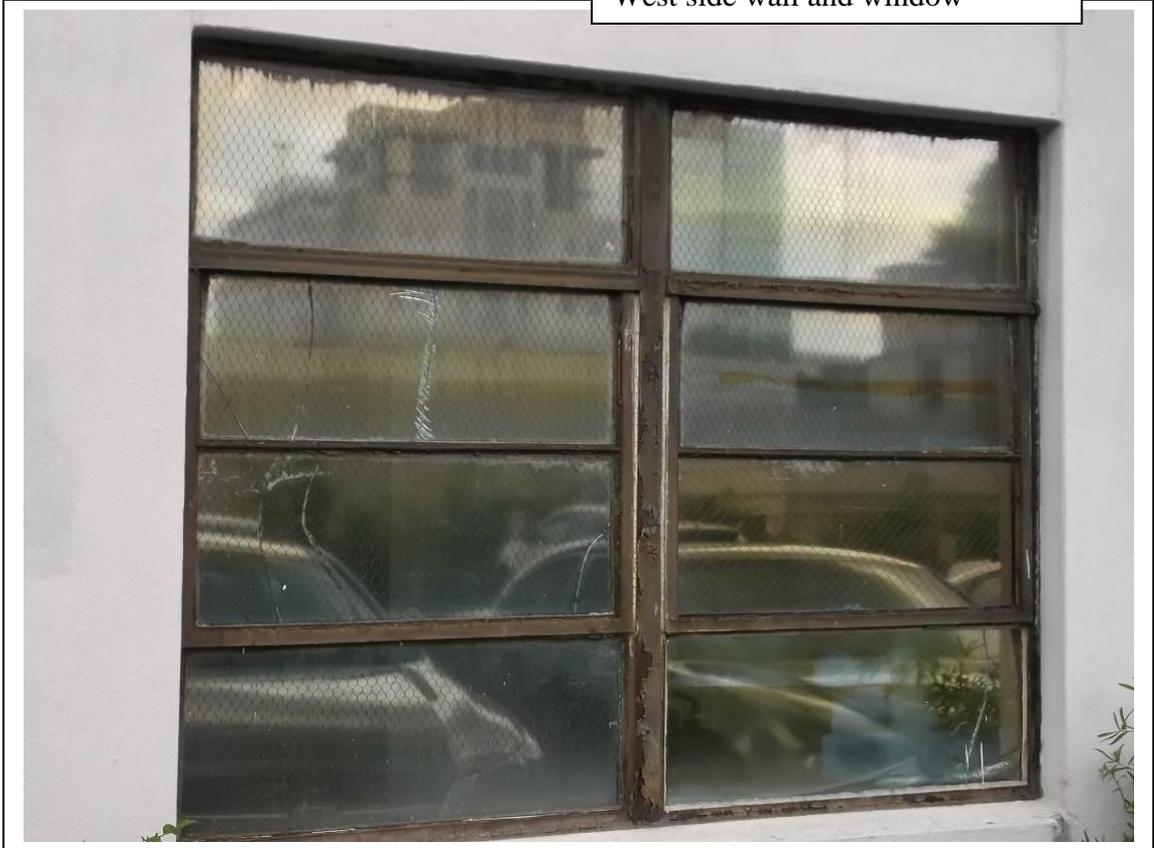
Close up of security glass

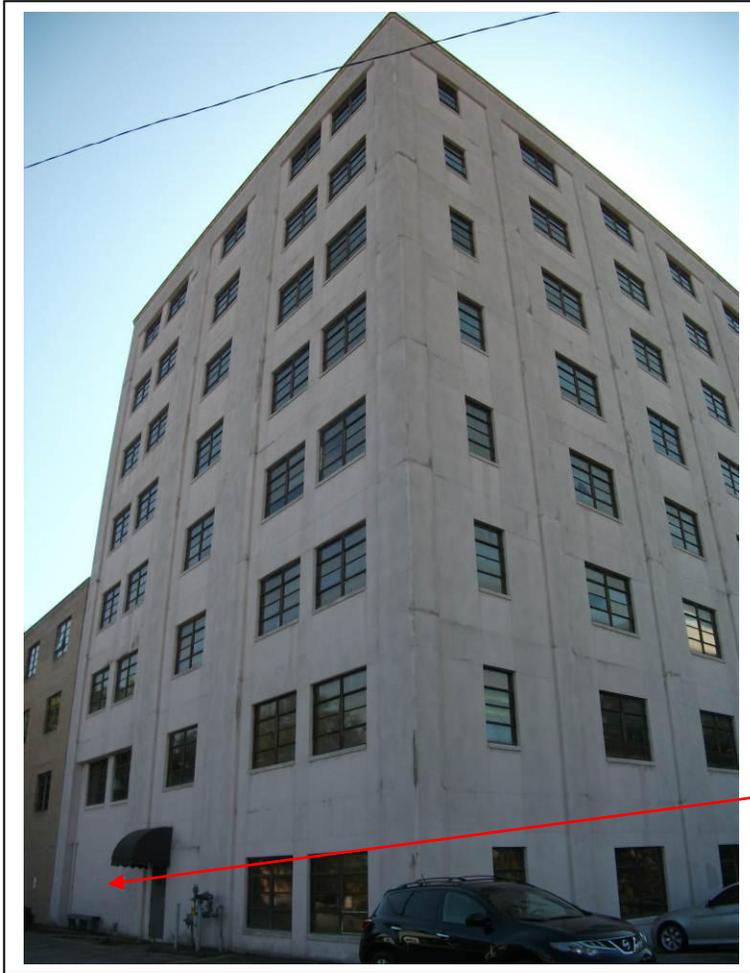
Rear of main building
Two replacement windows will go here

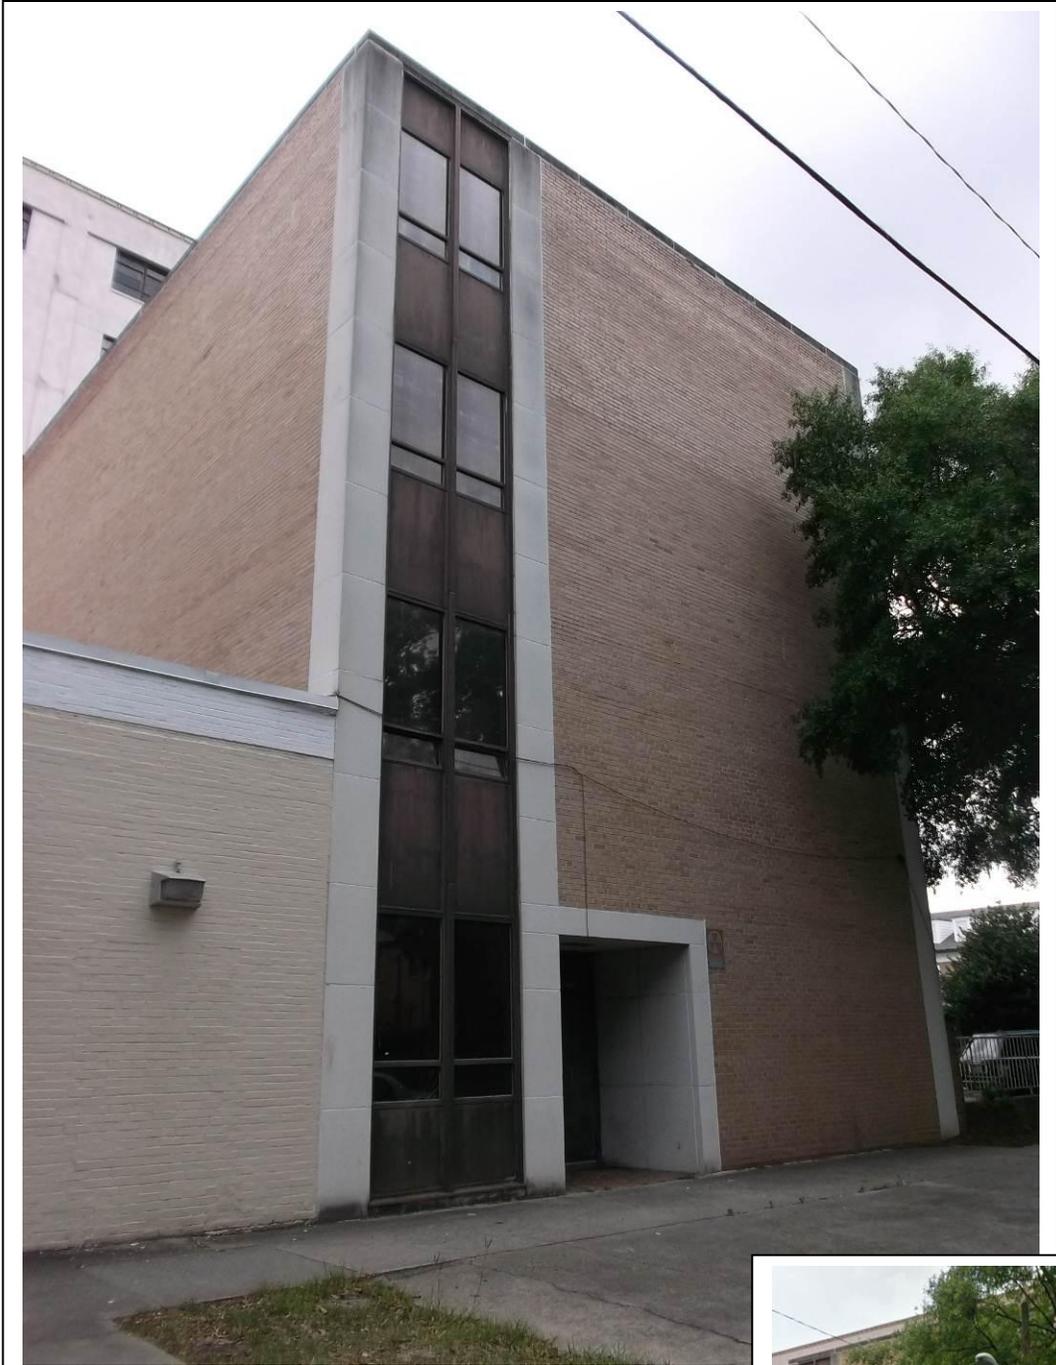
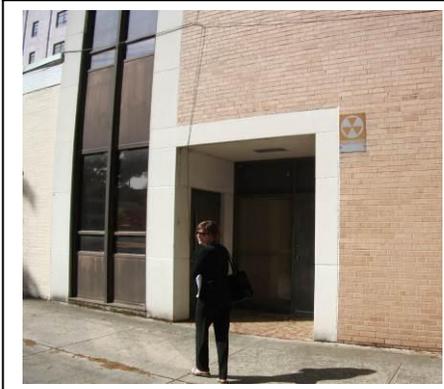
Staff photos above and left, proposed door is in right side of entry above

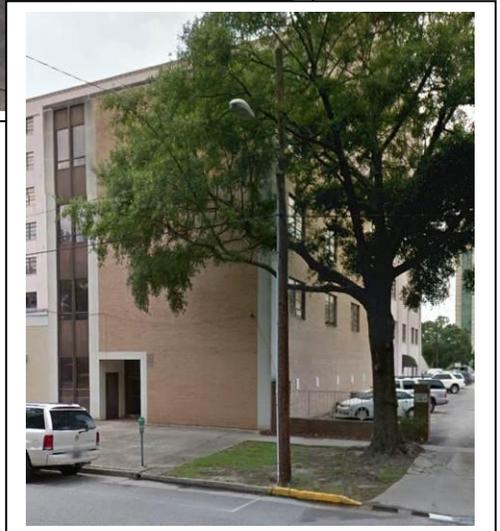
Google view at right, three new windows will be on first floor on right side, starting in second bay

There are three new windows proposed for the north side of the annex on the first floor. They will be differentiated from original windows in that they will have six panes instead of the eight panes found on original windows, according to the drawings supplied. This is a long blank wall but is secondary in that it is on the same plane as the rear of the main building and is already somewhat hidden by cars that park immediately adjacent to the building. It does not characterize the property as much as the blank wall of the façade, and the proposed windows are compatible with the massing, size, scale and other features of the annex.

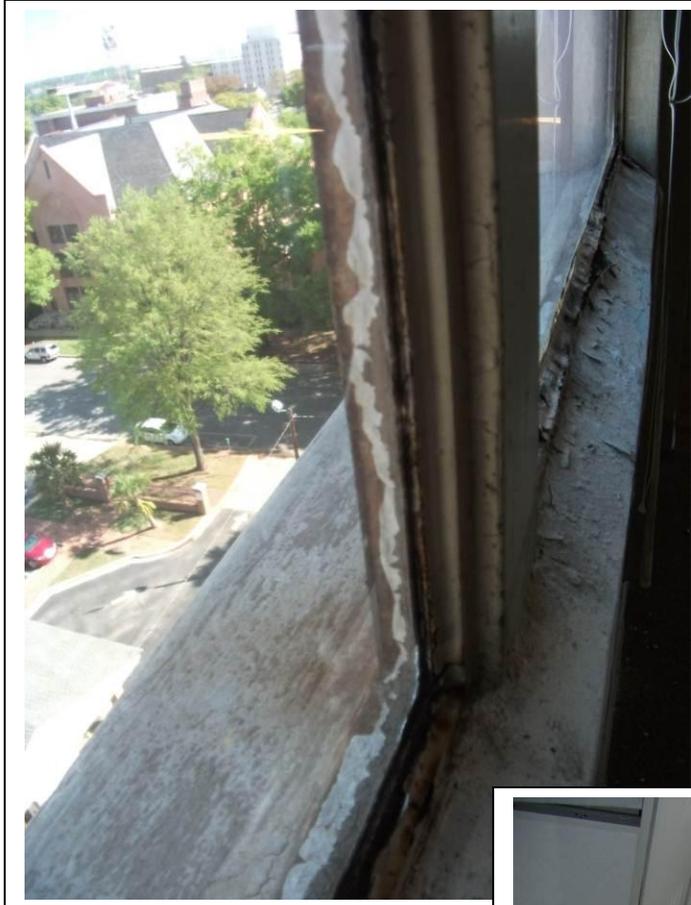
Above: exterior view looking down at window in original building

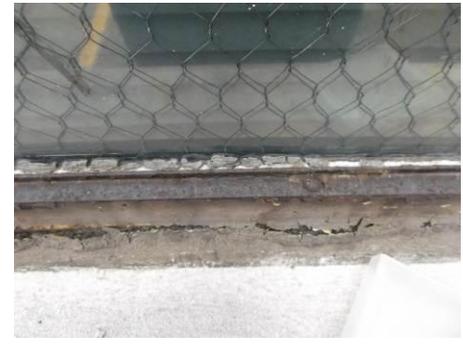
Left: interior view looking at window from side, showing metal flanges, original building

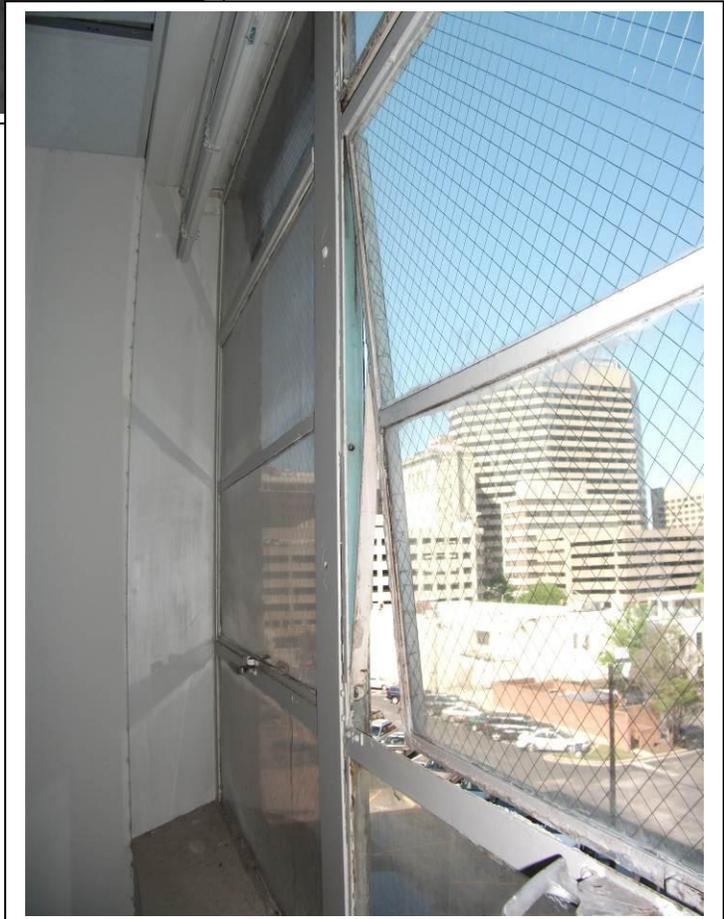
Below: Annex window with diamond-shaped wire in glass
