D/DRC Case

1300 Geiger Avenue
Cottontown/Bellevue Architectural Conservation District
TMS: 09109-07-01

DESIGN/DEVELOPMENT REVIEW COMMISSION
DESIGN REVIEW DISTRICT
HISTORIC AGENDA
EVALUATION SHEET
Case # 6

NATURE OF REQUEST: Request Certificate of Design Approval for exterior change

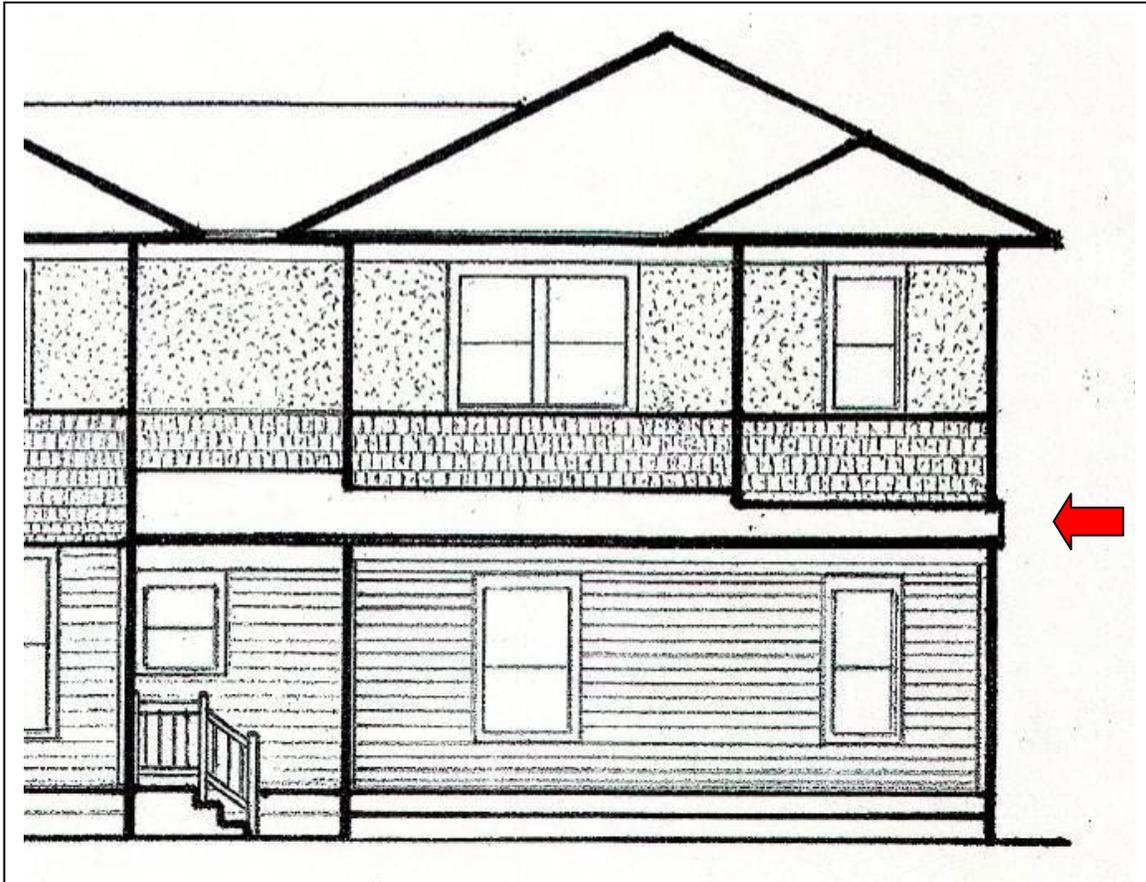
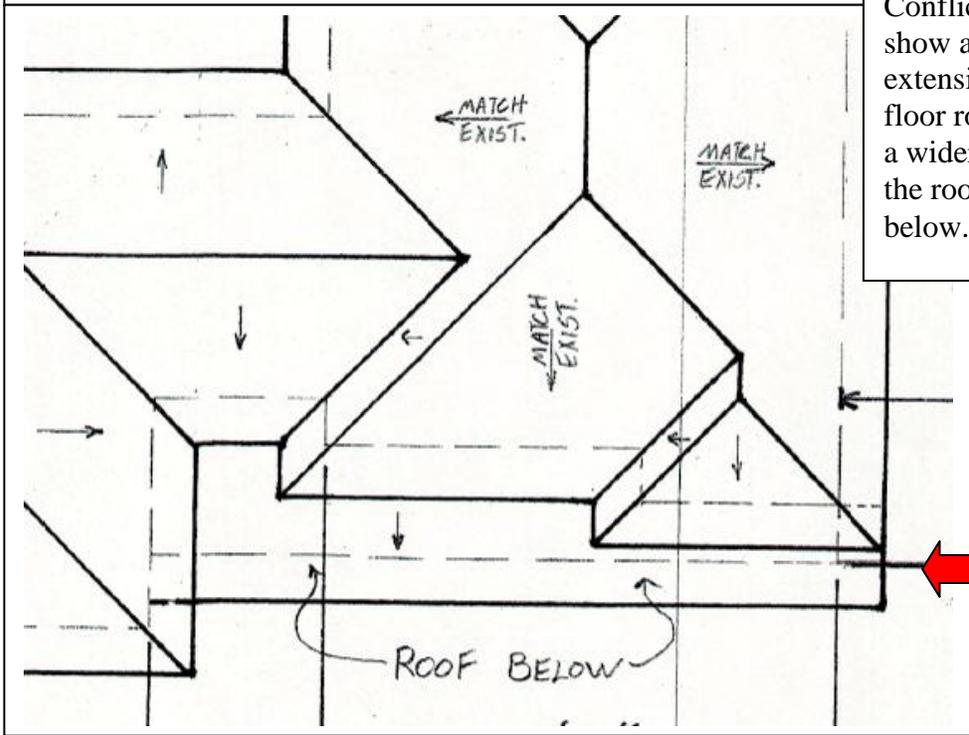
Conflicting drawings show a shallow extension of the first floor roof above and a wider extension in the roof plan drawing below.

At the time this project was approved, the contractor supplied a set of plans that presented conflicting drawings for the first story roofline along the streetfront on the addition, in the right rear corner as you look at the building. He has since stated that he was unsure of how he would build the roofline at the time of the drawings and that is why they conflict. In the drawings the elevation of the new street façade shows that the roofline went past the rear wall just a few inches. However, in the roof plan the roof line extended out the same distance as the second story roof, a distance of about 2 ½ feet. The only detailed drawing of this roofline is in a rear elevation, which shows that the new first floor roof was going to end in a small half gable, to mimic the details of the porch half gable that is nearby. When the contractor built the roofline, he constructed a feature that is unlike any of the options represented in the submitted drawings. Some of his concerns involve the way the feature will tie into the shingle siding that will be placed on the rear wall.

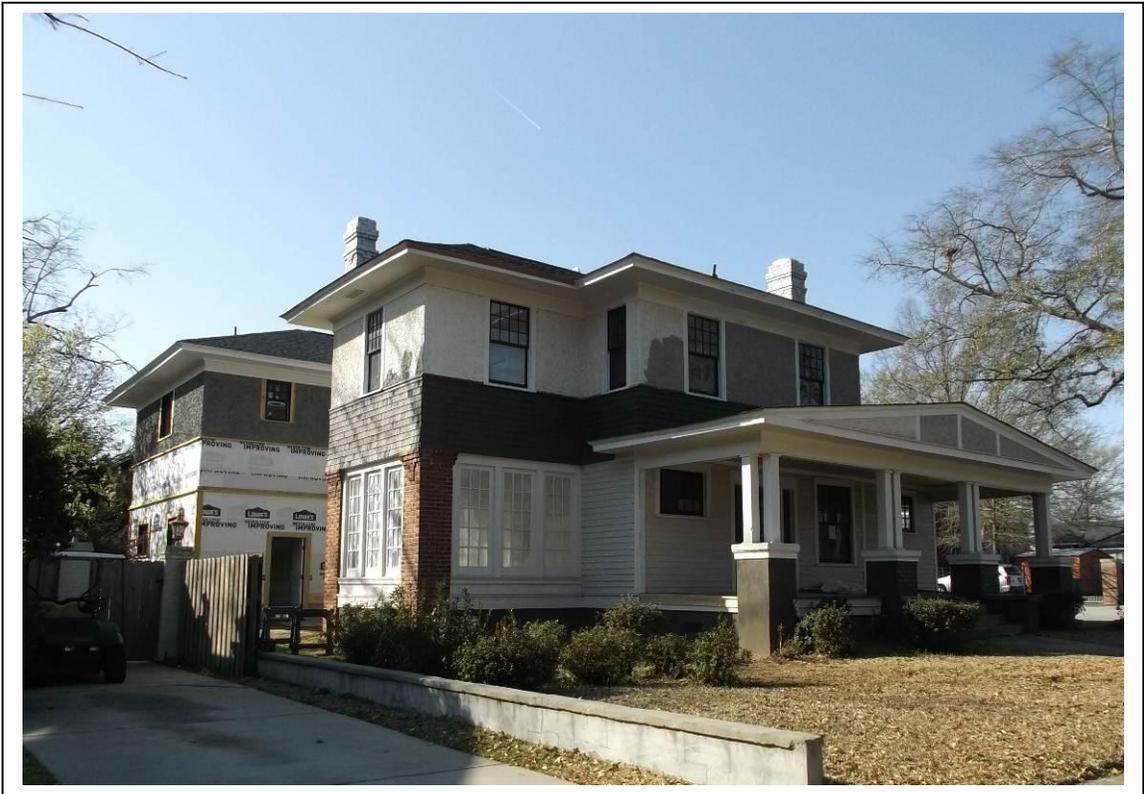
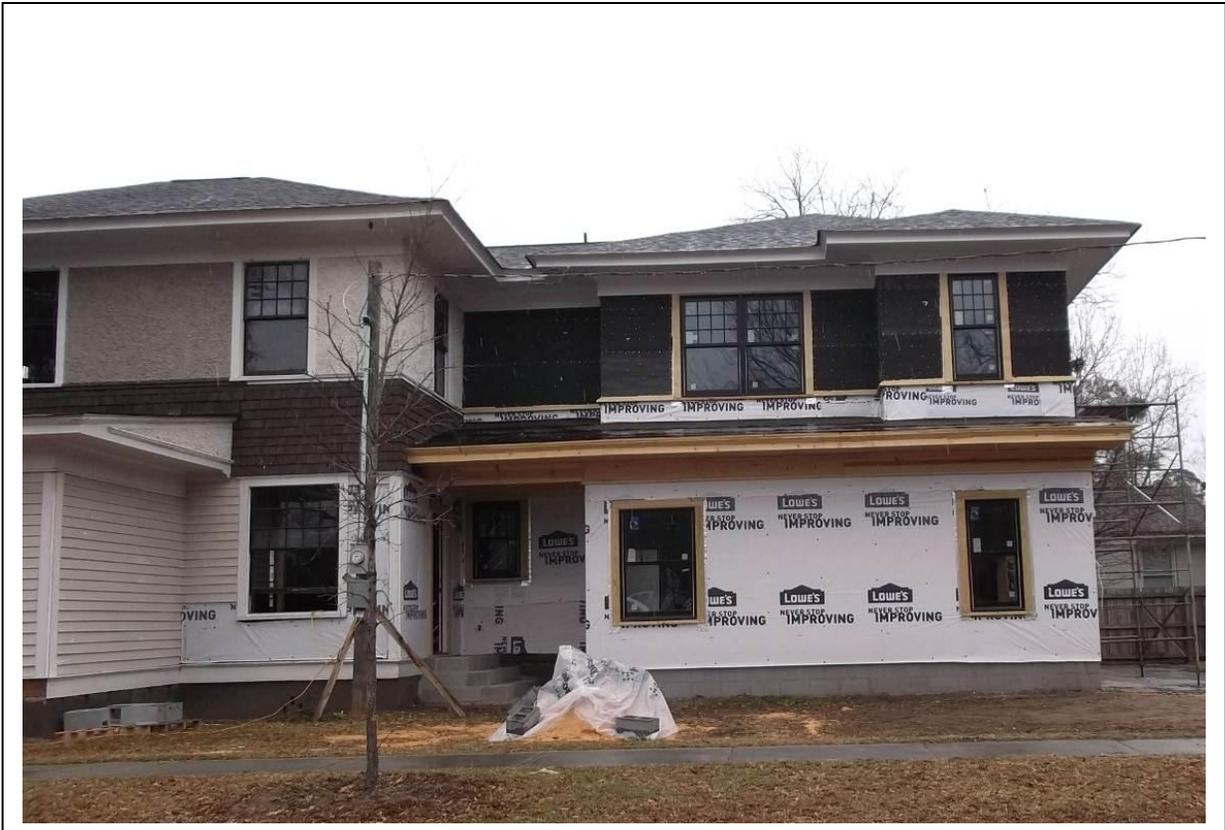
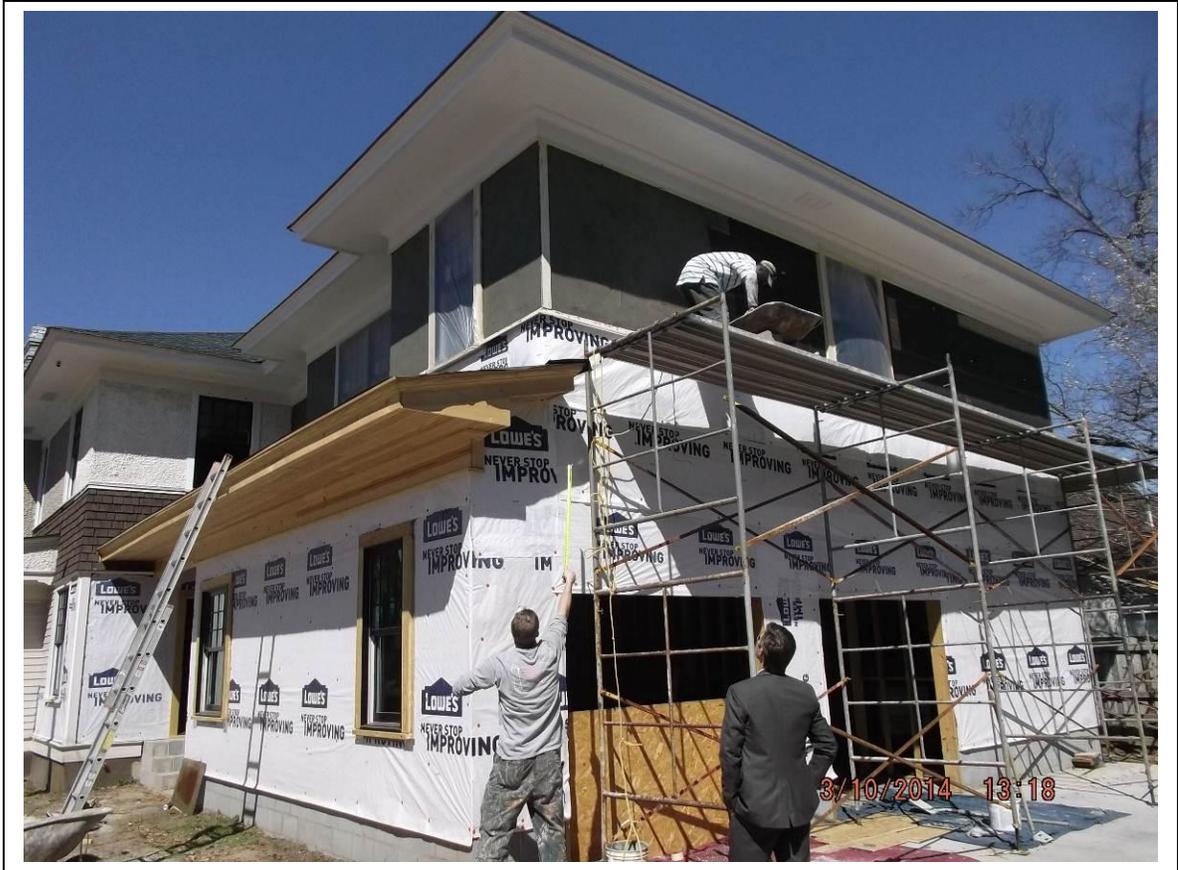
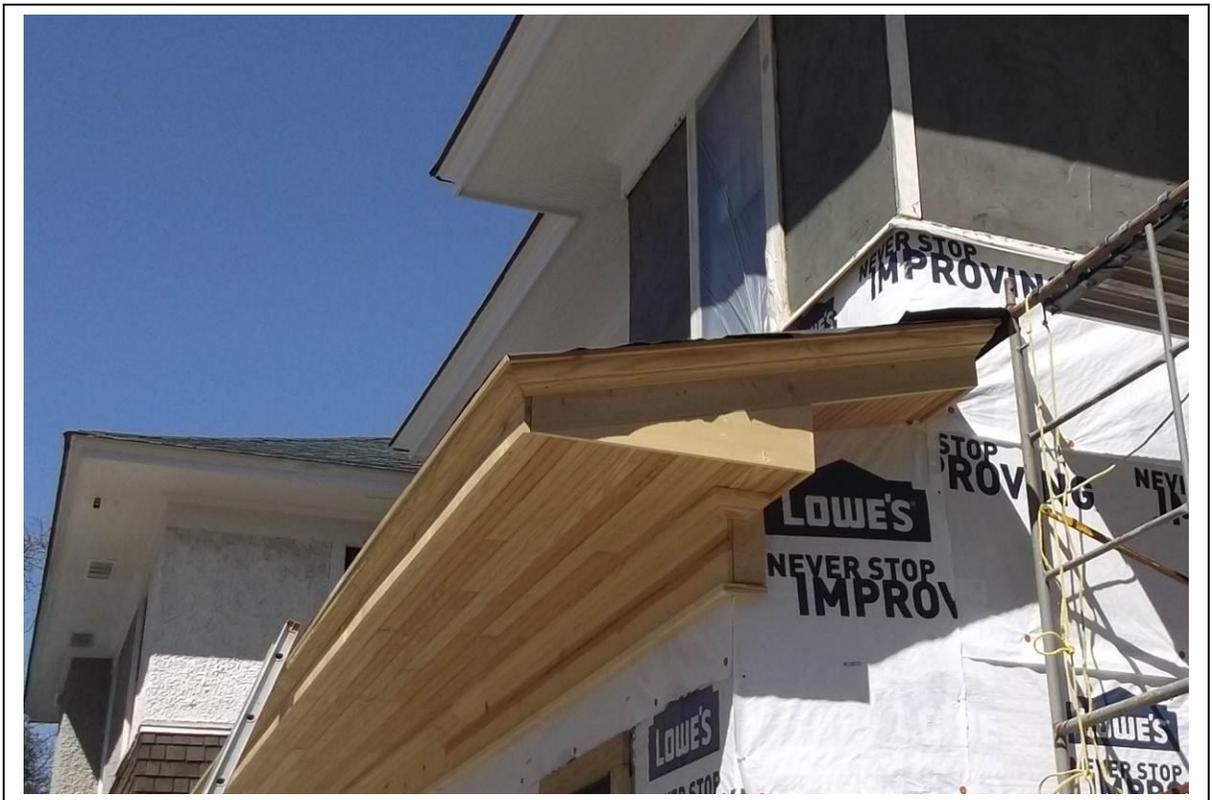
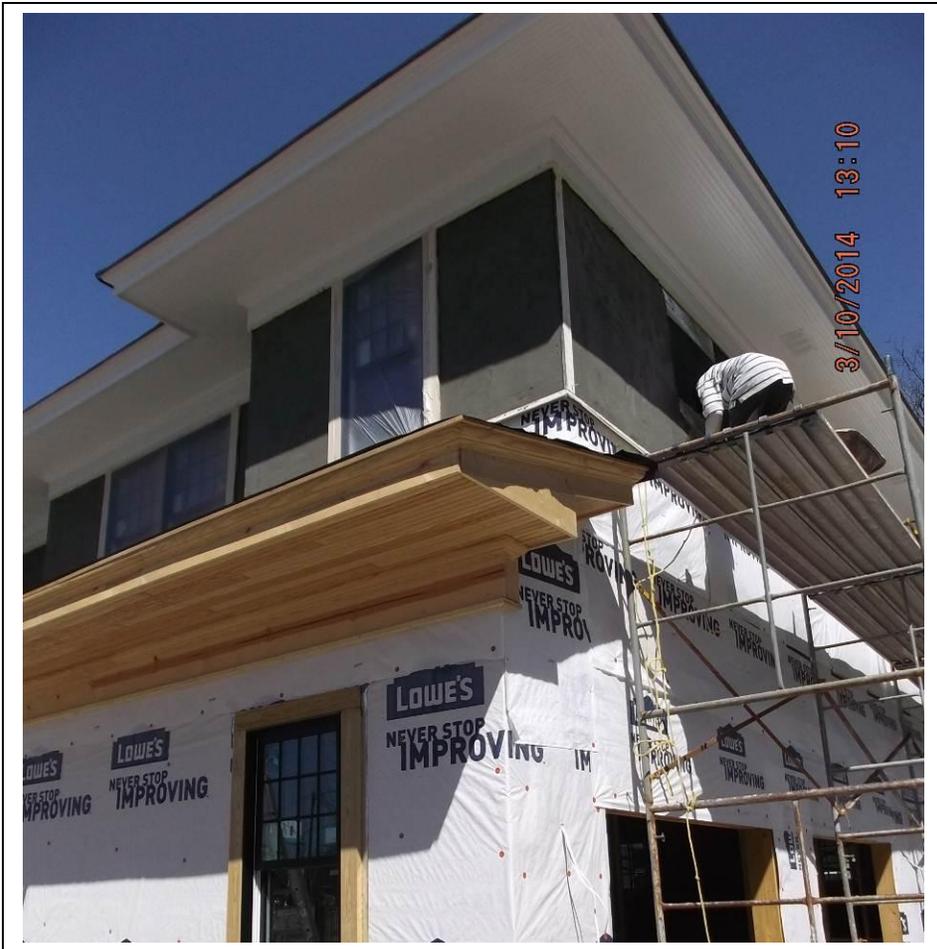
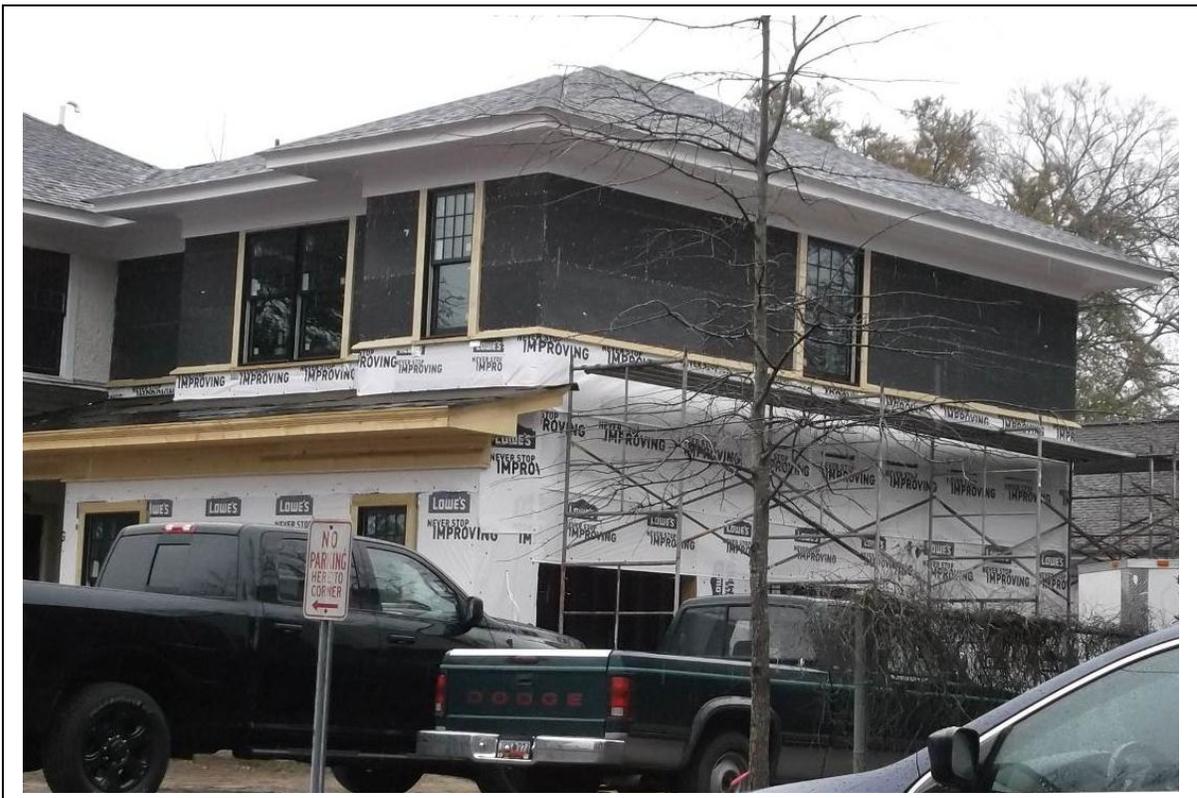
Since the contractor built the roof in a way that is inconsistent with the plans approved by the D/DRC, the owner is applying today to have the roof approved as built. Staff's concerns are that the roofline concludes in a way that is inconsistent with the historic house and that it does not reflect what was previously approved. The contractor has explained that he built the roof feature to match the corner of a gable (please see diagram at the end of the evaluation).

Staff suggests that the gable detail is unlike the main house, which features a hip roof and a full gable on the porch, and that the use of a gable corner feature that is then "altered" or interrupted by the second story is uncharacteristic of the historic house or historic patterns found in the district.

It does not appear that the detailing of the first floor roof is compatible with the original structure in style and detailing. It does attempt to mimic a gable end, and there is a gable on the front porch roof, but that is full gable that completes its design with no disrupted elements. All of the gables and roof components on this house either terminate into a nearby wall or wrap completely around to continue around the building or around a corner; no elements are concluded “unexpectedly” or interrupted in a way that is represented in the new first porch roof. No roof elements extend past a wall plane without terminating in a predictable historic pattern. Therefore the project as built does not seem to meet this guideline, as the feature does not match the detailing of the house.

The roof pitch as built is compatible, but this is actually a shed roof with a partial gable detail at the end, which is not visually compatible with the surrounding buildings. A shed roof is found in the façade of the house to the left of 1300 Geiger, but it is part of a pedimented gable and does not extend past a wall plane. A shed roof that ends with a gable

While gable ends are features found on the block or street, they are always part of a complete gable. The use of an interrupted gable end on the shed roof of the addition is not visually compatible with historic buildings nearby, as they do not have only portions of gables. This segment of a gable end appears to end abruptly and is not an architectural feature found on the block or street. The use of wood is appropriate for the material.

Staff finds that the proposal does not meet Sections 5 and 6 of the guidelines and recommends that the request for Certificate of Design Approval be denied. Since Staff has been unsuccessful in negotiating an acceptable solution for the feature, if the D/DRC denies the project they should consider making a motion for the original design to be executed, with specific parameters, or recommend another solution in keeping with the guidelines, within a certain time frame.

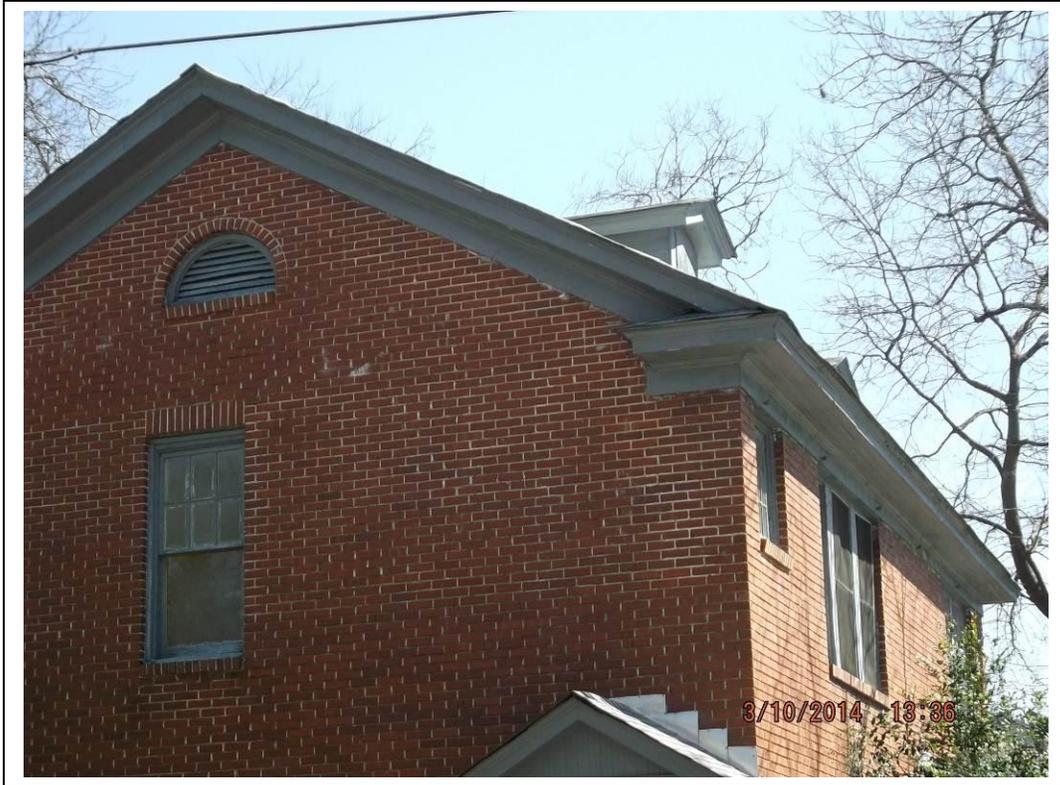
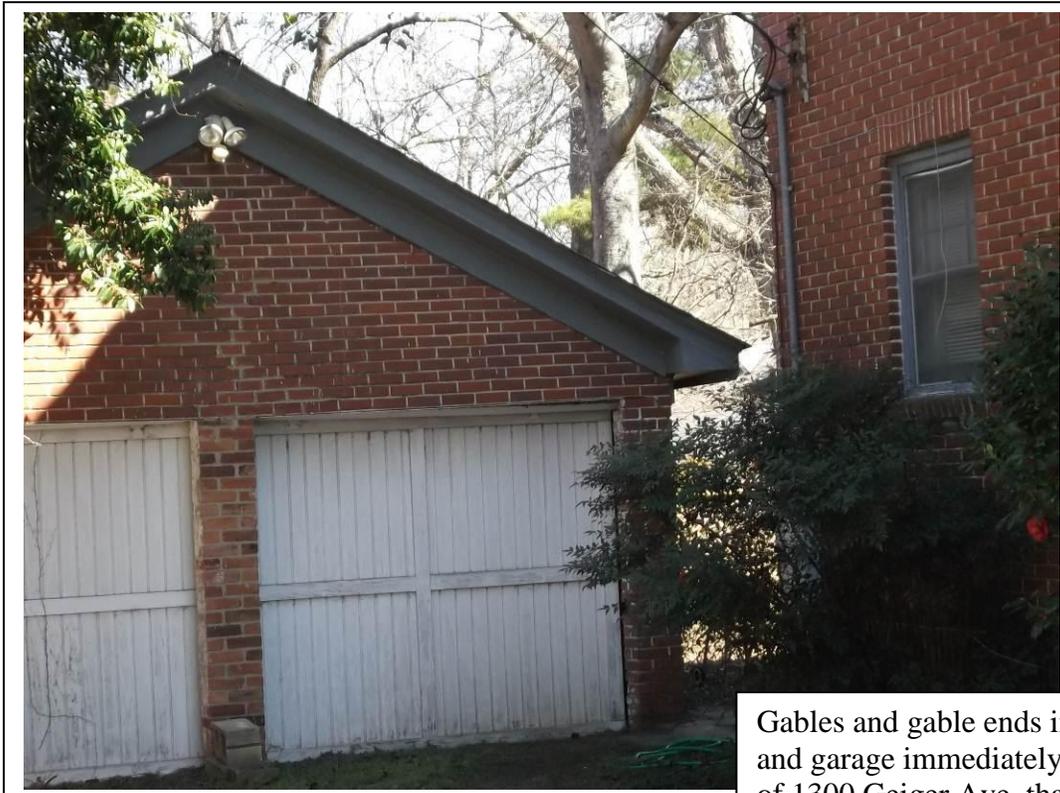
Gables and gable ends in a house and garage immediately to the rear of 1300 Geiger Ave. that the contractor pointed out as nearby examples.

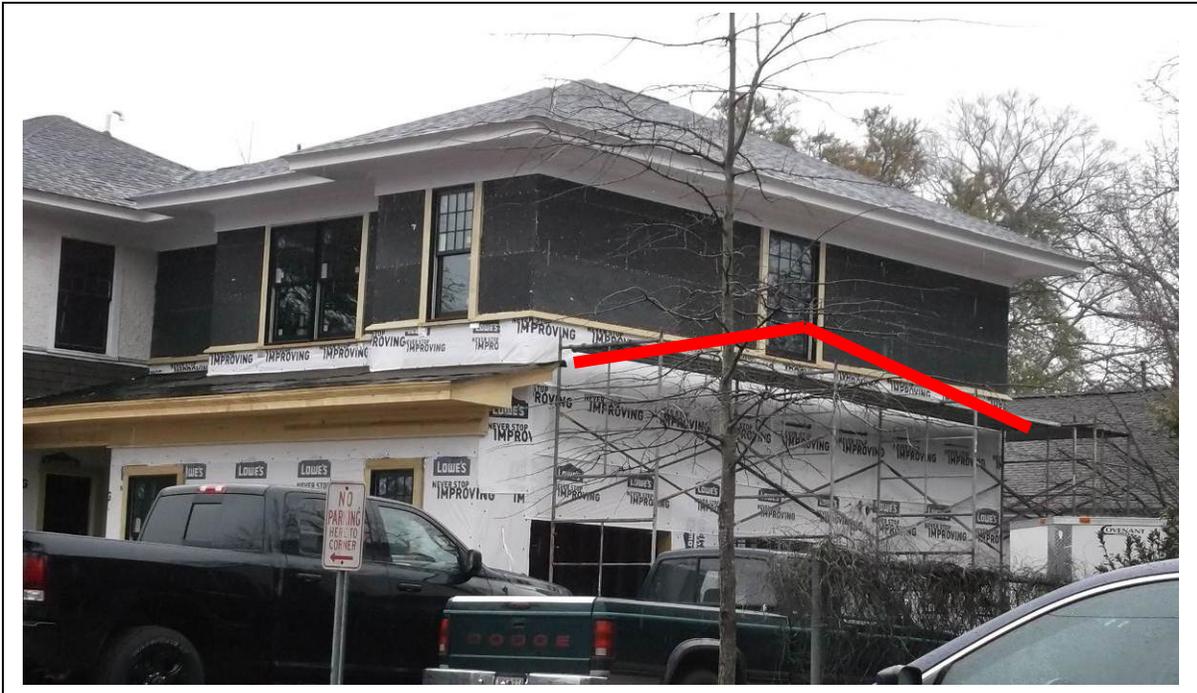
Staff's understanding of what the contractor was creating is shown above. He was trying to create a feature that reads as a remnant of a gable that was later removed. The part projecting from the building off of the shed roof would have been a gable end if a gable (red line) had continued across the rear wall.

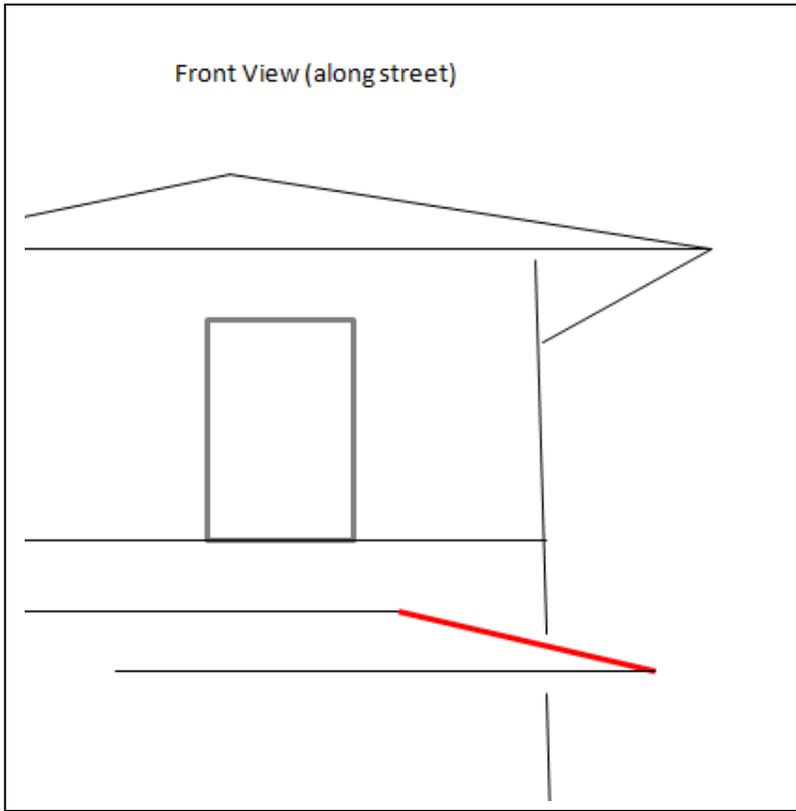
Staff's recommendation of a half hip at the edge to complete the first floor roof in a way that is visually compatible with the historic house.
