## D/DRC Case

4035 Ensor Avenue

Seminary Ridge Architectural Conservation District

**NATURE OF REQUEST:** Request Certificate of Design Approval for exterior change, to replace all 19 original windows in the house with vinyl windows

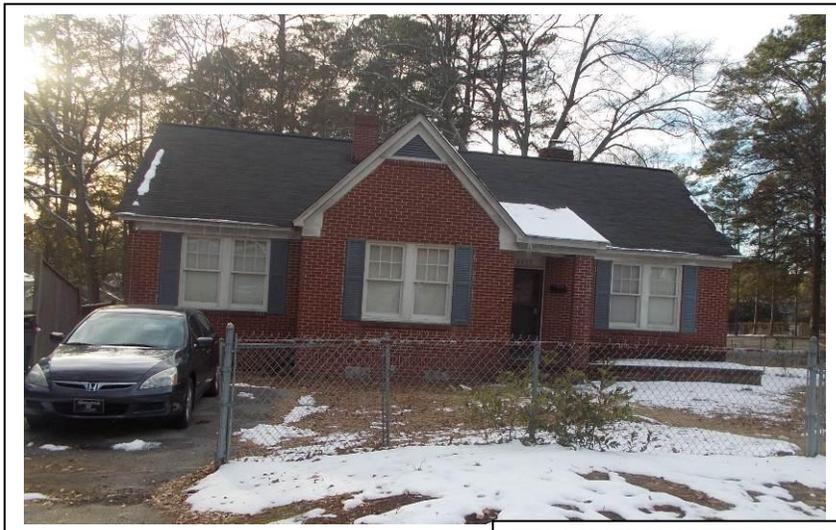
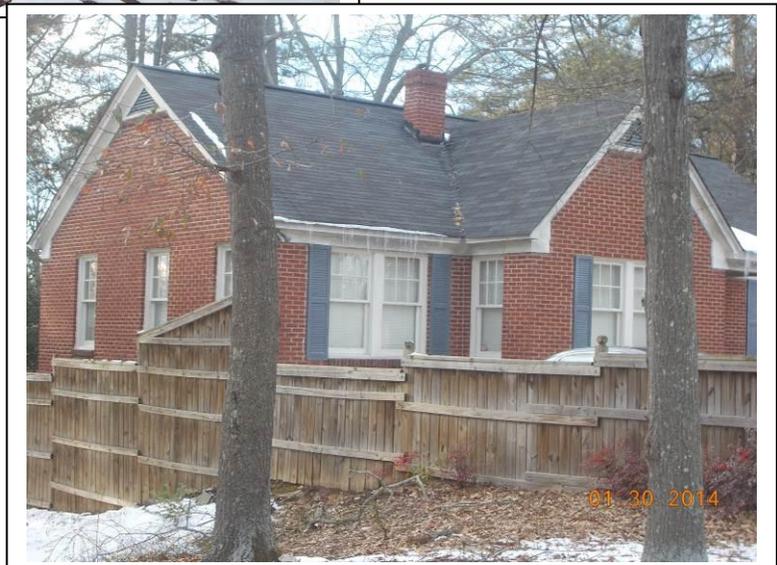
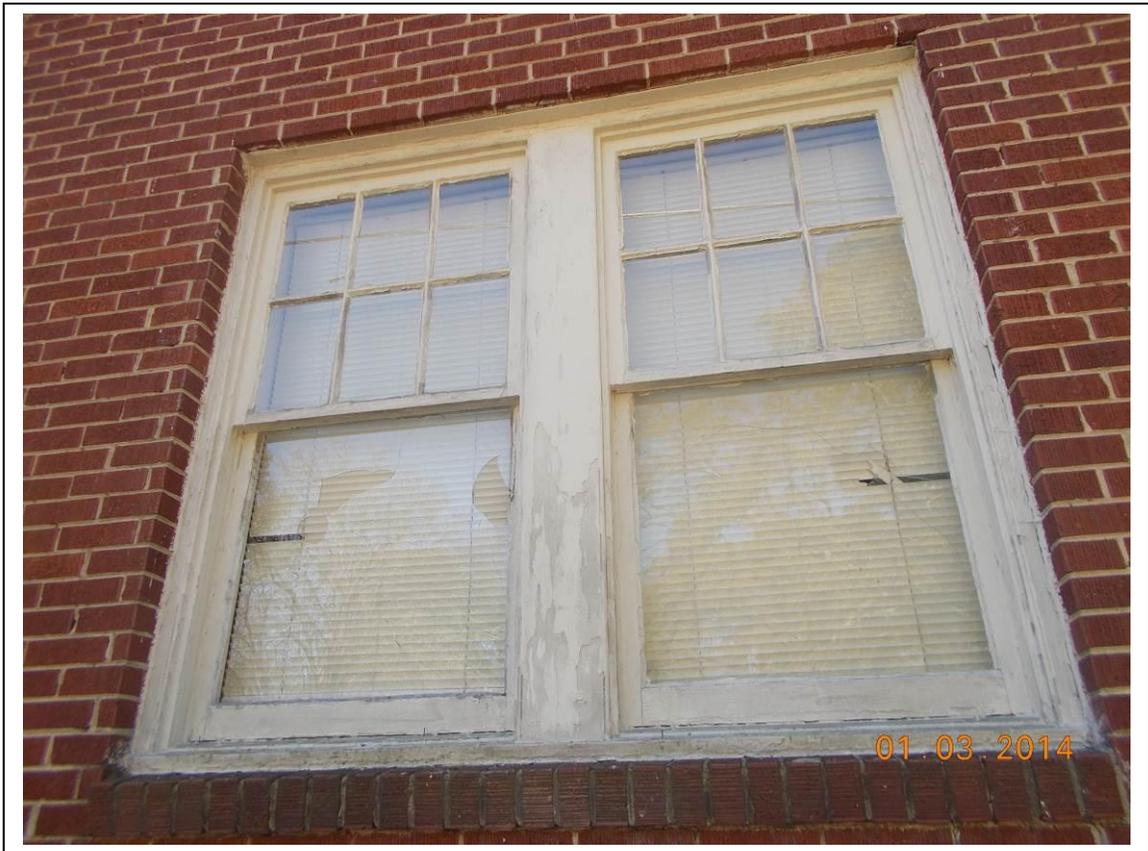
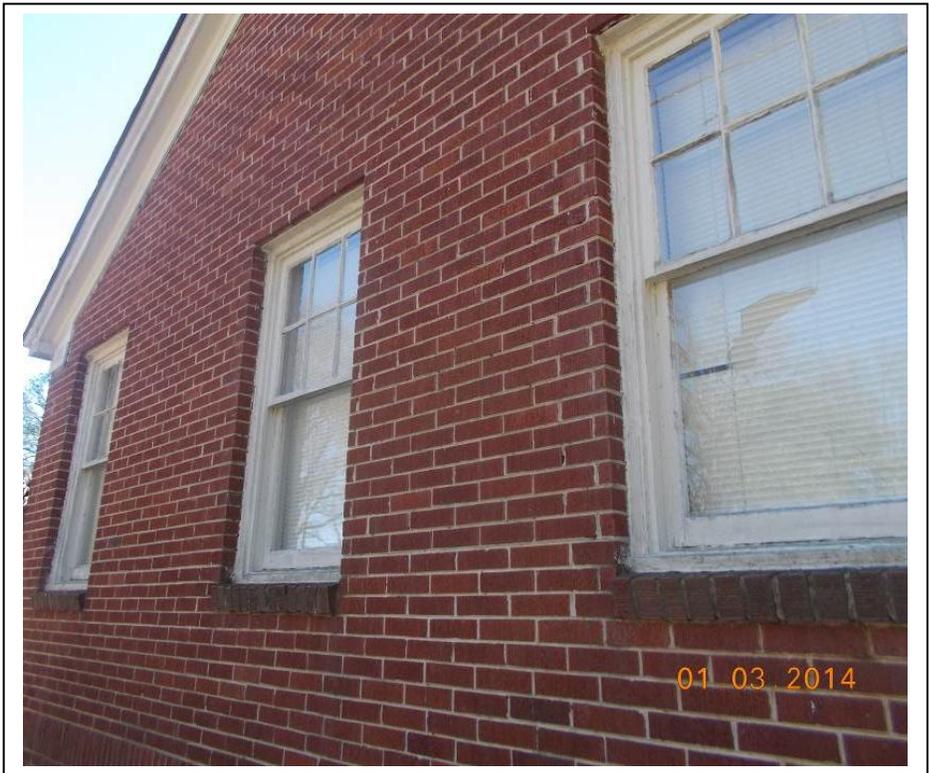
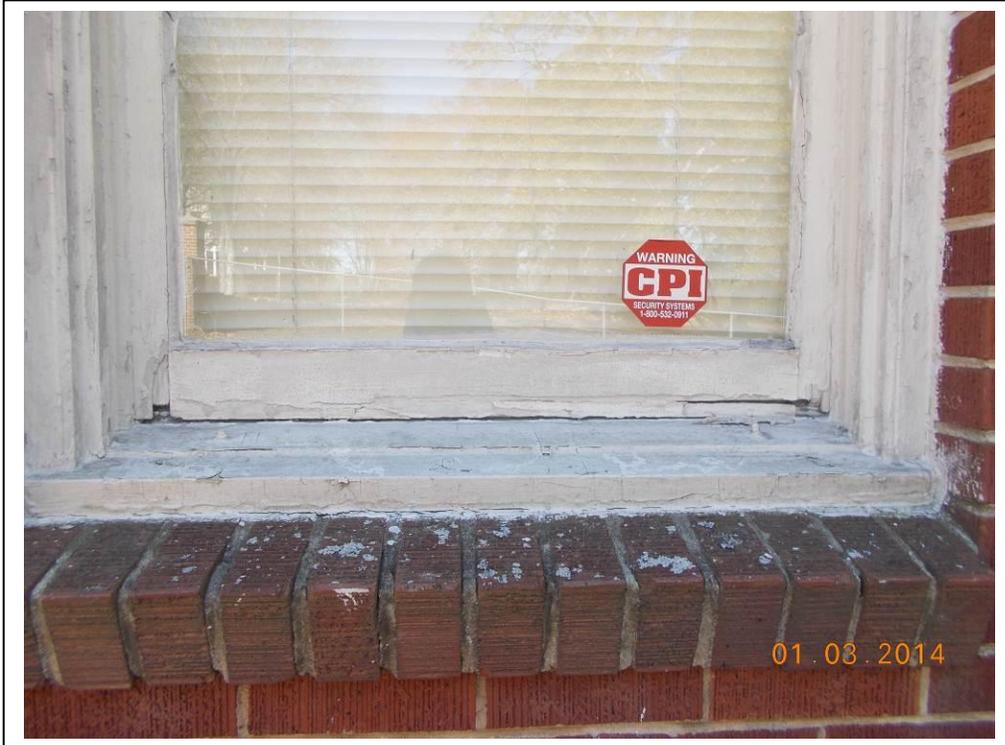
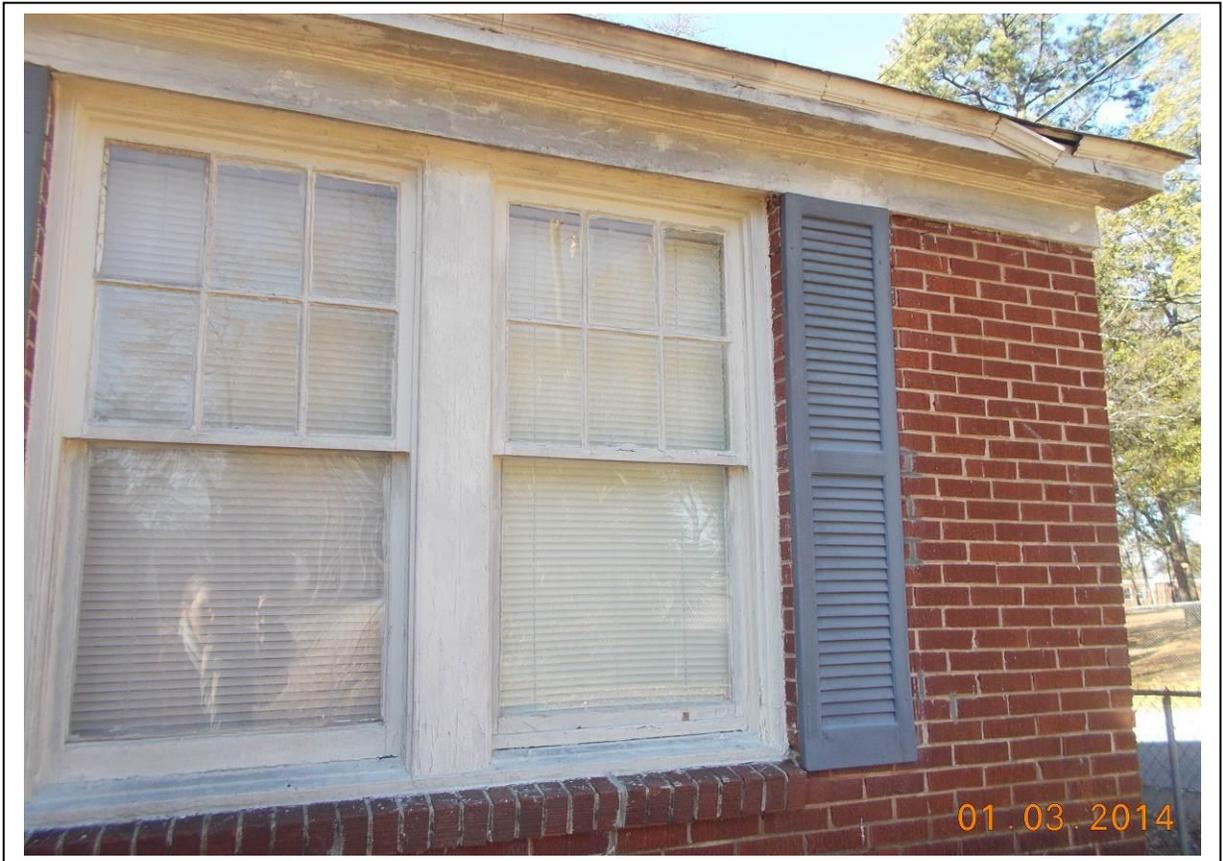
The damaged windows should be repaired to meet this guideline. Many windows appear to be painted shut, and some have peeling paint and deteriorated putty. These are regular maintenance items that are relatively minor and easy to repair. Some of the windows would require wood repairs along the bottom of the sashes where the wood has deteriorated or been damaged. These repairs are feasible.

It does not appear necessary to replace the windows. The damage that is visible is broken glass, which is a very minor repair, and peeling paint and putty, with some areas of damage at the bottom of a few sashes. The proposed windows do attempt to match the configuration of the original, but as they are vinyl, they do not match the materials and will likely not match other details such as the width of the wood stiles and rails that make up the sashes. Vinyl windows also typically have wider and flatter muntins than those found on historic wood windows.

Staff encourages the use of storm windows for added protection against breakage and for increased energy efficiency.

Staff finds that the proposal does not meet Section 7-3 of the guidelines and recommends denial.
