Wales Garden Architectural Conservation District

**DESIGN/DEVELOPMENT REVIEW COMMISSION
DESIGN REVIEW DISTRICT
HISTORIC CONSENT AGENDA
EVALUATION SHEET
Case #3**

ADDRESS: 199 Wateree Avenue

NATURE OF REQUEST: Request Certificate of Design Approval for preliminary certification for the Bailey Bill

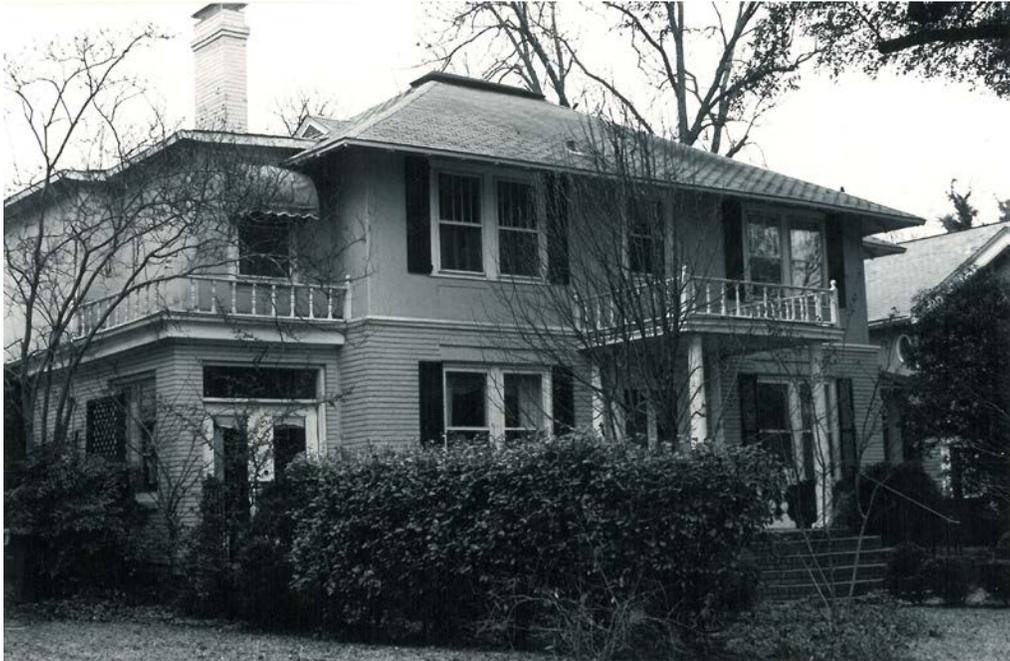
199 Wateree Avenue – January 1993

The two-story painted brick and stucco house located at 199 Wateree Avenue was built in 1920 and is a contributing structure in the Wales Garden Architectural Conservation District. The exterior of the house has received some alterations over the years but still retains its historic character. Significant architectural features include a hip roof with exposed rafters and a front portico supported by fluted columns and pilasters. The owners are planning some rehabilitation work and are requesting preliminary certification for the Bailey Bill as part of their plan. Most of the proposed work will affect the interior of the house and will not require design review. The exterior component of the project includes repairing the existing historic wood windows and adding storm windows for energy efficiency. Also, four non-historic windows on the first floor of the façade will be removed and replaced with new wood windows with pane configurations to match the historic windows.

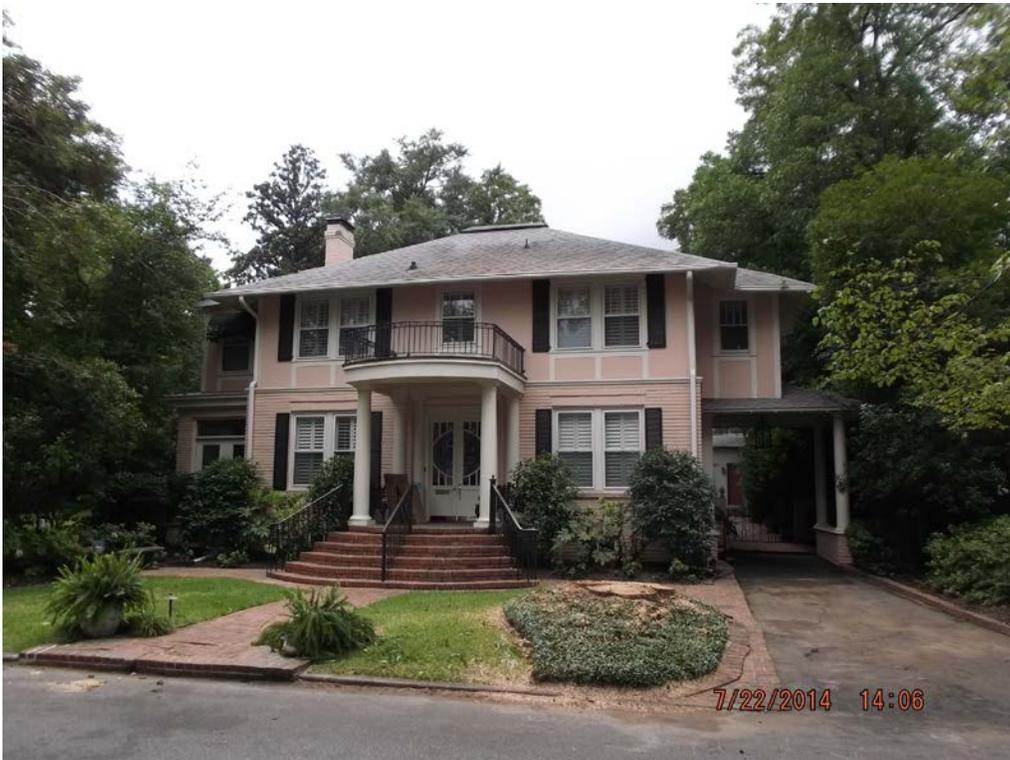
199 Wateree Avenue – Existing Conditions

All historic wood windows that are visible from the public right-of-way will be repaired. Four non-historic windows on the first floor of the façade will be removed and replaced with new 5/1 wood windows to match the historic windows on the second floor. Staff recommends making the size, pane configuration, and muntin width of the proposed windows consistent with the existing windows. This style window typically features a 5/8" muntin width with a putty glaze exterior profile. All glass should be as clear as possible and avoid coatings that result in a tinted appearance. No plastic, vinyl, or PVC products will be used.

- *All historic wood windows that are visible from the public right-of-way shall be repaired*
- *Four non-historic windows on the first floor of the façade shall be removed and replaced with new 5/1 wood windows with 5/8" exterior muntins to match the historic windows on the second floor.*
- *Storm window specifications shall be submitted to staff for review*
- *All details deferred to staff*
