D/DRC Case

928 Pine Street

DESIGN/DEVELOPMENT REVIEW COMMISSION
DESIGN REVIEW DISTRICT
HISTORIC CONSENT AGENDA
BAILEY BILL EVALUATION SHEET
Case #1

NATURE OF REQUEST: Request for a Certificate of Design Approval for preliminary certification for the Bailey Bill.

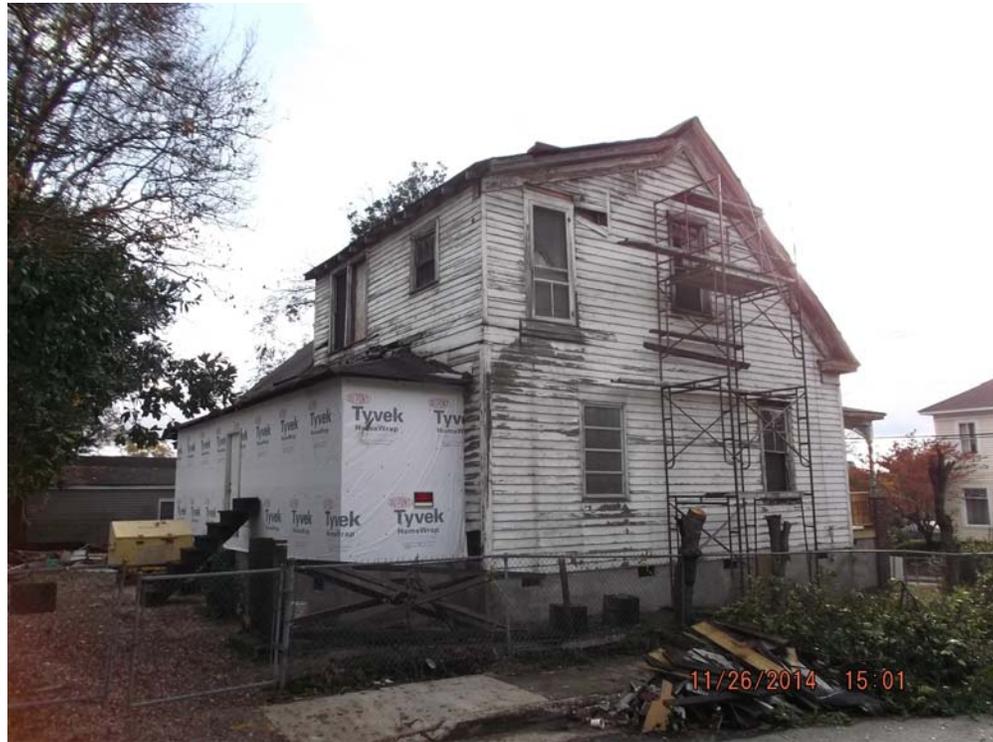
928 Pine Street – Current exterior conditions

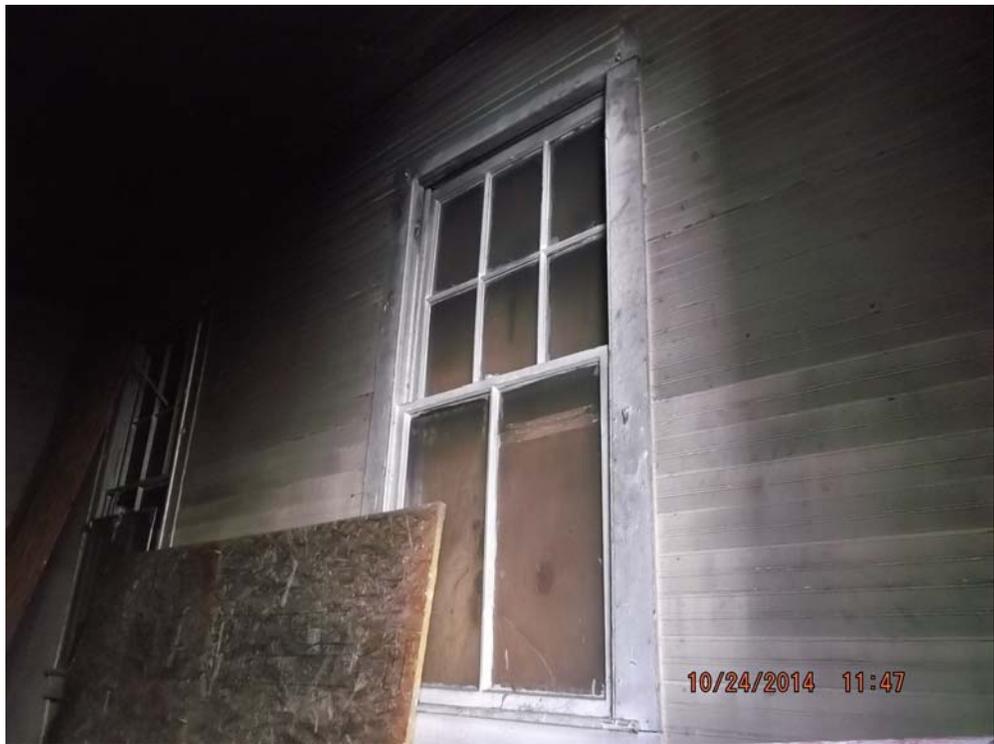
Uncommon 6/2 windows in the dependency

The applicant is requesting preliminary certification for the Bailey Bill for a rehabilitation proposal that includes retaining and repairing historic architectural features including the historic wood siding, front porch columns and decorative brackets, replacing the roof, correcting any foundation/structural concerns, repairing or replacing the electrical and plumbing systems, and installing a new HVAC system. The removal of historic materials or alterations of features and spaces that characterize the property shall be avoided. The existing windows on the house are mismatched, non-historic, or completely missing. The applicant would like to replace the majority of the windows with wood windows with a 4/4 or 6/6 pane configuration. The windows on the dependency are currently boarded; however, they appear to be original 6/2 windows when viewed from the inside. Staff recommends for

these windows to be retained and repaired. Additional work including painting exterior woodwork will count towards the investment threshold. Interior work, new construction costs, and work that has already been completed will not be included. The applicant estimates that qualified rehabilitation expenses for this project will meet or exceed the 20% minimum investment threshold needed to make the project eligible.

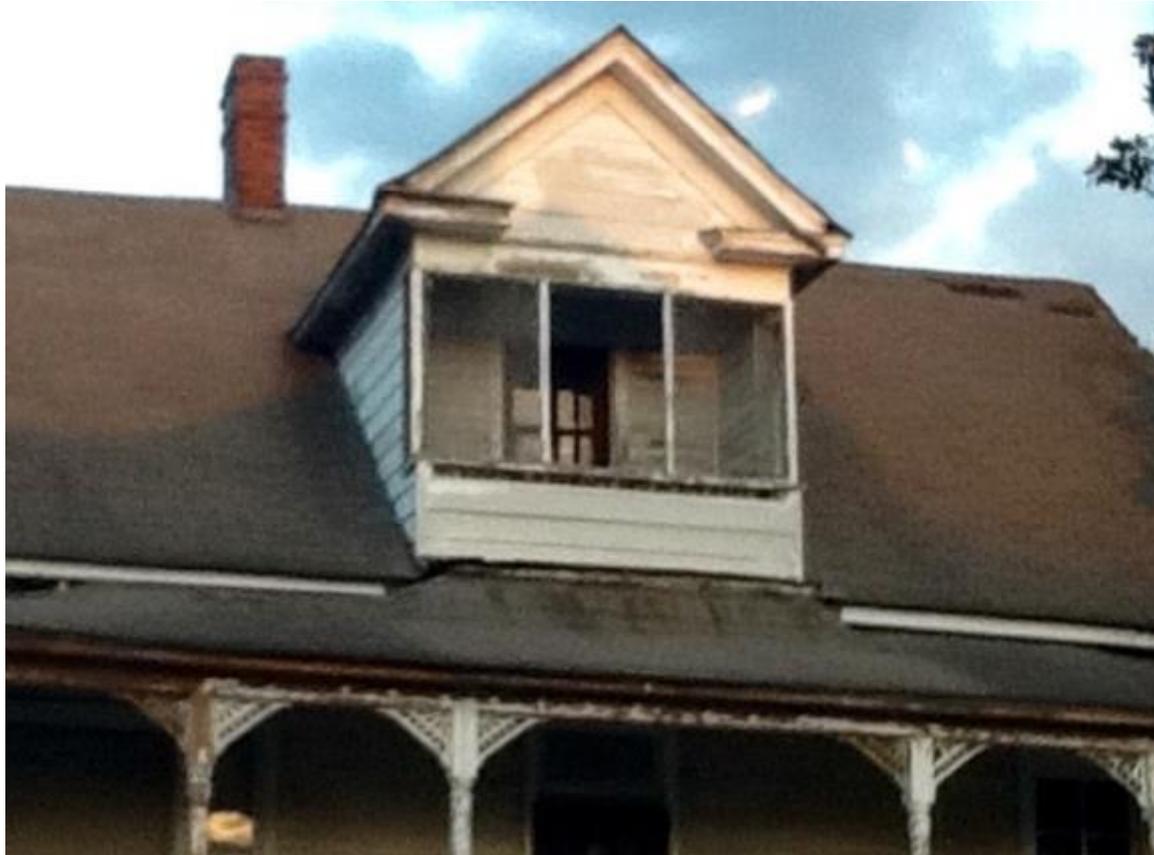
Photo 3

| Architectural feature <u>Roof</u> Approximate date of feature <u>Not known</u> Describe feature and its condition Roof is asphalt and in poor condition, including holes in places. Photograph No. <u>3</u> Drawing No. _____ | Describe work and impact on feature Replace roof to protect integrity of the house. |

928 Pine St. - roof

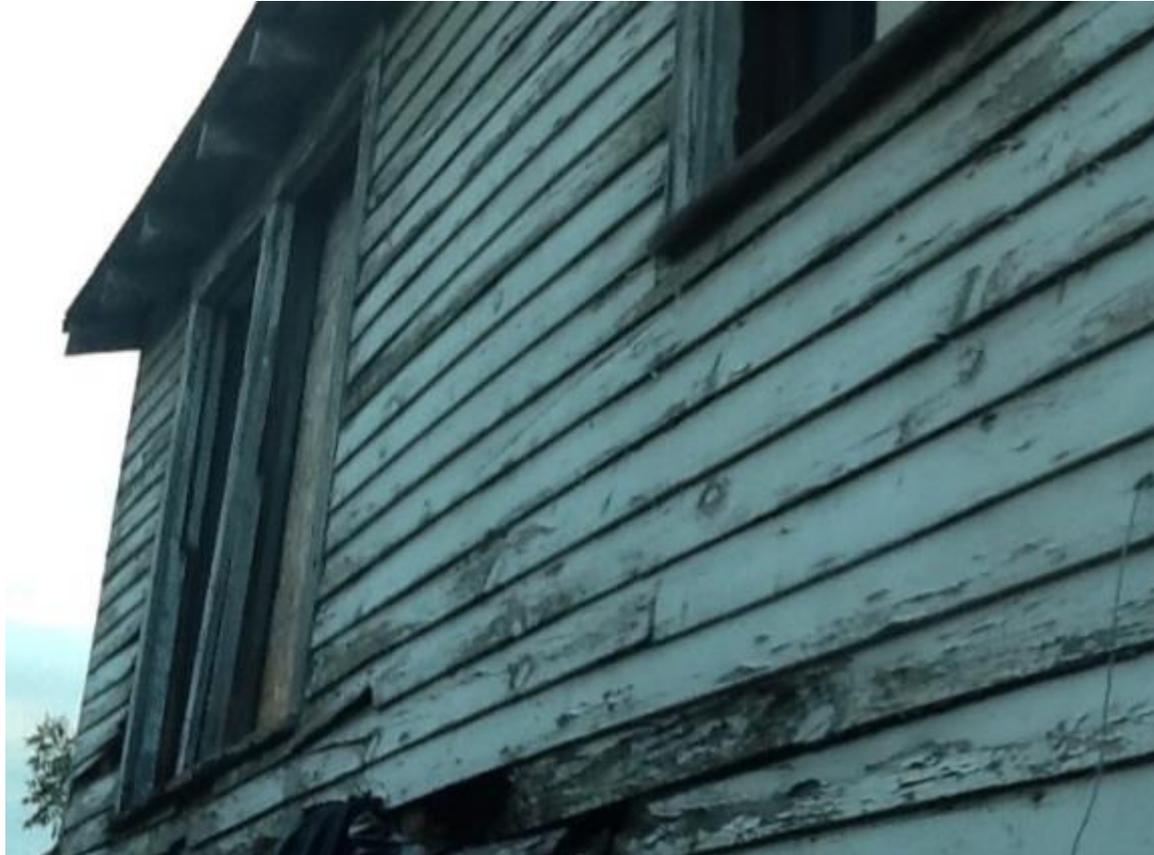
Photo 4

| Architectural feature <u>Siding</u> Approximate date of feature <u>Original</u> Describe feature and its condition Siding is in fair condition, but deteriorating and missing in places Photograph No. <u>4</u> Drawing No. _____ | Describe work and impact on feature Repair or replace damaged boards; clean, seal and repaint |

928 Pine St. – Siding, rear upstairs

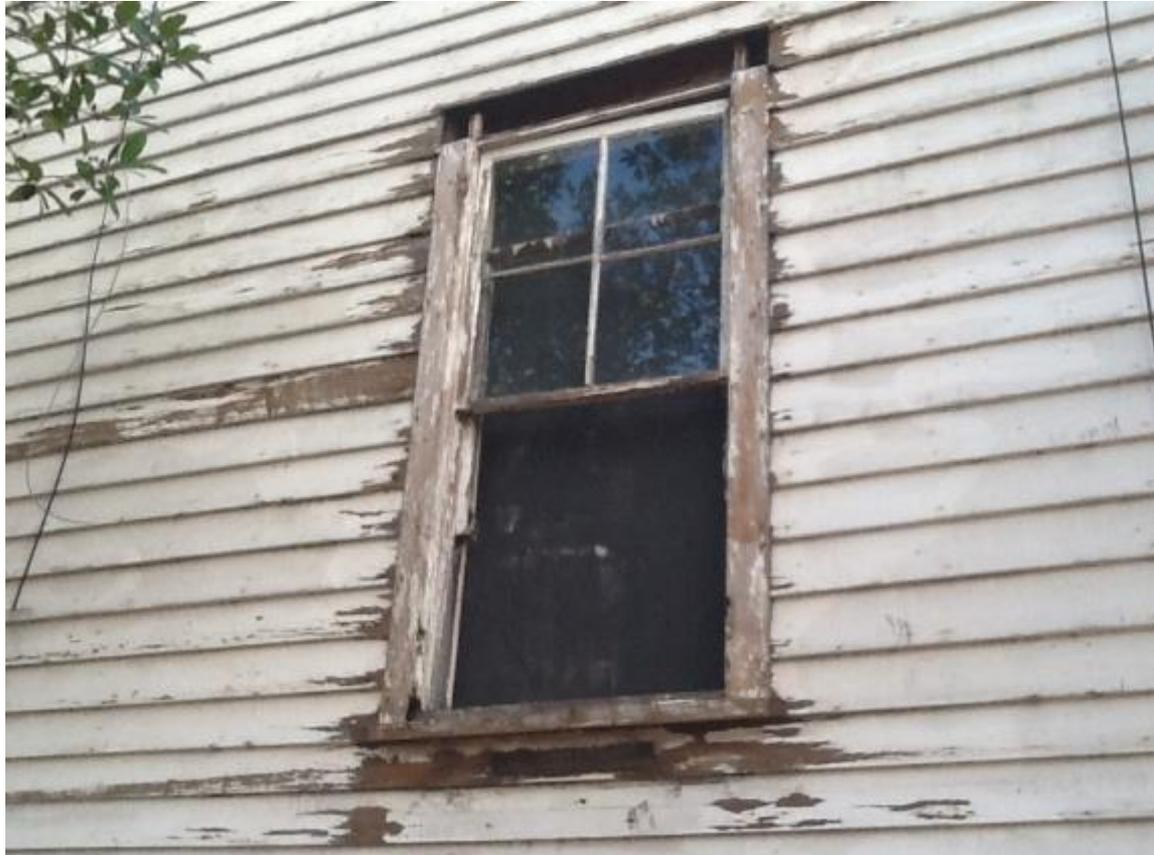
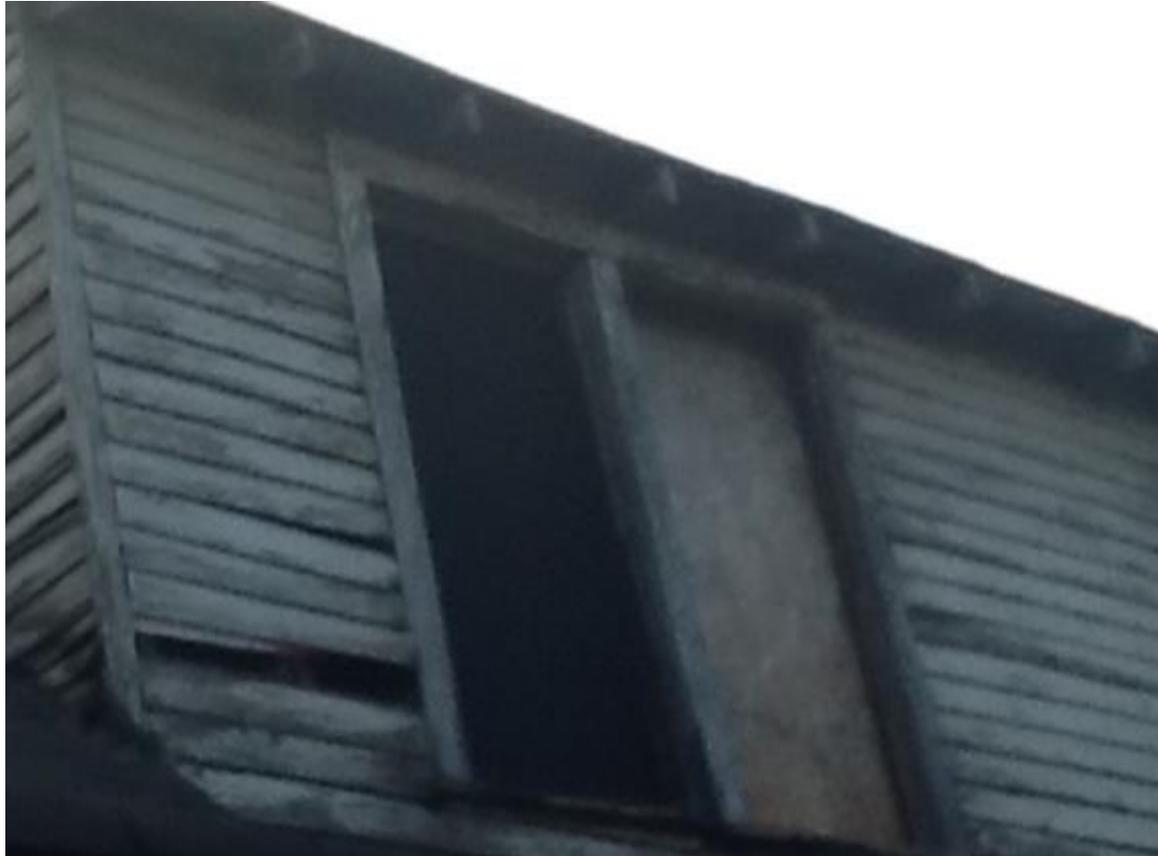
| Architectural feature <u>Windows</u> Approximate date of feature <u>Original (most)</u> Describe feature and its condition Most are in poor condition and unsalvageable Photograph No. <u>5, 6</u> Drawing No. _____ | Describe work and impact on feature Replace unsalvageable windows with custom wood-framed windows |

928 Pine St. – left side first floor window

928 Pine St. – Upstairs rear windows

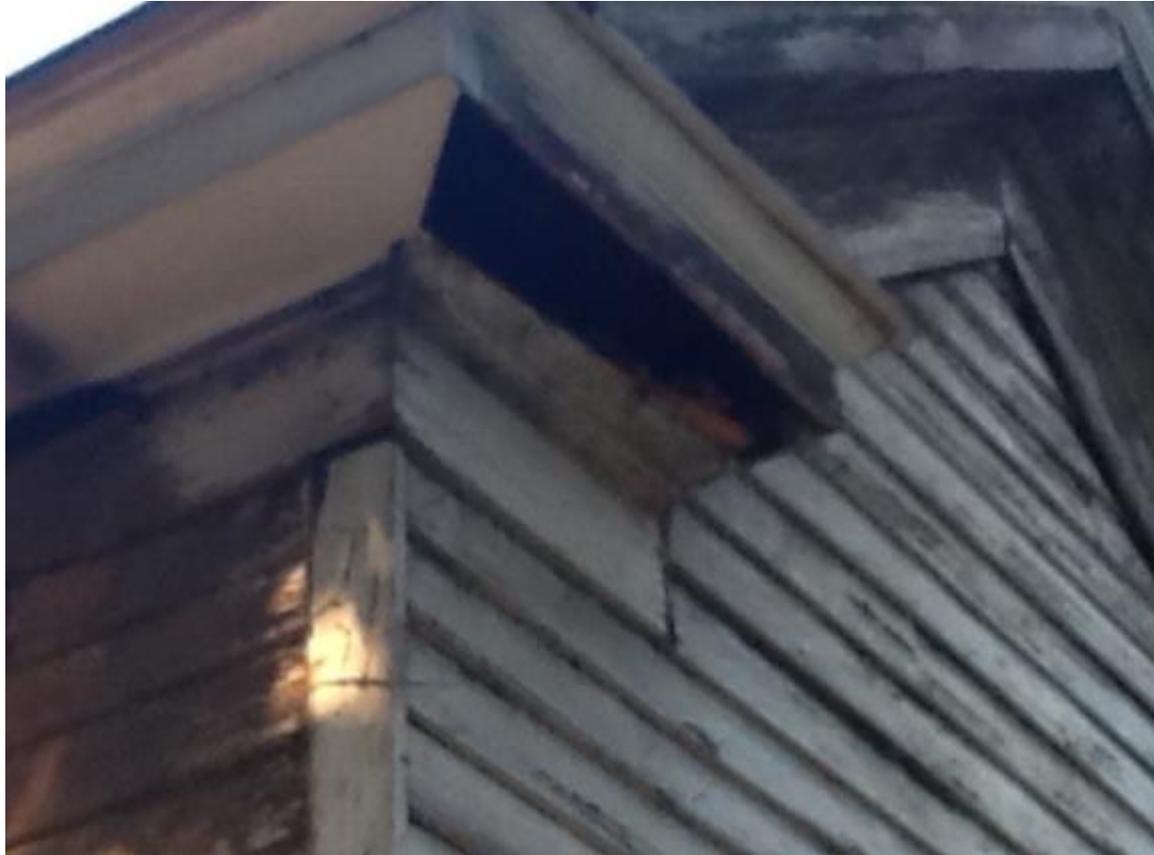
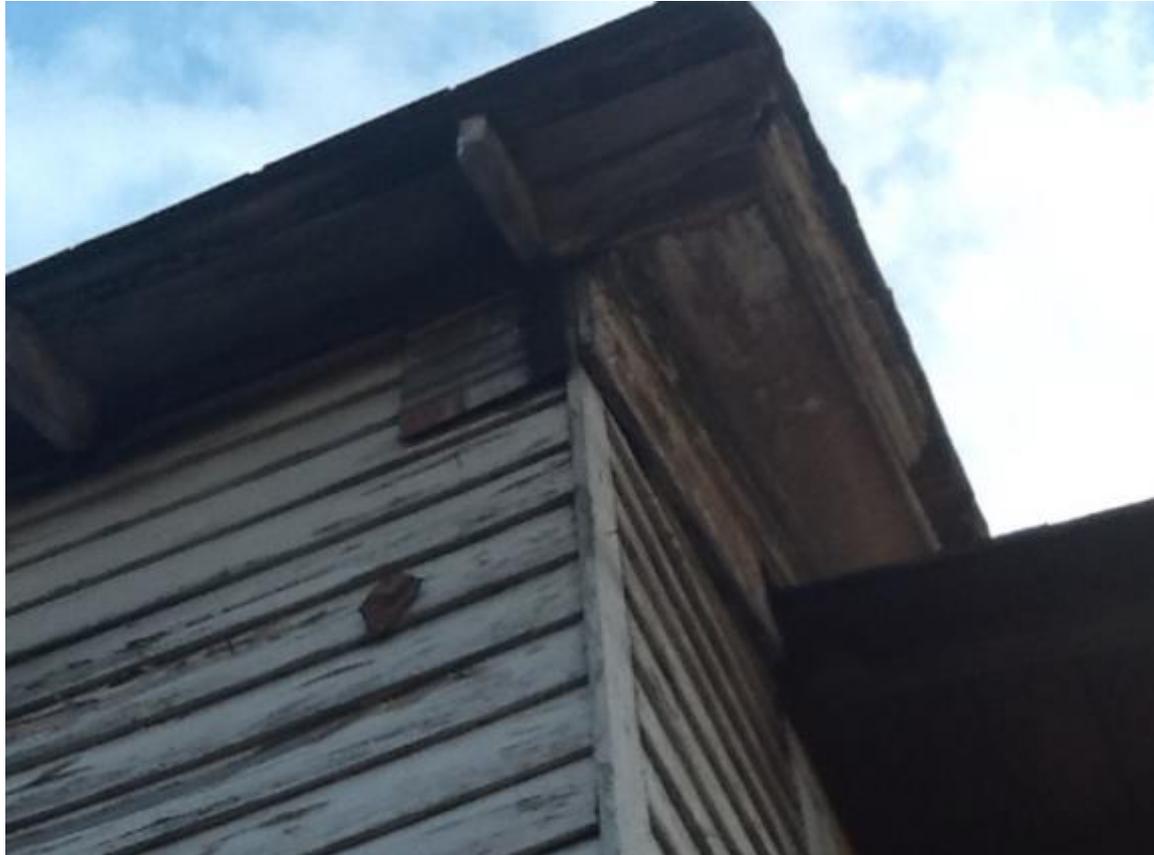
| Architectural feature <u>Soffits & fascia</u> Approximate date of feature <u>Original</u> Describe feature and its condition Soffits and fascia are weather beaten and damaged in places Photograph No. <u>7, 8</u> Drawing No. _____ | Describe work and impact on feature Repair or replace soffits and fascia, as needed, and repaint |

928 Pine St. – soffit & fascia right front (out building)

928 Pine St. – soffit & fascia left rear corner

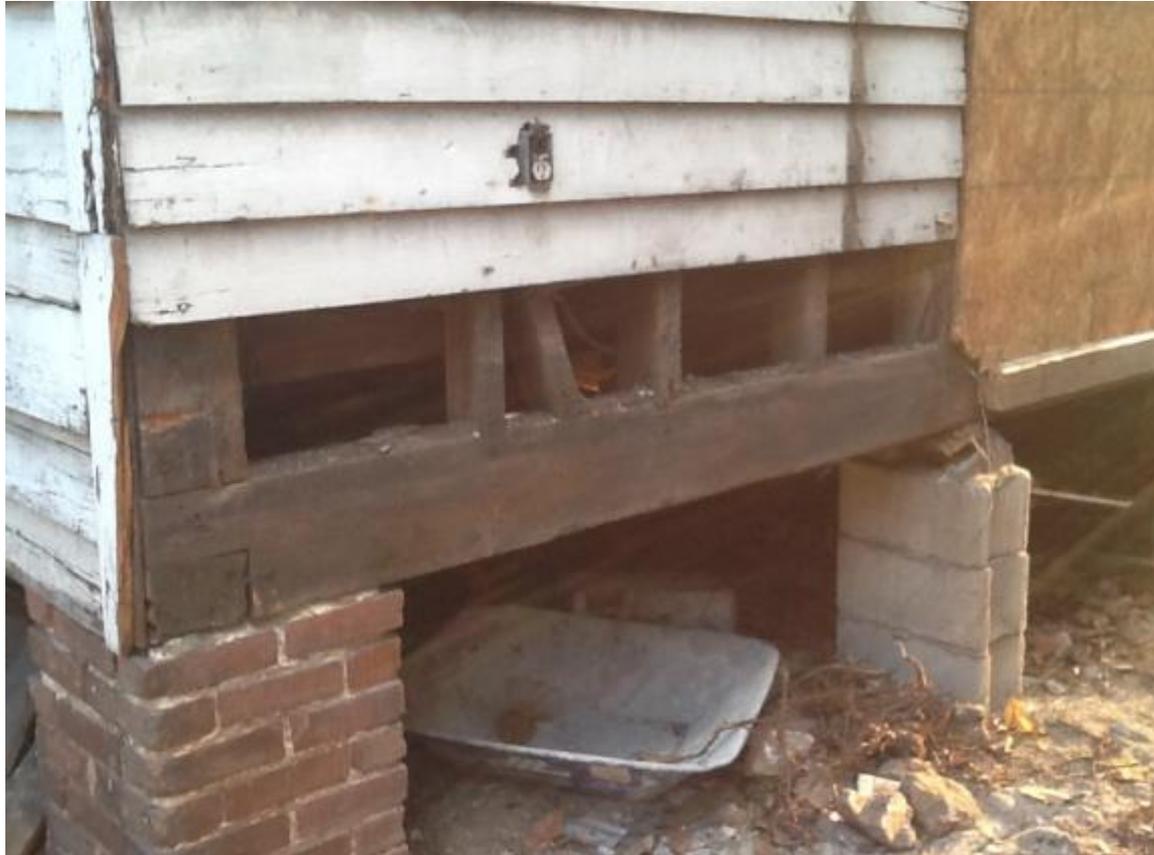
Photo 9

| <p>Architectural feature <u>Foundation</u> Approximate date of feature <u>Original</u> Describe feature and its condition</p> <p>Termite damaged and inadequate for support in places</p> <p>Photograph No. <u>9</u> Drawing No. _____</p> | <p>Describe work and impact on feature</p> <p>Replace termite damaged wood; Repair, replace or add seals and pillars</p> |

928 Pine St. – outbuilding foundation

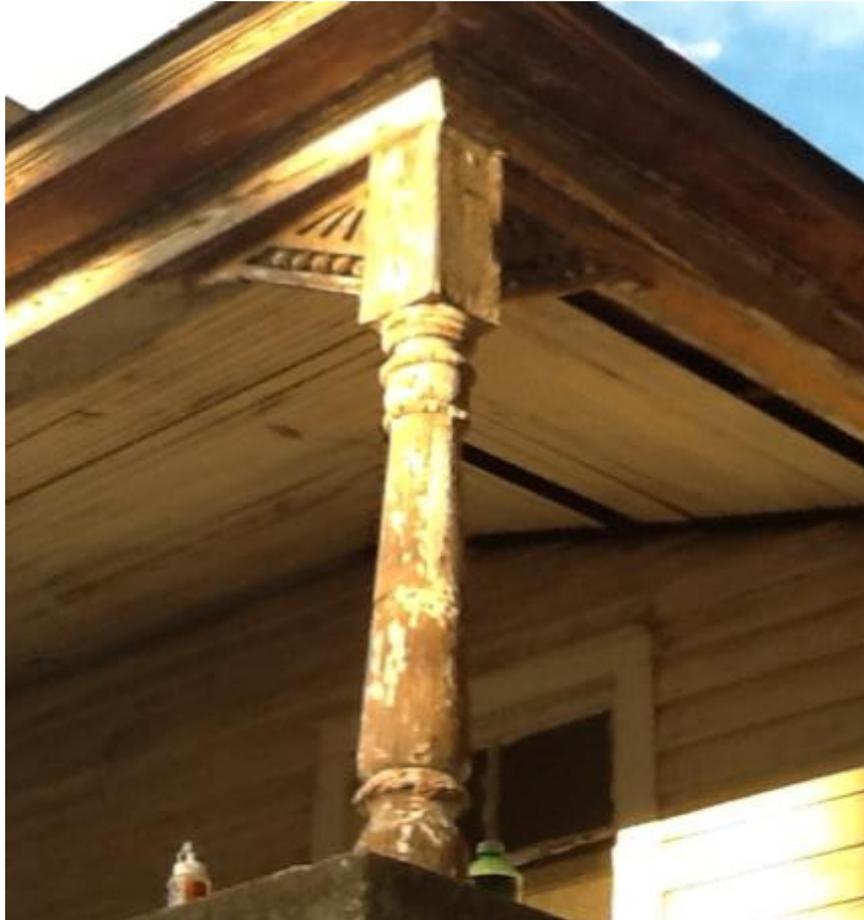
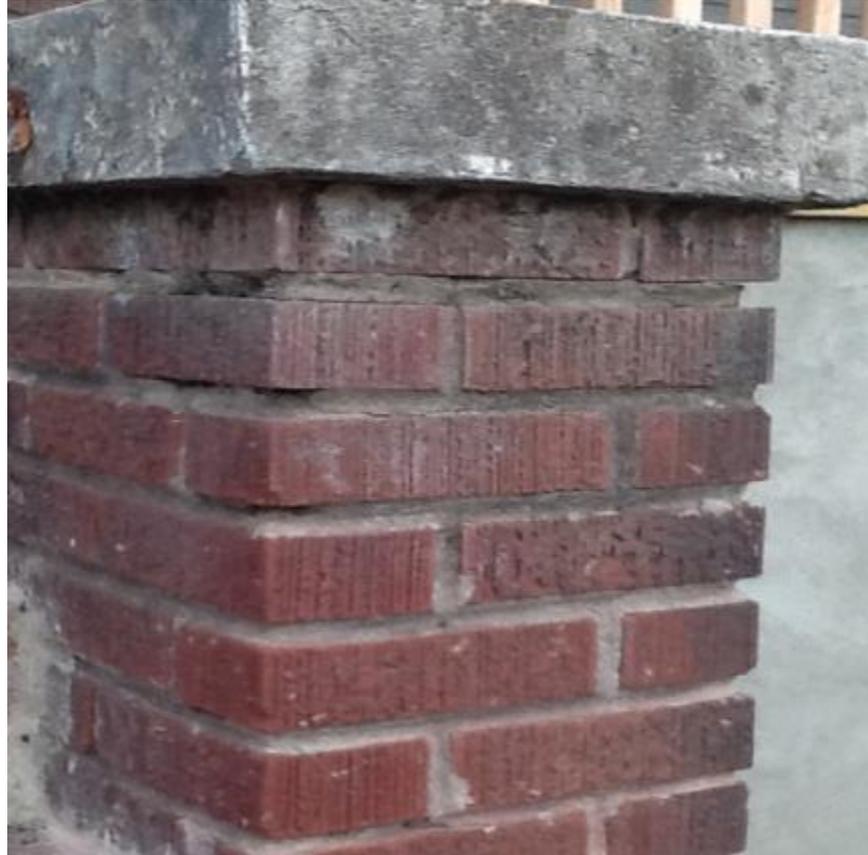
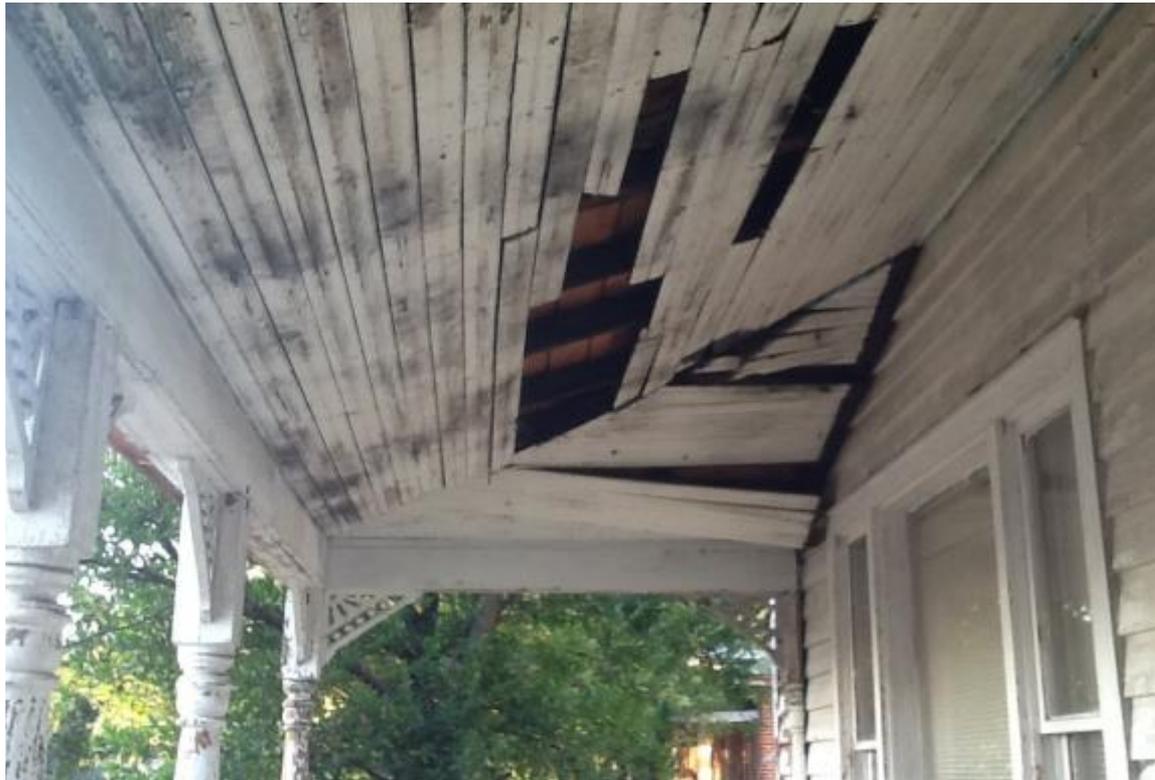
| <p>Architectural feature <u>Front porch</u> Approximate date of feature <u>Original</u> Describe feature and its condition</p> <p>Wood columns and corbels are in poor condition. Brick columns are in fair condition. Ceiling is in poor condition.</p> <p>Photograph No. <u>10, 11, 12</u> Drawing No. _____</p> | <p>Describe work and impact on feature</p> <p>Repair and repaint wood columns and corbels. Clean and point-up brick columns. Replace porch ceiling with similar appearing material.</p> |

928 Pine St. – Front porch columns & corbels

928 Pine St. – brick pillar in front of house

928 Pine St. – front porch ceiling

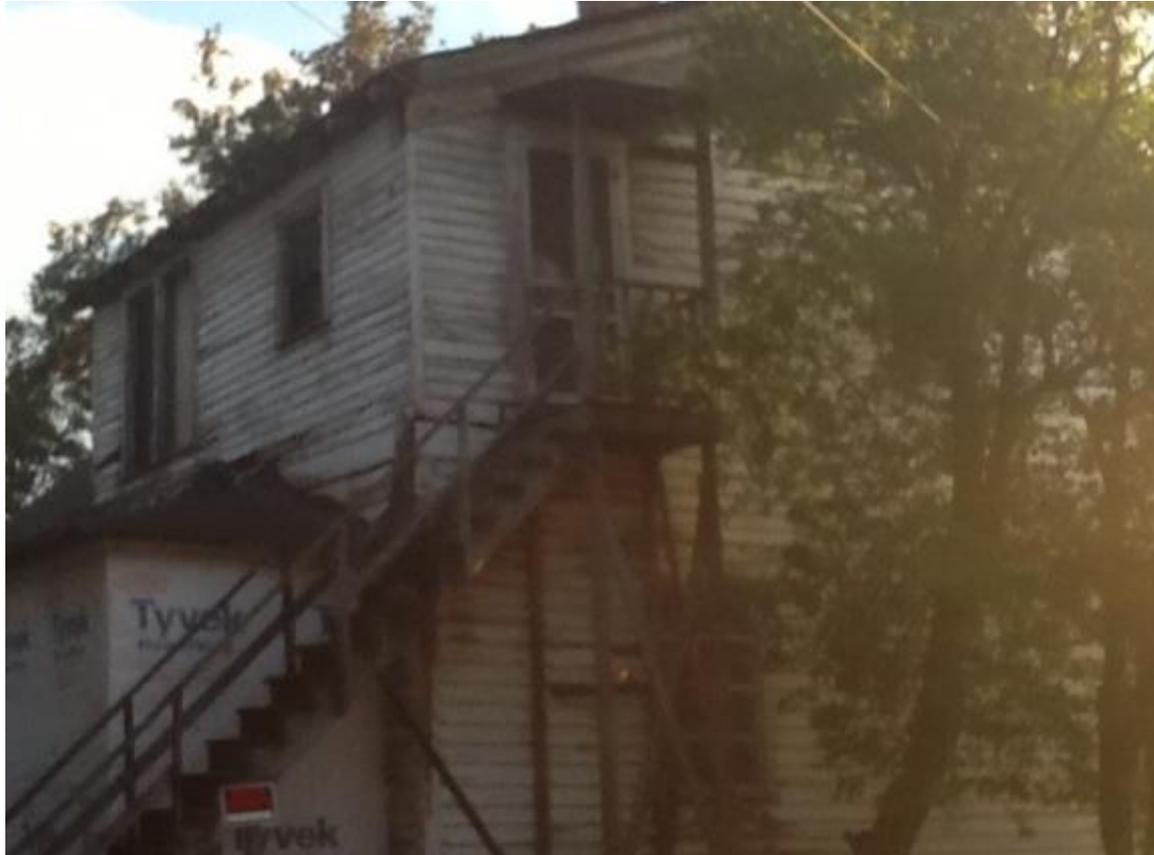
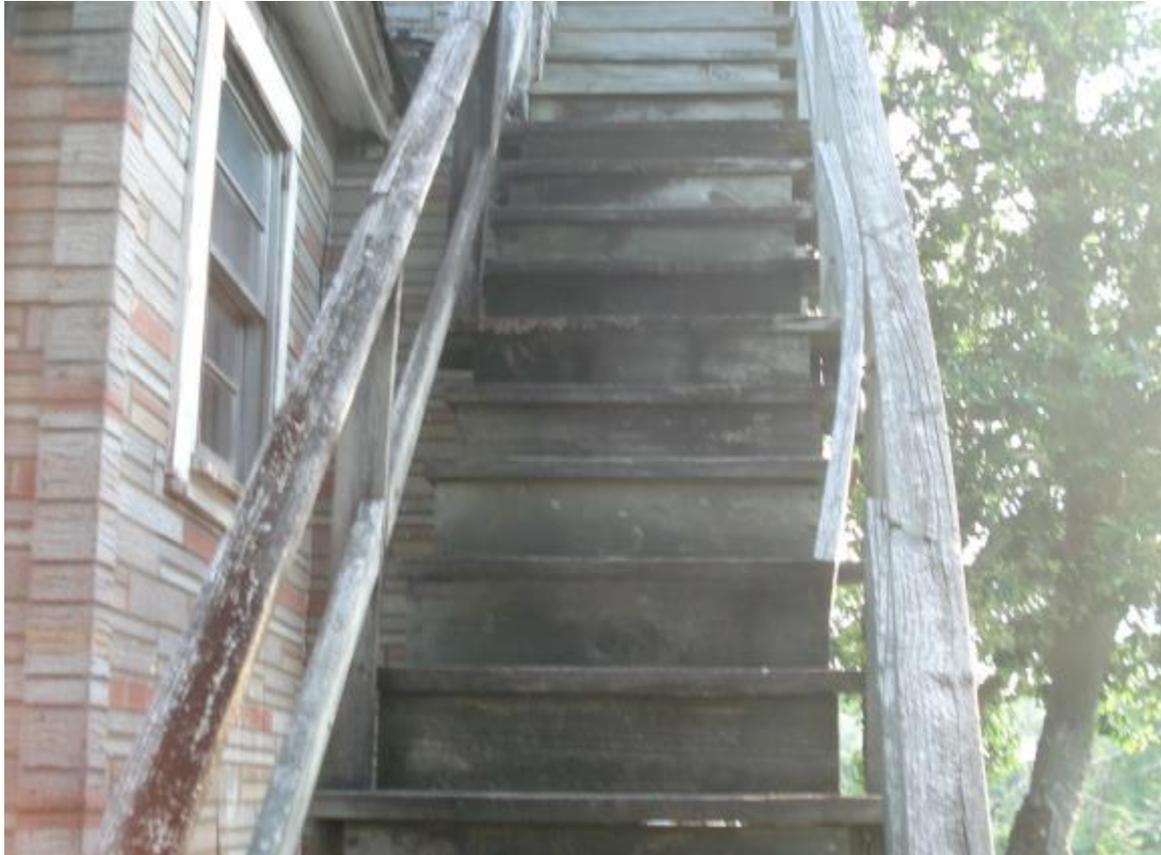
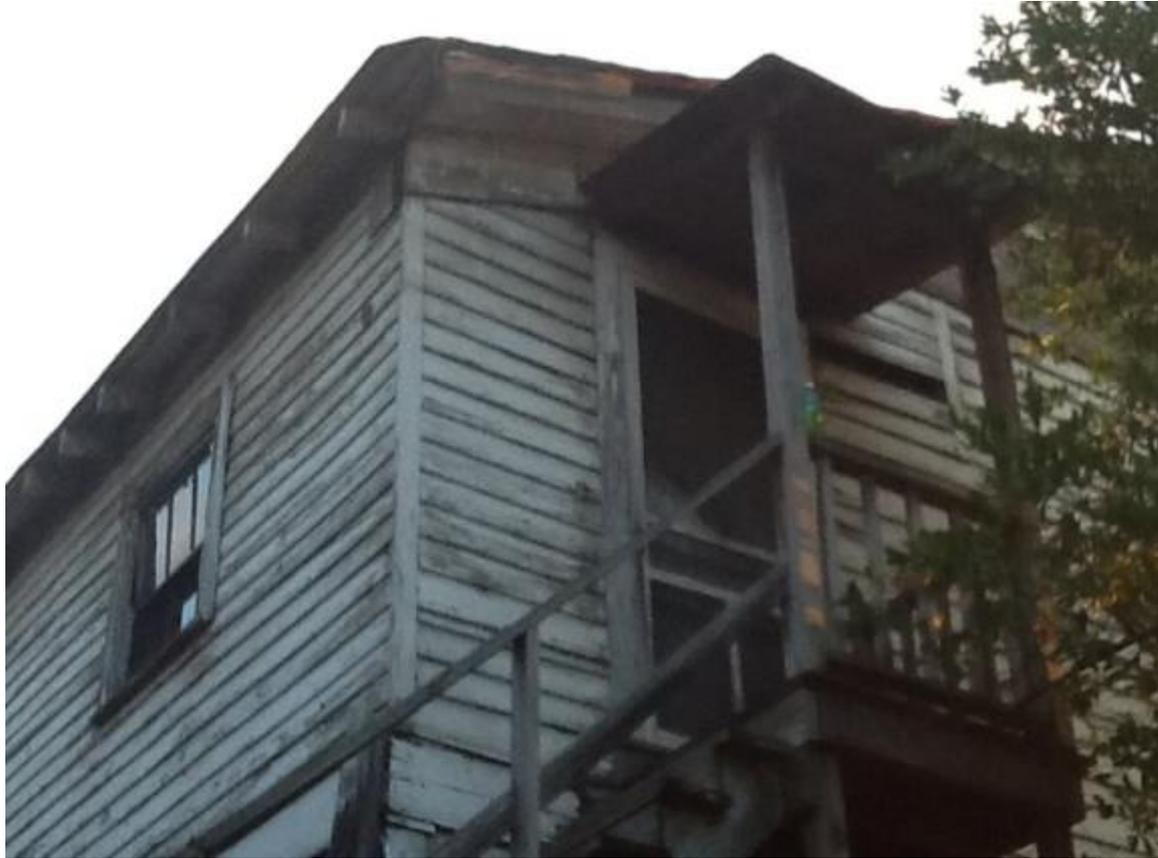
| <p>Architectural feature <u>Stairs & 2nd floor door</u> Approximate date of feature <u>Not known</u> Describe feature and its condition</p> <p>Stairs are damaged and a hazard. Door is not original to the house.</p> <p>Photograph No. <u>13, 14, 15</u> Drawing No. _____</p> | <p>Describe work and impact on feature</p> <p>Remove stairs. Remove door and replace with siding to return house to original appearance.</p> |

928 Pine St. – Exterior stairs, left side

928 Pine St. – exterior stairs, left side

928 Pine St. – Upstairs door, left side

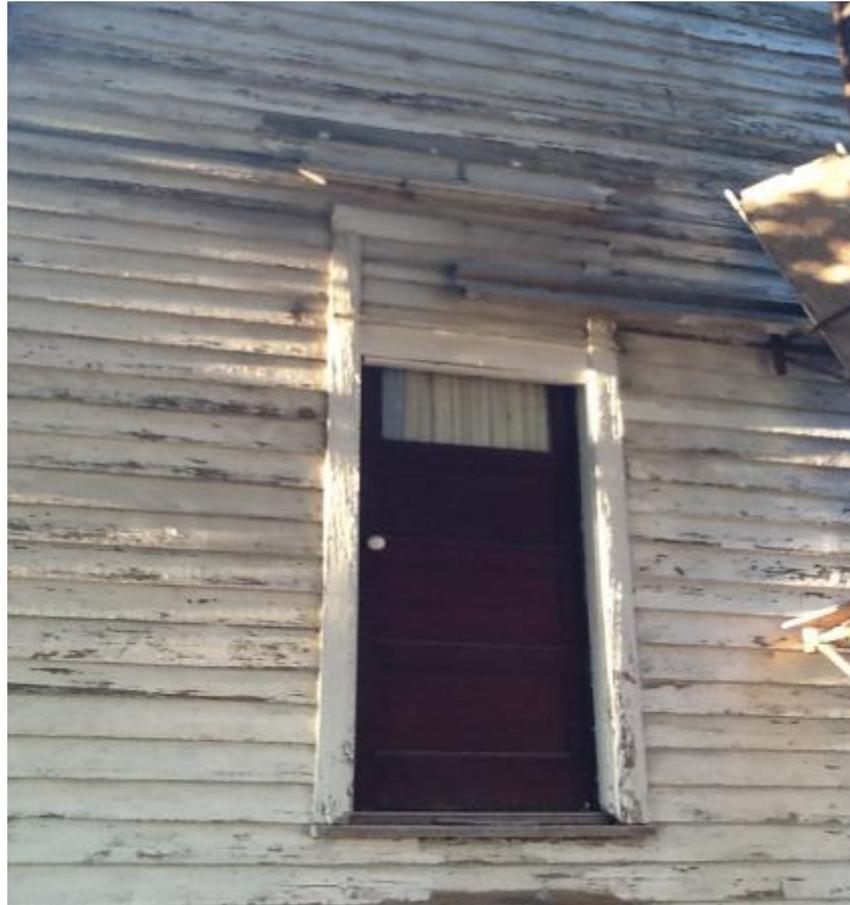
Photo 16

| <p>Architectural feature <u>Door (right side)</u> Approximate date of feature <u>Original</u> Describe feature and its condition</p> <p>Door opening is partially covered by siding.</p> <p>Photograph No. <u>16</u> Drawing No. _____</p> | <p>Describe work and impact on feature</p> <p>Return door opening to original size.</p> |

928 Pine St. – right side door
