## D/DRC Case

1402 Jim Hamilton Boulevard

**DESIGN/DEVELOPMENT REVIEW COMMISSION**  
**DESIGN REVIEW DISTRICT**  
**CONSENT AGENDA**  
**EVALUATION SHEET**  
Case #

**ADDRESS:** 1402 Jim Hamilton Boulevard, Curtiss-Wright Hangar

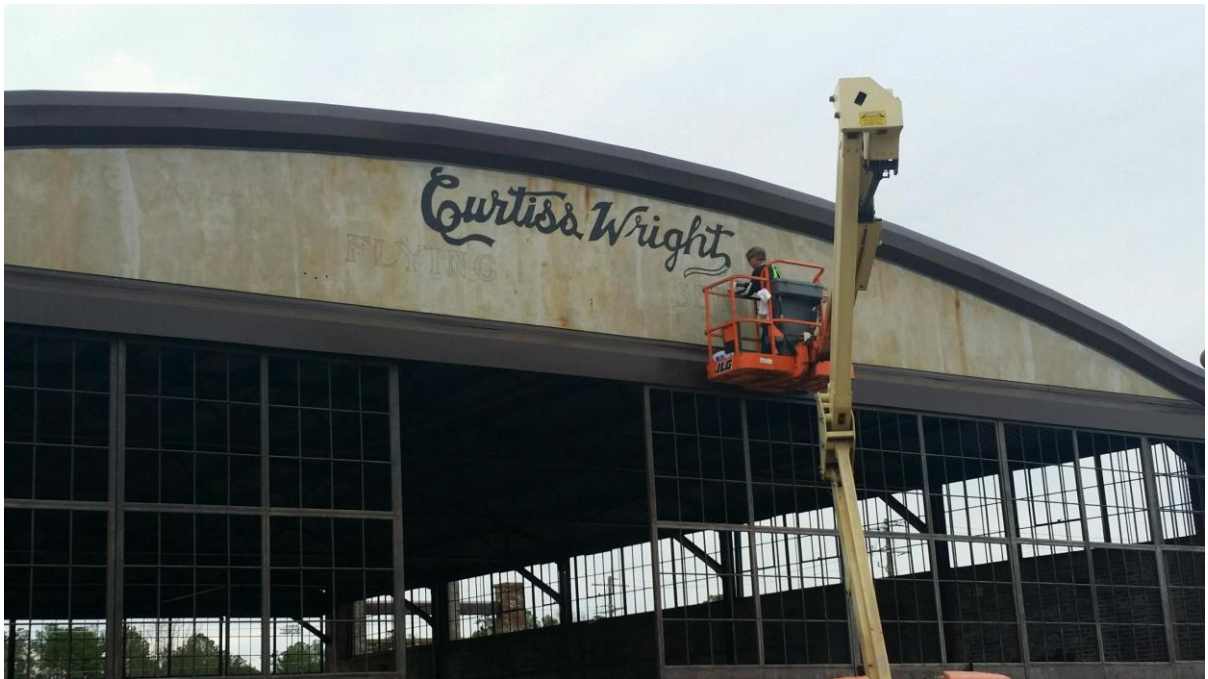
*Historic Curtiss-Wright sign being repainted (photo by applicant)*

There were a number of painted signs on the hangar, located above the hangar door and on the roof of the building. One sign, above the sliding hangar doors, originally said “Curtiss Wright” and “Flying Service”. This Curtiss-Wright sign is in the process of being re-painted to match the original. Another sign will be painted on the opposite side of the building, facing Jim Hamilton Boulevard, to say “Hunter-Gatherer” and “Brewery & Alehouse”. This new sign will match the lettering of the historic “Curtiss Wright” sign. Since the Curtiss-Wright Hangar historically included painted signage, adding a new painted sign that matches the historic and also gives indication of the building’s usage is appropriate for the building.

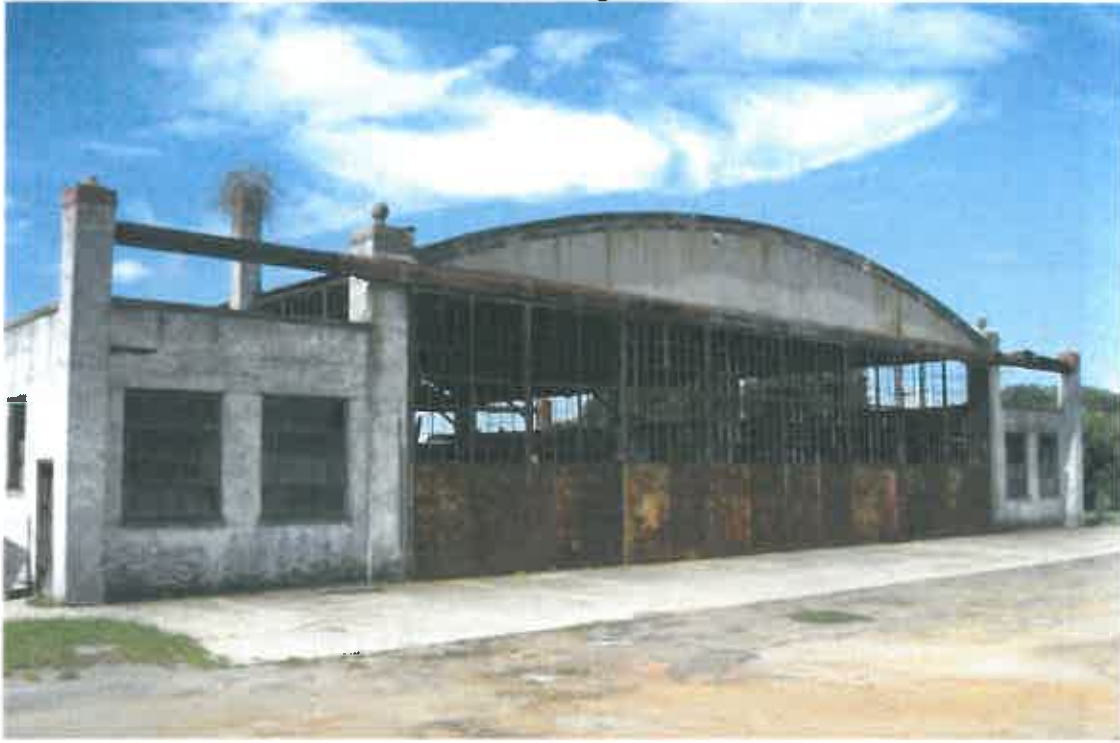
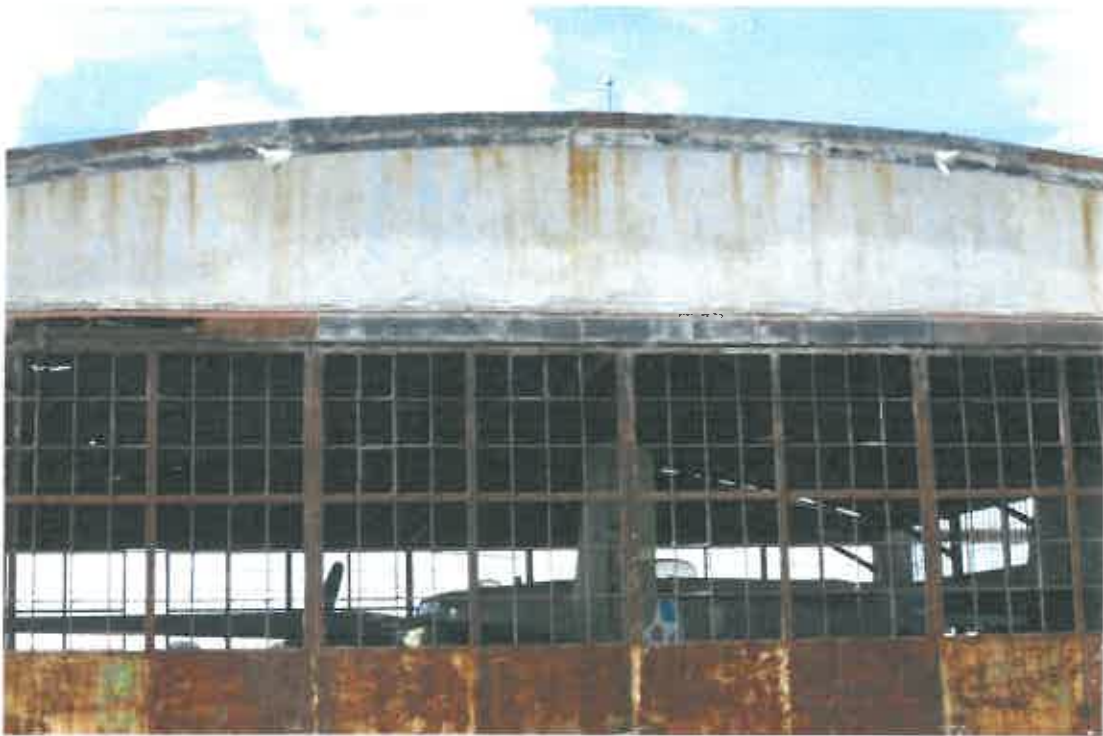
The north and south elevations feature two large sets of sliding steel doors. Each of the doors is comprised of eight separate segments, and the top two-thirds of each segment is made up of a block of four windows. On the north elevation there is a pedestrian door, which was cut into the steel, although it is not certain whether this feature is original or a later addition.

Photo 1 – Hangar doors, north elevation

Photo 2 – Hangar doors, north elevation

The proposed work includes removing the rust from all of the doors with Rust Converter, a product that chemically neutralizes rust into a neutral organic layer and dries as a tough, protective coating on the metal (see attachment A). Strengthening of the sliding door mechanism and column system will also be done. The remnants of the "US ARMY" sign on the south elevation will remain. The windows along the top of the doors will be reglazed (see #3 below).

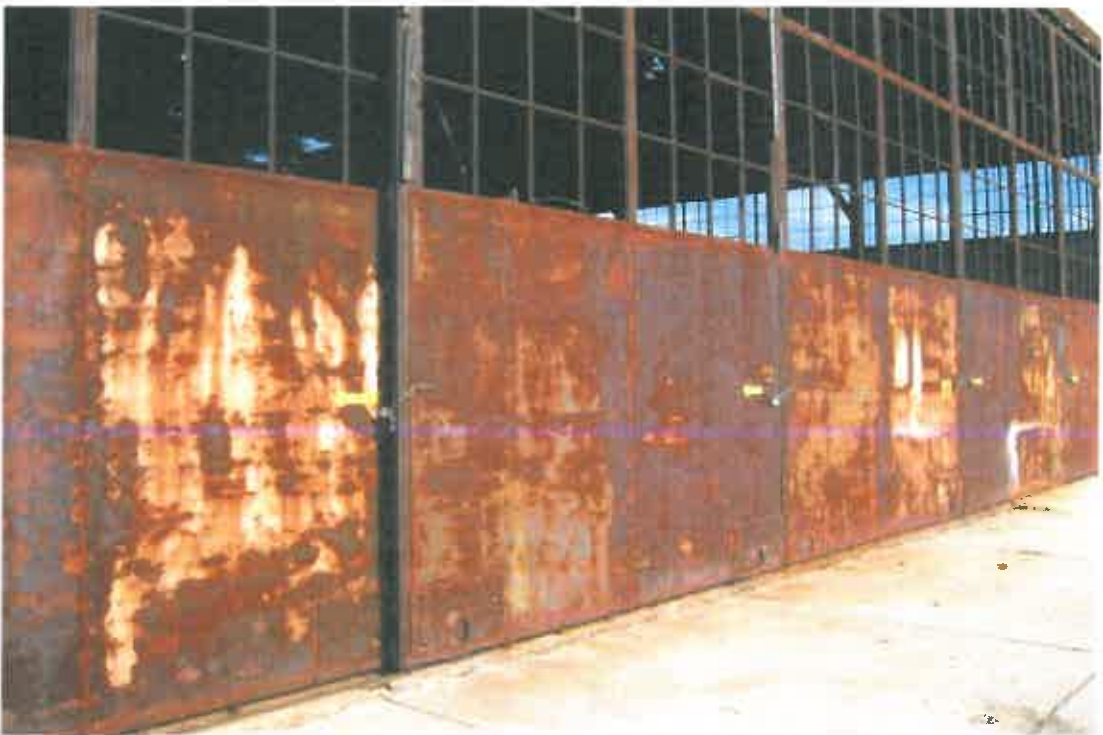
Photo 3 – Detail, hangar doors, south facade

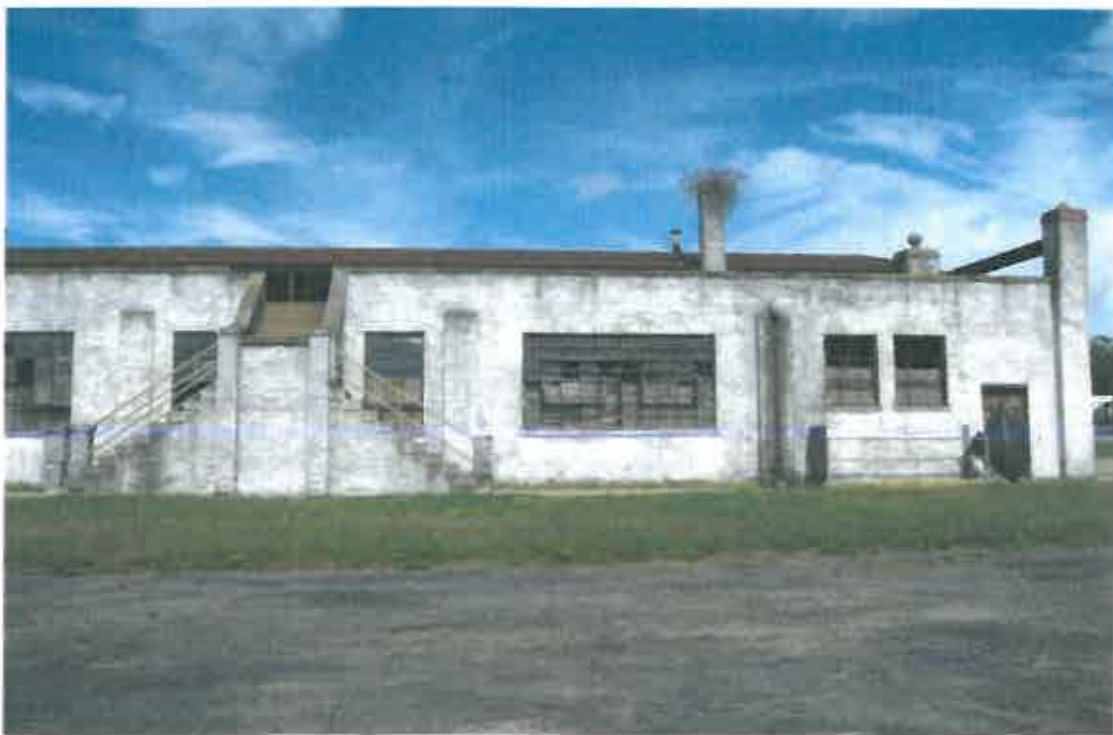
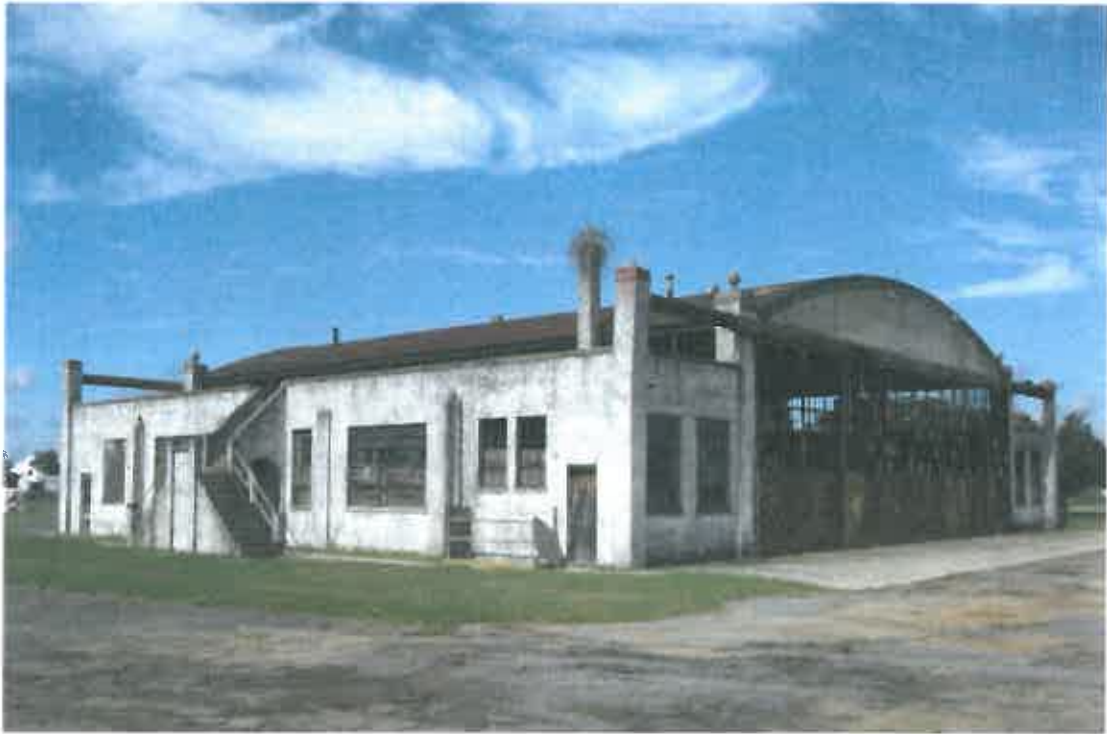
The hangar's corrugated metal roof features a distinguishing rounded design and is supported by metal framing in the interior. Metal panels overlap across the roof beneath the corrugated metal roof and asbestos insulation rests between the outer roof and the panels.

Photo 6 – View of roof, east elevation

Photo 7 – View of roof, northeast oblique

The roof will be completely replaced due to substantial deterioration and to remove asbestos. This new roof will retain its unique shape and the original interior framing to preserve the character of the original character. The roof will be laid with 1 1/2" metal interior panel, with a 3 1/2" middle insulating panel, and finished with similarly shaped rounded corrugated metal roof (see comparison of new and original roofing panel and proposed new metal roofing panel-photo 33. Also see A1.3 N & Attachment B). The roof color will be gray. All of this be laid on top of the original interior roof frame.

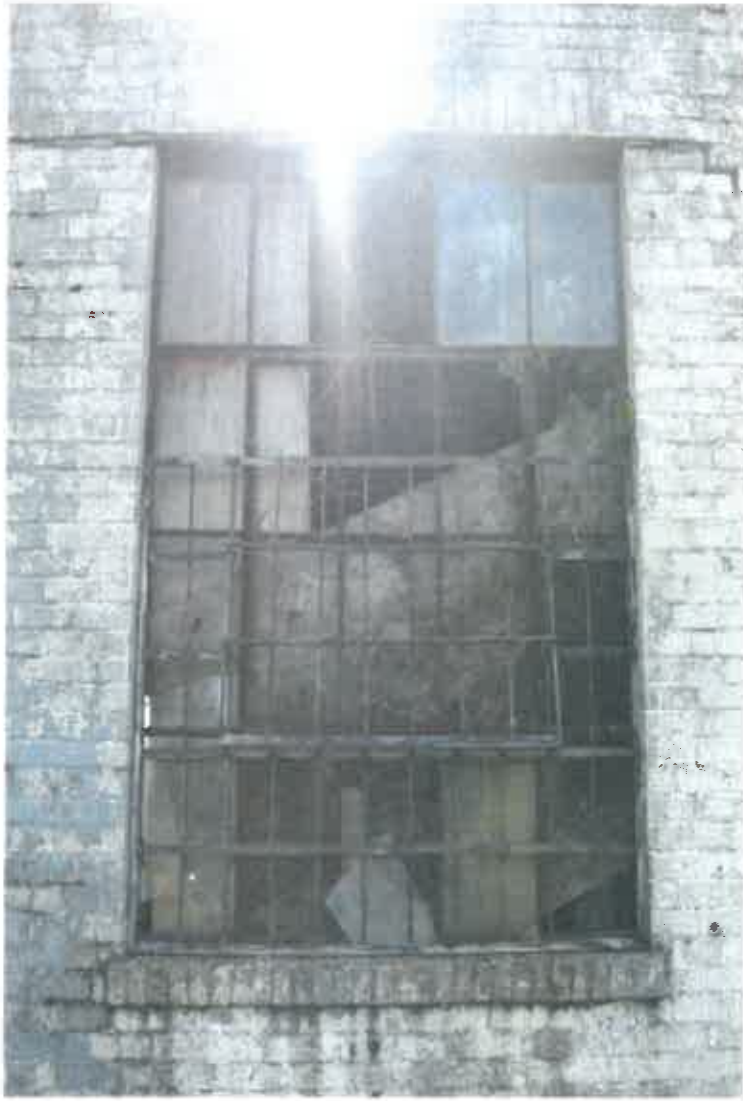
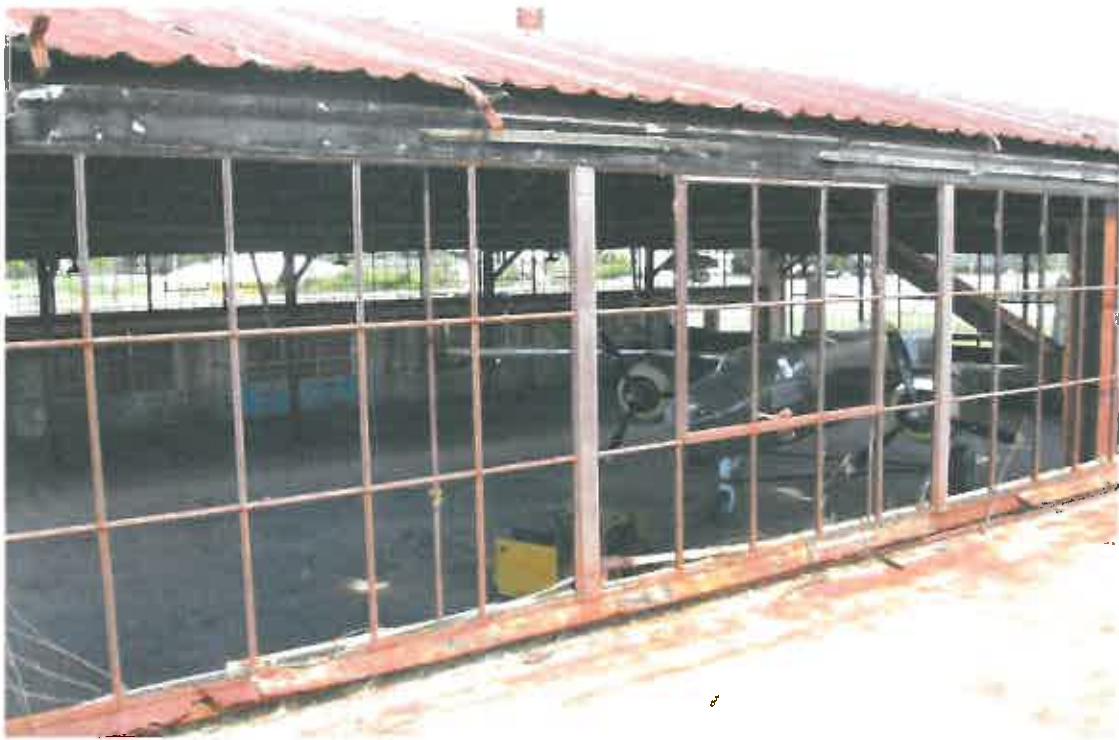
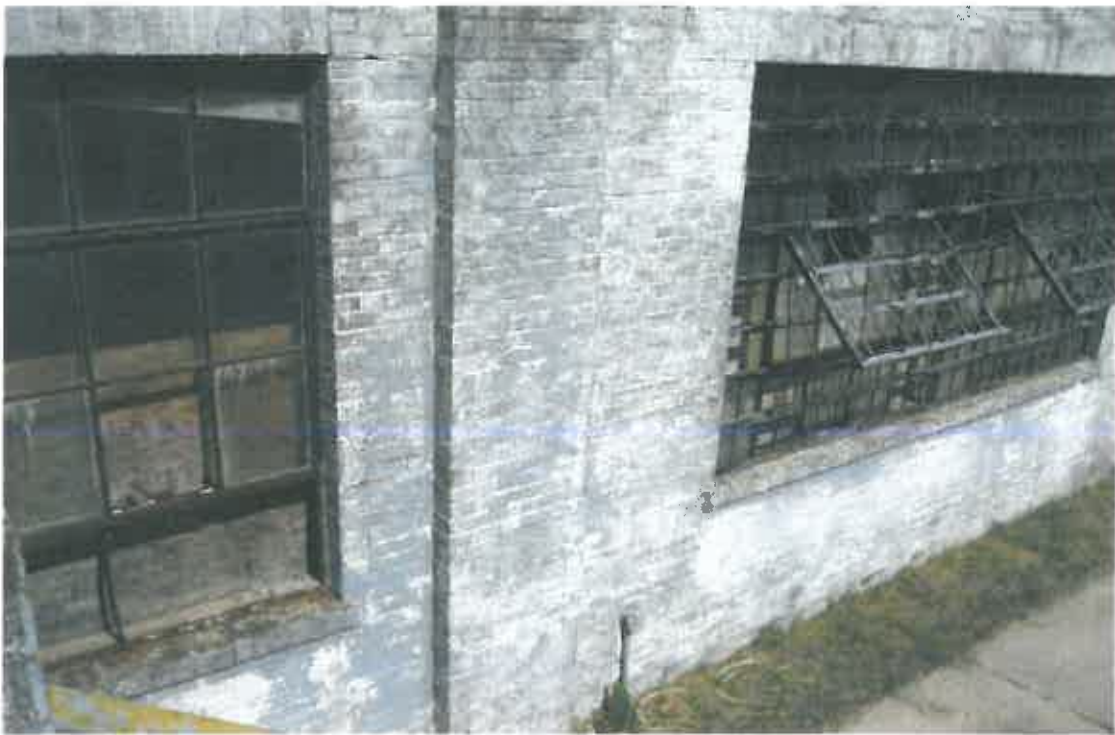
Most of the windows of the hangar are generally the same size except for the east elevation windows, which are larger. The window frames are all composed of steel as are the muntins.

Photo 8 – Window detail

Photo 9 – Clerestory windows

Photo 10 – Hopper windows

The glass window panes will be replaced and reglazed. These new windows, which are detailed in the attachment A3.0, will be single pane hard coated low-E panes which have

low reflectivity so as not to detract from the historic character of the building. The current muntins will be kept, but will be hand cleaned with wire brushes and sandpaper, and then restored with Rust Converter, the same product described in Number 1.

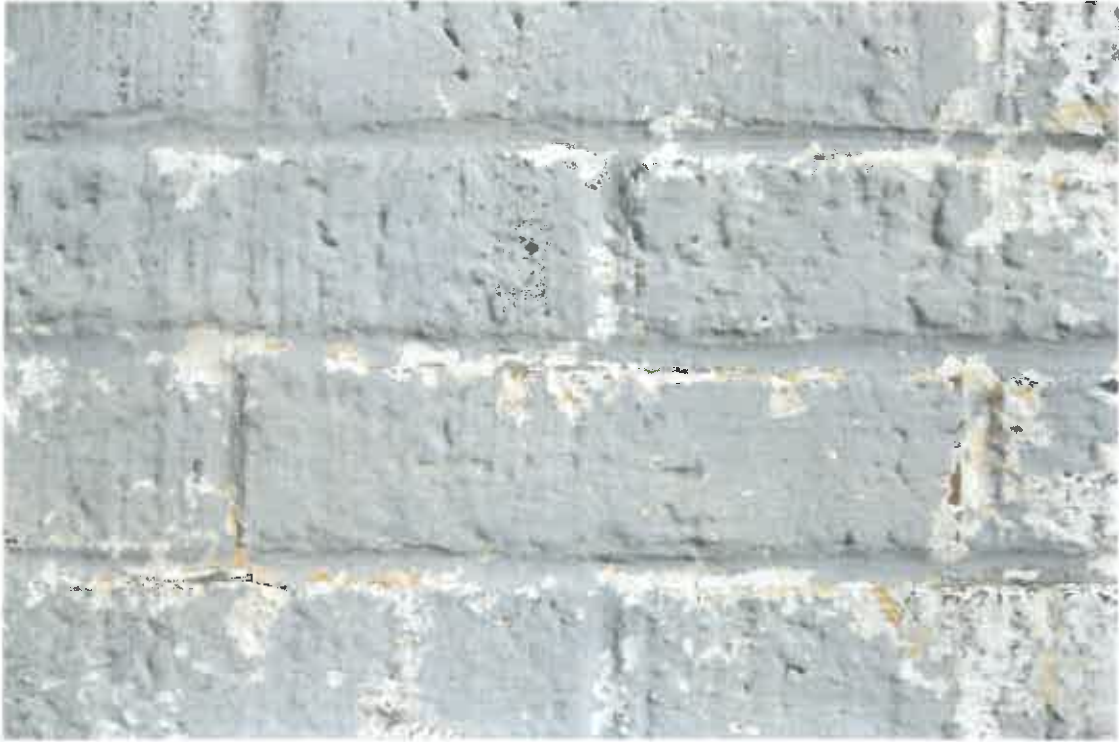
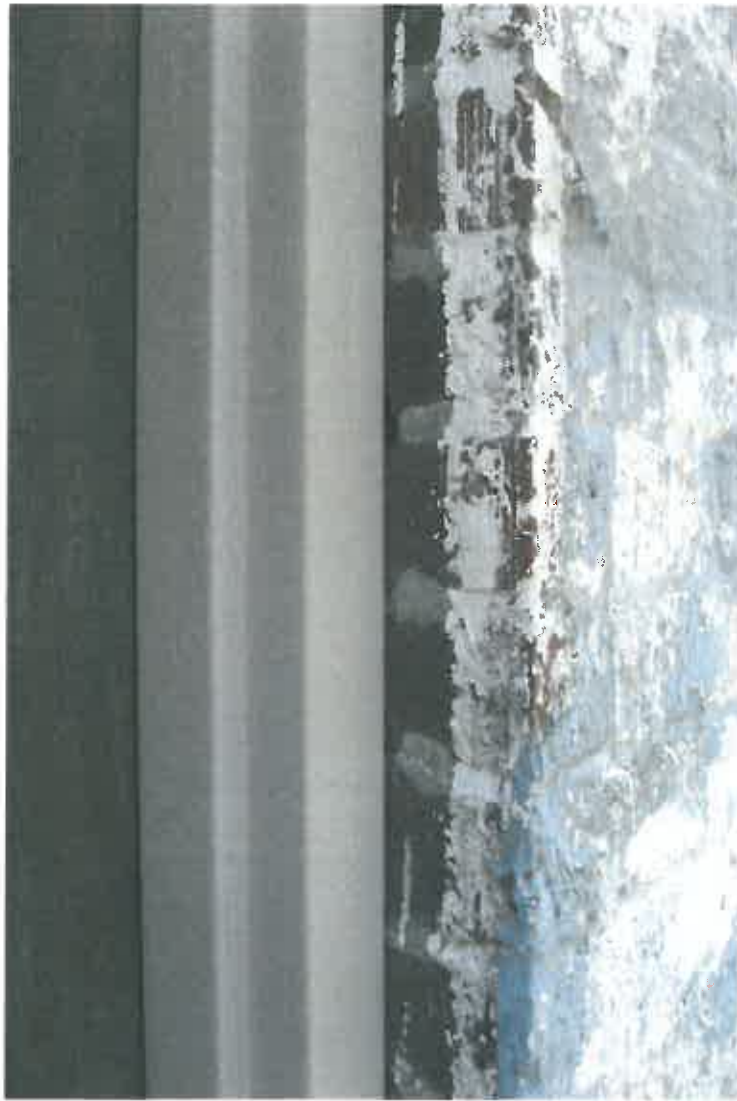
The hanger bricks are spalling in a number of locations, but are otherwise in good condition. Scratch-cut brick is used on the exterior while the interior features smooth brick. The south façade in the east corner has some damaged bricks from the sliding doors.

Photo 11 – Exterior painted brick detail

Photo 12 – Exterior brick detail

Repointing of the mortar joints is needed in various locations where the mortar has deteriorated. Previous repairs have been made to the brick columns, but do not match, and will be removed and the new or locally salvaged scratch-cut brick will be used to rebuild the columns to match the existing brick. The interior bricks will be cleaned with a non-abrasive cleanser such as ProSoCo Enviro Klean Restoration or a similar product. The paint on the exterior brick will be removed using an environmentally friendly paint stripping product and a low pressure power wash (see Attachment D).

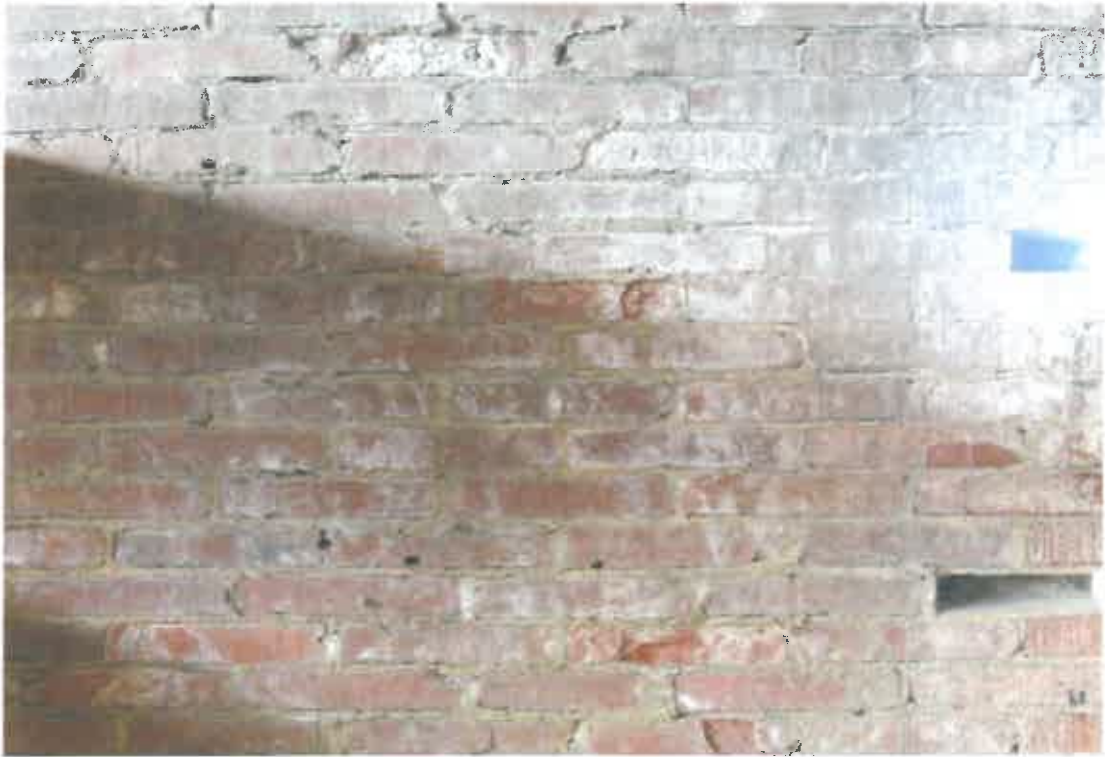
**Photo 13 – Interior brick detail, repointing needed**

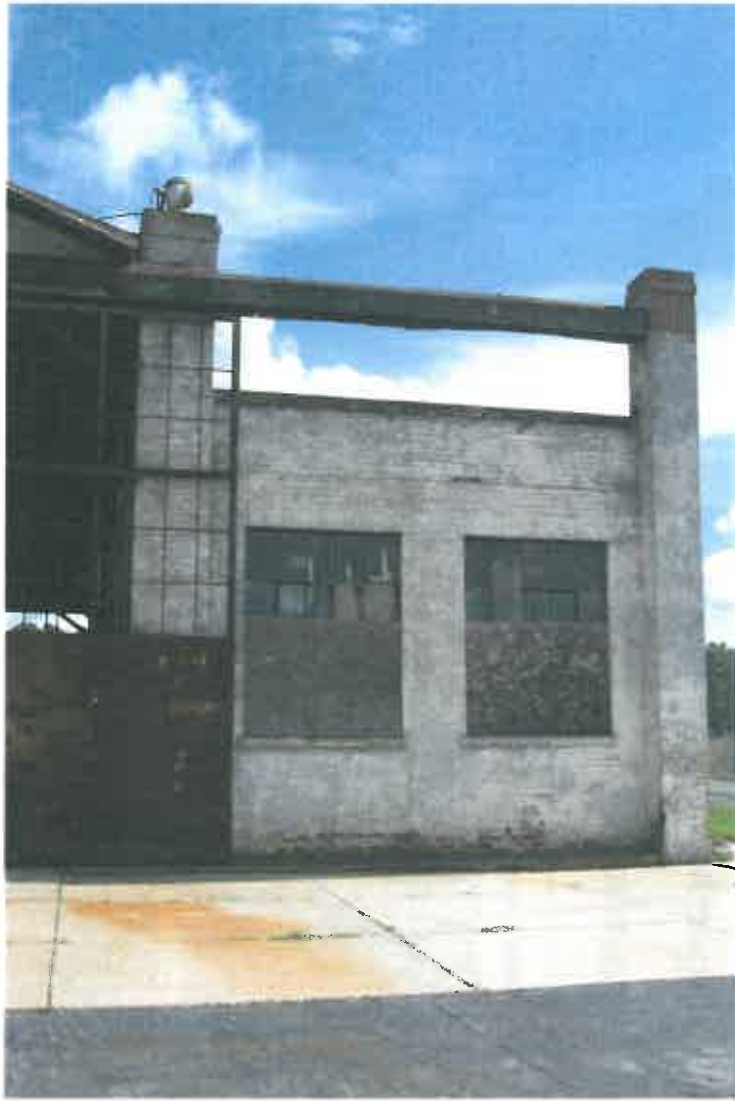
Years of wear and tear have impacted the columns, particularly the outermost columns nearest to the doors. Necessary repairs were made, but with improper materials, including brick that does not match the historic scratch-cut brick. These bricks will be removed and replaced with more appropriate bricks that match the scratch-cut original bricks. The

Photo 22 – Southeast corner columns

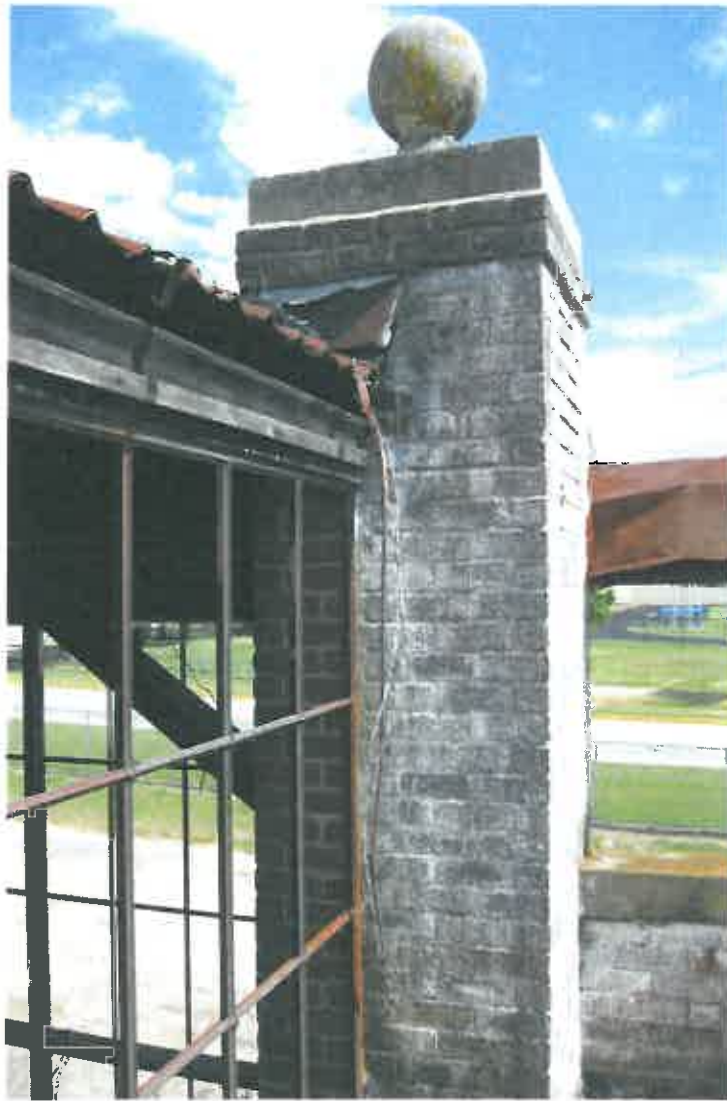
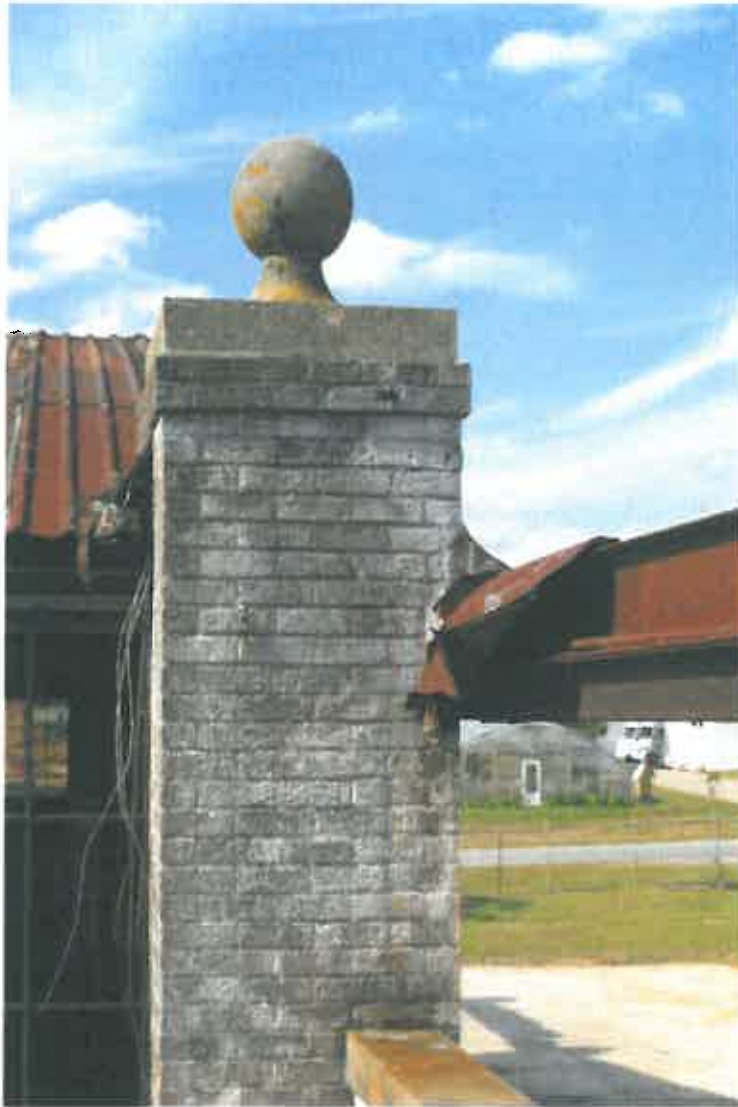
Currently, there are only four unharmed finials, and they appear on the four innermost columns. The finials atop the four outer corners are either missing or severely damaged. The remaining finials will have the yellow paint removed from them, and the new finials will be replaced with new concrete reconstructions. It is important to recreate these features since they were the only purely decorative addition to the hangar as well as the only Curtiss-Wright hangar to have this embellishment.

Photo 23 – Concrete finial, southwest corner

Photo 24 – Concrete finial, northeast corner

There are concrete finials that were in place on the top of the columns that support the hangar doors. Four of these finials are now missing or damaged. These finials will be replaced with concrete finials to match the historic finials that are still intact on four of the columns. The location of the finials is supported in pictorial and physical evidence.

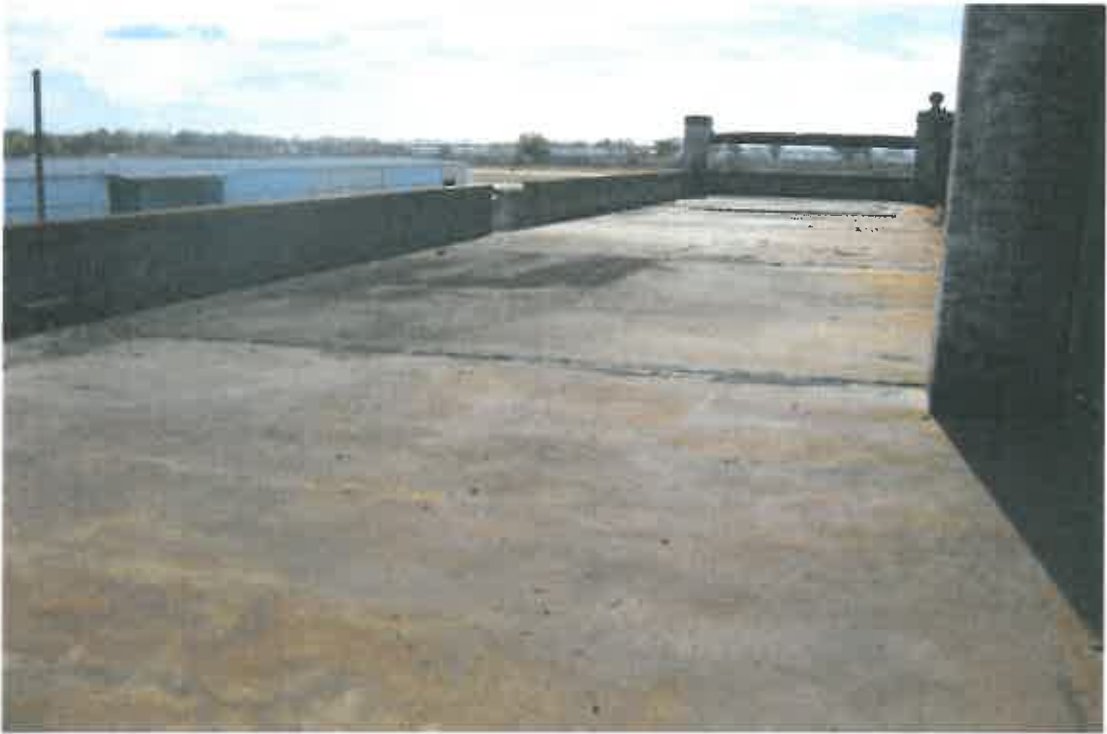
Photo 25 – Observation desk, looking southeast

The observation deck only requires minor repairs such as repairing or replacing concrete caps along the brick walls and ensuring that the floor is level. It will be necessary to provide a higher railing to keep visitors safe, but these changes will be made in the least invasive manner possible, which is seen on the architectural plan A1.2(J-M). The deck is an integral part of the hangar's history as it was a pivotal piece of all Curtiss-Wright hangars across the country.

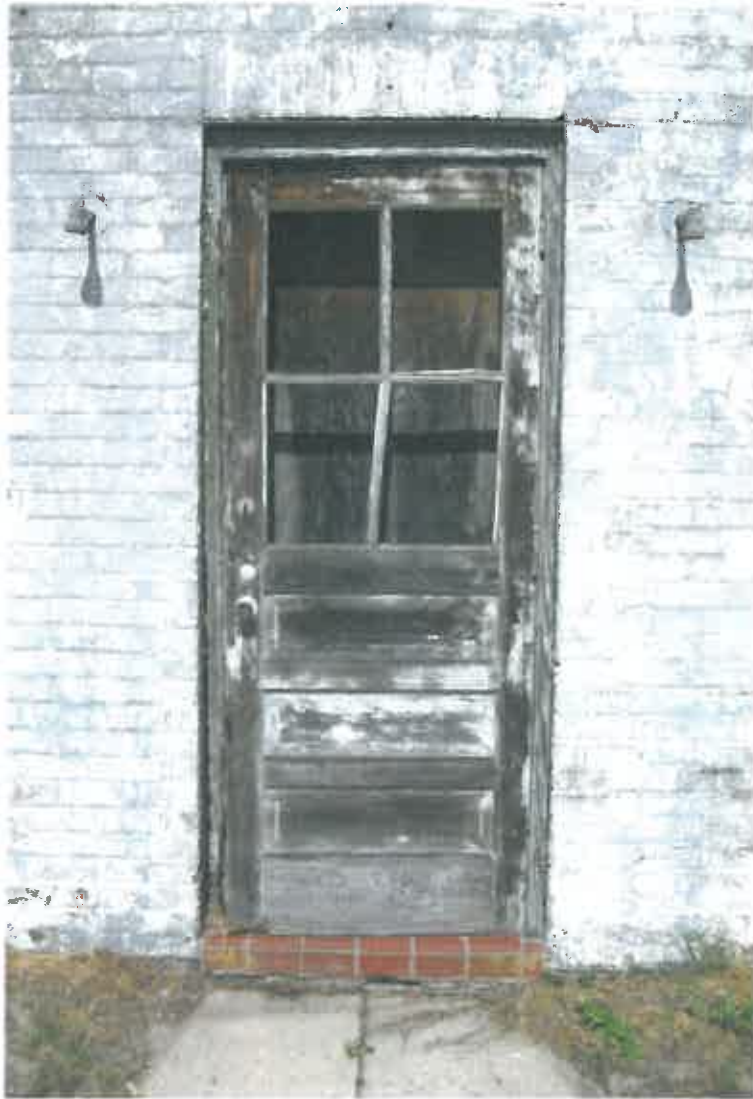
The Manager's Office Door is a wooden exterior door comprised of four windowpanes along the top half and three horizontal panels at the bottom half. The door's hardware is a recent replacement.

Photo 26 – Manager’s office door, east elevation

Since the door remains in salvagable condition, it will be restored. The windows will feature the same glass panes as in Number 3 above and will be reglazed. The door frame is also in good condition and will be repaired. Since this is the only remaining historic door aside from the steel doors, it is crucial that it be preserved and repaired. See

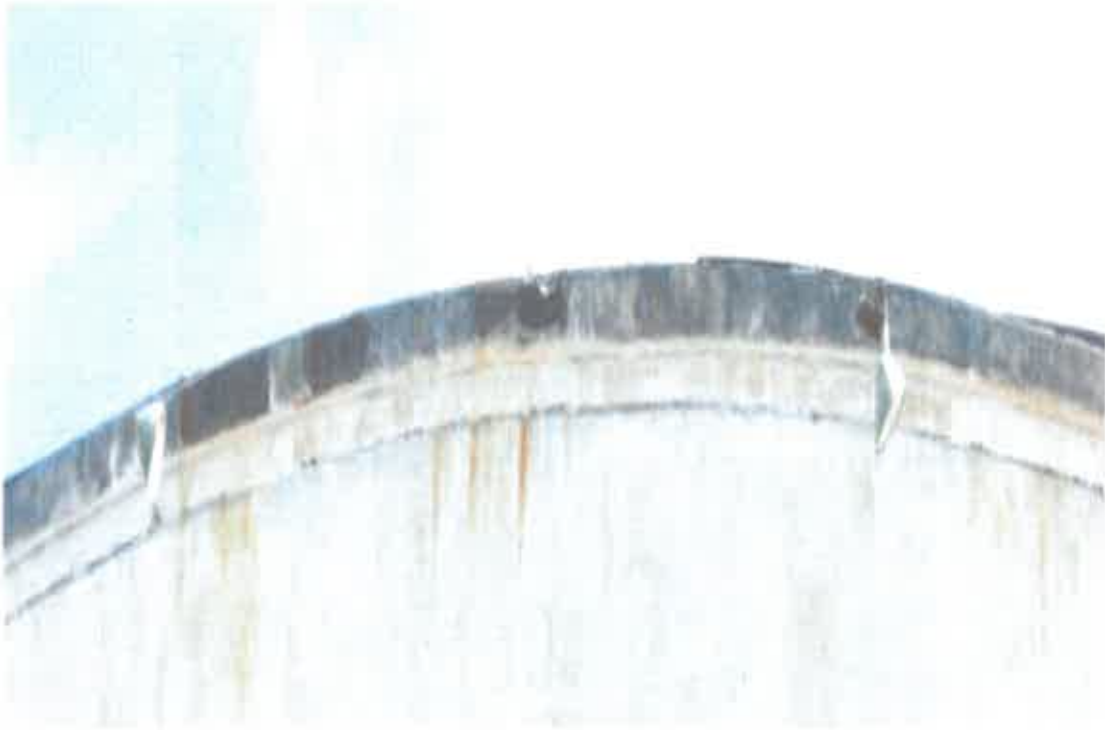
Photo 27 – Two exterior light fixtures, north gable

Due to their historic nature, the lights will be rewired and reinstalled. These lights will be repaired and used to light the signage on the two gables. The fact that these are original and demonstrate the functional and basic style of the hangar is important and therefore imperative to keep and use.

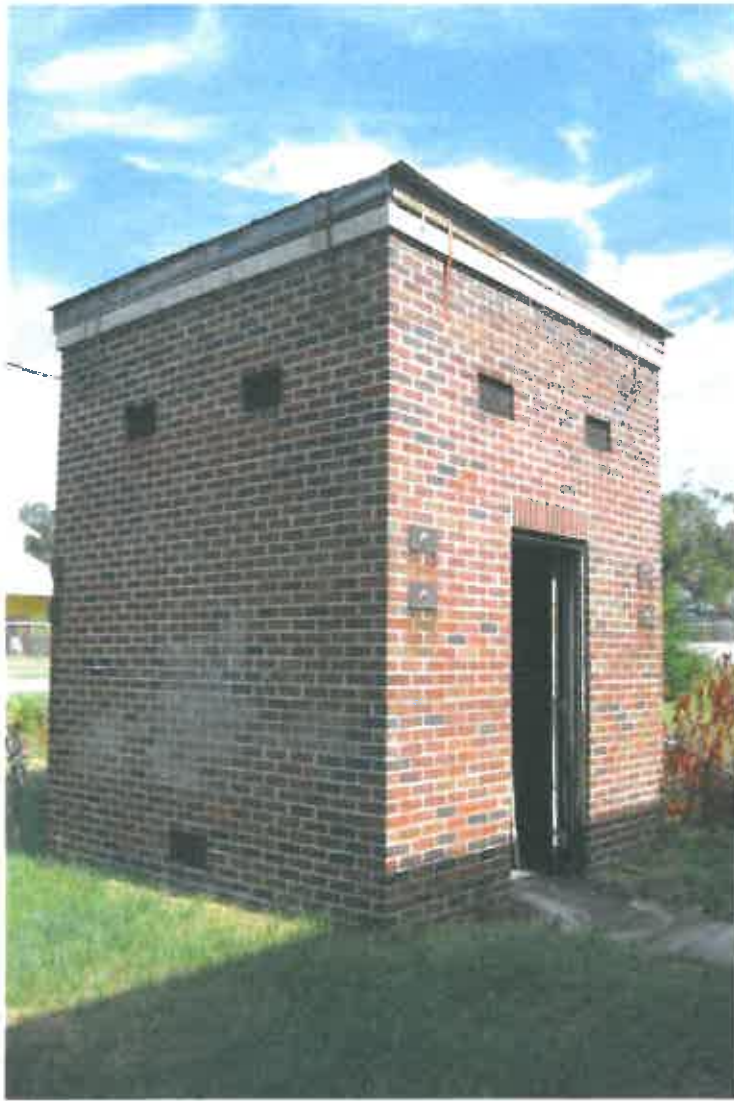
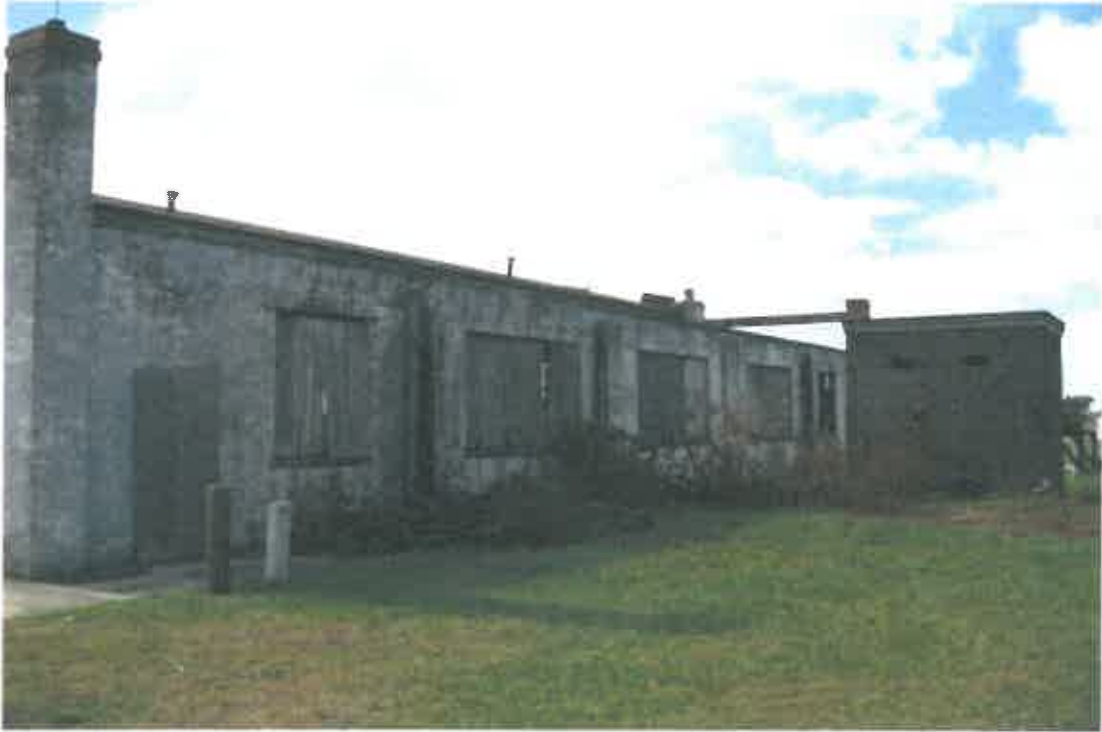
This 1940 outbuilding is a small, square-shaped building situated about ten feet from the west side of the hangar. It is laid in common bond, except for a decorative soldier course about the doorway. The only entrance to this building is on the east side, facing the hangar for easy access, and is the only elevation to retain two sets of metal bolts. There are two steel grates about 2 ½ feet from the roof. The original roof was flat and deteriorated. It has since been replaced by roofing steel as a temporary measure.

Photo 28 – Electrical outbuilding

Photo 29 – Electrical outbuilding at west elevation

The roofing steel will be removed and replaced with a new roof as shown in drawing. Additionally, the building will have a new wooden door installed that is consistent with the existing door in Number 12 above. This door will match the original door as discussed in Number 12. There are electrical insulators in the interior corners of the building, which will be retained as references to the building's historic use. Since this was the Hangar's only outbuilding, it is extremely important to keep the building where it stands.

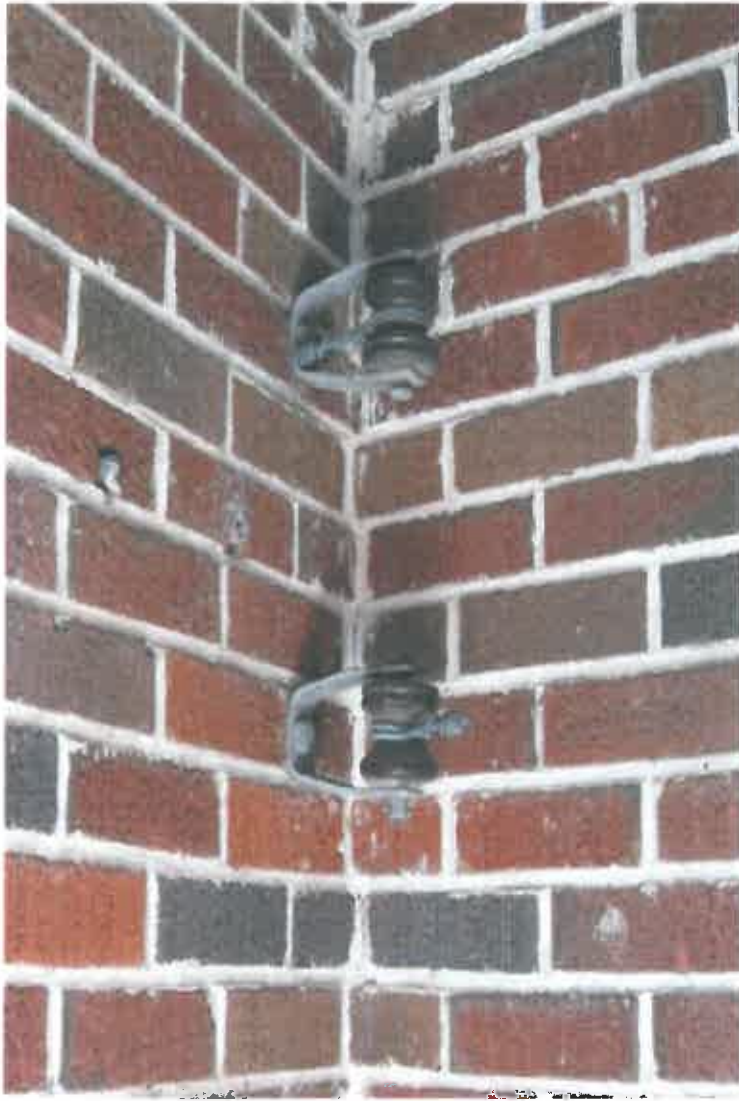
Photo 30 – Electrical outbuilding brick detail

Some repointing of mortar joints may be necessary, but overall the brick is in good condition. If new bricks are required, locally salvaged Richtex brick would be the best option. Maintaining the original appearance of the 1940s structure is significant to preserve the architectural and historical integrity.

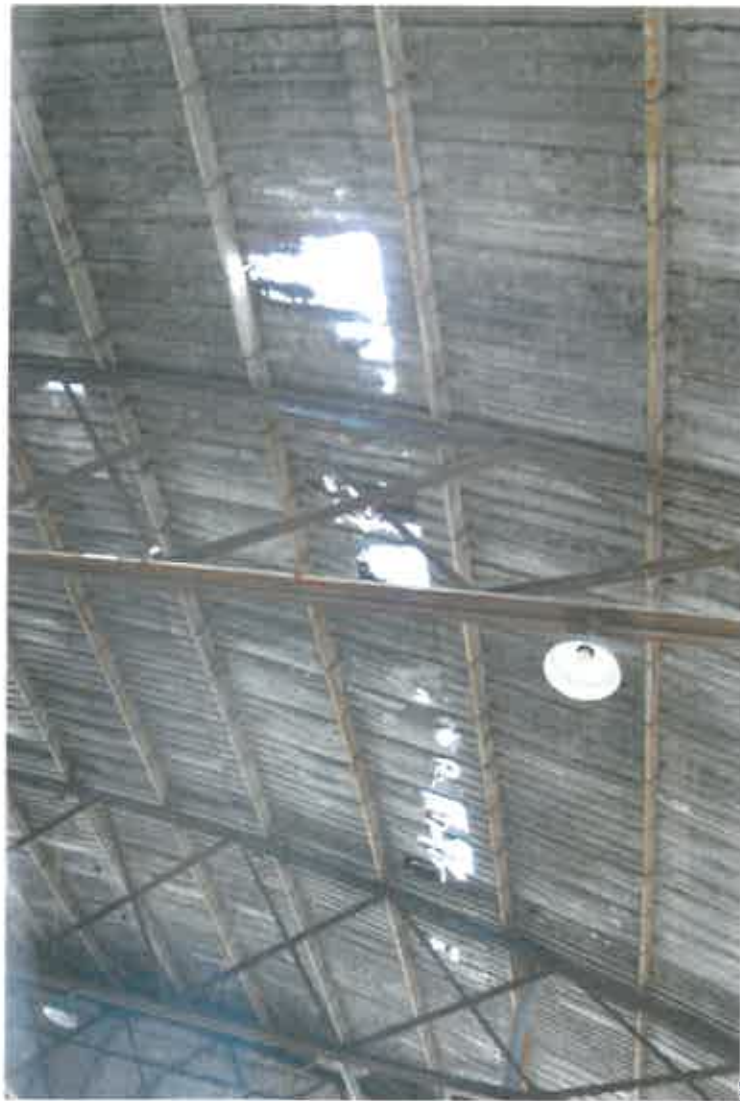
Photo 31 – Roof deterioration and exposed trusses

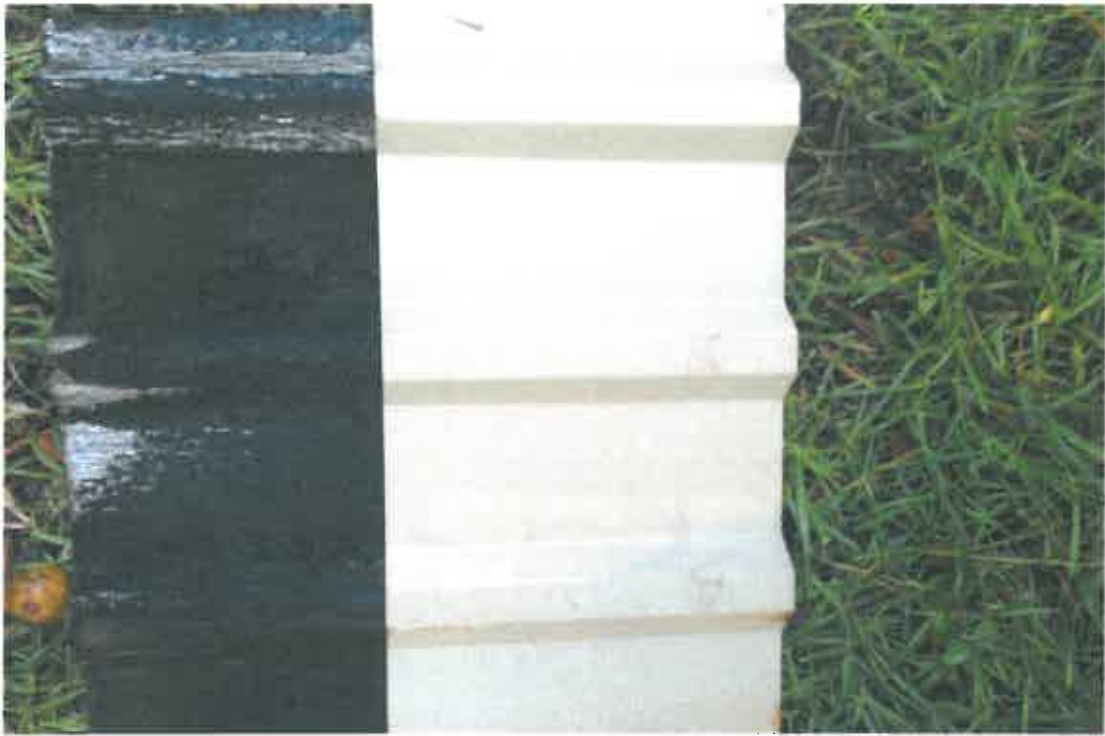
Photo 33 – New roofing panel compared with existing

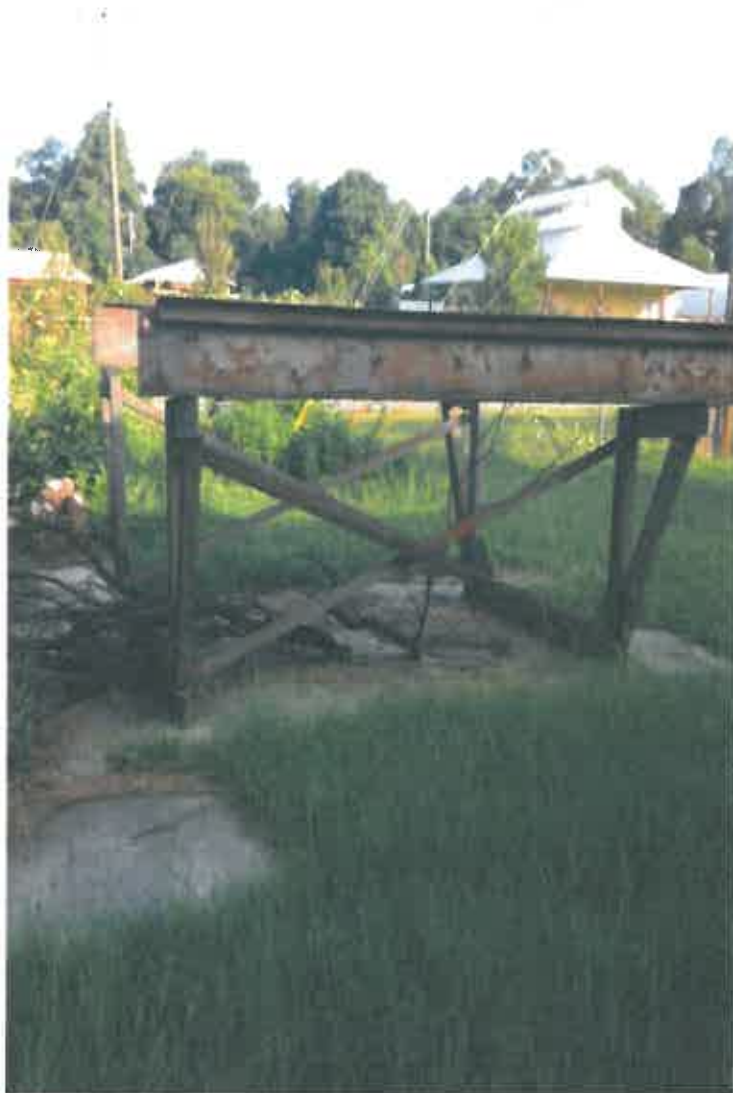
An airplane fuselage cradle is found on the west side of the building near the electrical outbuilding.

Photo 34 – 1990's Airplane fuselage cradle
