## D/DRC Case

1817 Pickens Street

**DESIGN/DEVELOPMENT REVIEW COMMISSION**  
**DESIGN REVIEW DISTRICT**  
**HISTORIC AGENDA**  
**EVALUATION SHEET**  
Case # 1

**NATURE OF REQUEST:** Request Certificate of Design Approval for exterior changes

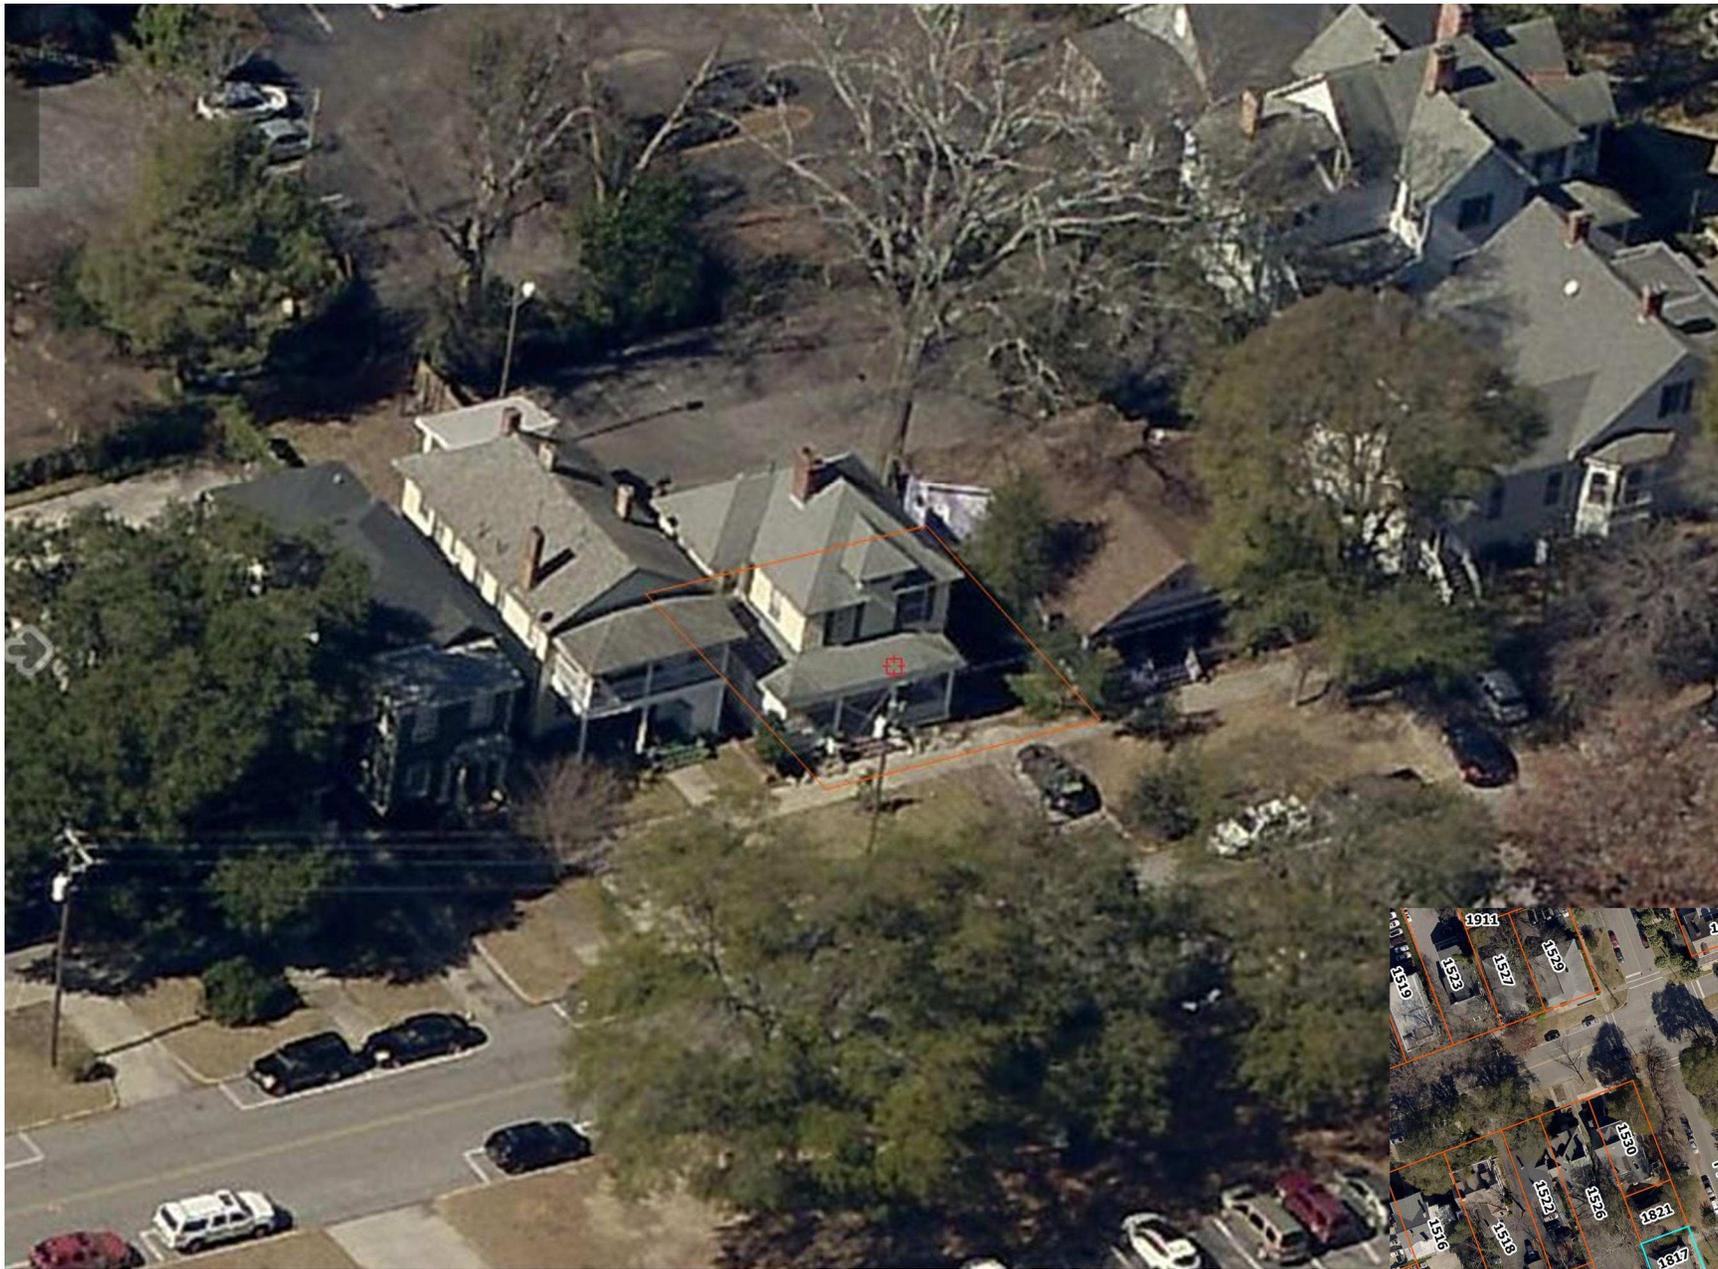
Staff received a complaint about a chimney being demolished at this site on October 14, 2013 and immediately went to the site. There was no permit for work being conducted, which was a re-shingle job for the roof. Staff spoke with the workers on site and with their boss by phone about the need for a permit and for approval from the D/DRC to remove a chimney. At the time staff visited, the chimney was removed completely from the roof plane up; the bricks were in a dumpster. Staff asked to see the bricks, which had been dropped off the roof and were broken. The mortar attached to the bricks was very sandy and flaked off easily. The bricks were oversized, but probably typical for the era.

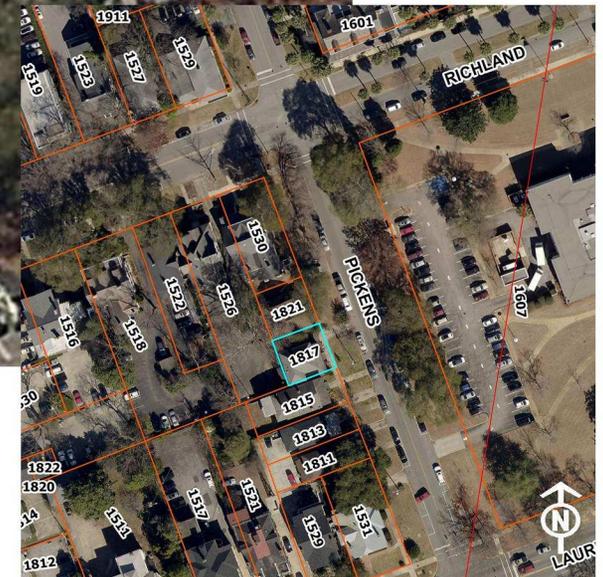
This guideline requires the repair of deteriorated features. The applicant has provided one photograph showing some mortar loss in the top courses of the chimney. Chimneys typically deteriorate from the top down because the soft lime mortar loses its binders over the years from rain water. Mortar has a life span and must be re-applied after several decades; this is a normal maintenance process for historic masonry. The mortar on this chimney was not repaired when it showed signs of deterioration.

The severity of the deterioration of this chimney could not be assessed by staff because it was completely removed by the time staff arrived at the site. The photograph from the applicant and staff's view of the sandy mortar indicates that there were areas of deterioration at the top courses of the chimney due to mortar loss, but there does not seem to be any indication that the bricks themselves were deteriorated or that the mortar loss continued further down than the top few courses. The chimney should have been repaired with new mortar and with re-pointing for deteriorated joints to comply with this guideline.

During repairs, they presented me a picture of the "chimney" (picture below) which you can plainly see was not active and falling apart. Since this chimney was no longer in use, nor was their any future intent to use it, we decided to "roof over" the chimney part and discard the remaining bricks.

Staff recommends that to comply with Section 17-674(d) of the City Code of Ordinances that the chimney be rebuilt exactly, within a period of 120 days.
