## D/DRC Case

335 S. Edisto Avenue

**DESIGN/DEVELOPMENT REVIEW COMMISSION  
DESIGN REVIEW DISTRICT  
HISTORIC AGENDA  
EVALUATION SHEET  
Case # 3**

**NATURE OF REQUEST:** Request Certificate of Design Approval for demolition

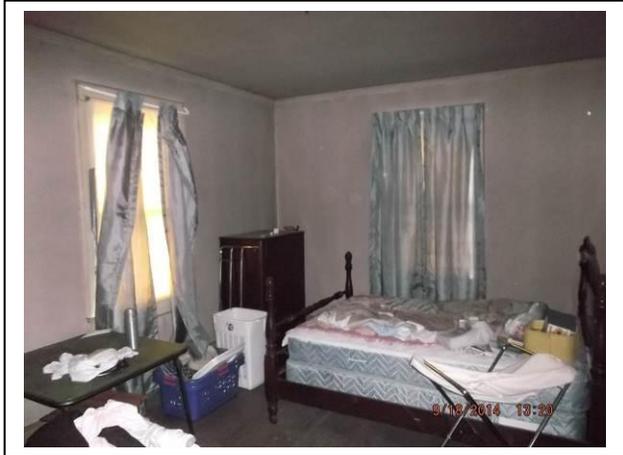
Staff photos of living room, rear bedroom, and foyer

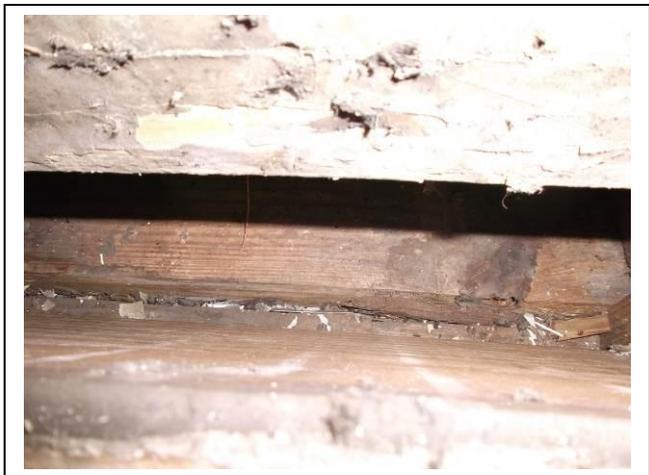
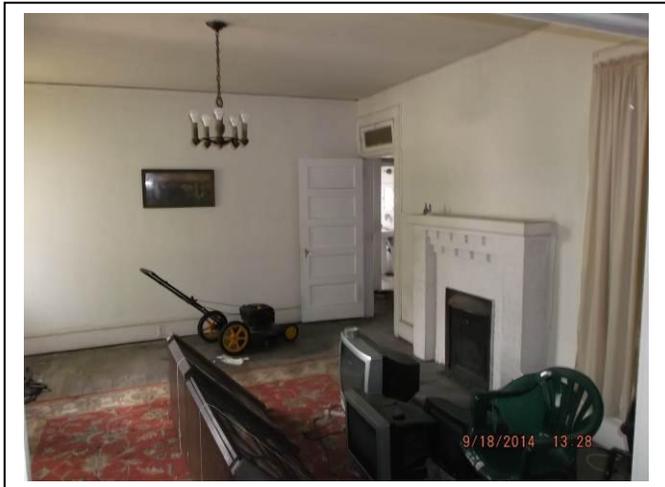
**Below:** Image of sill plate behind baseboard, the plate and studs were intact with no visible termite or water damage

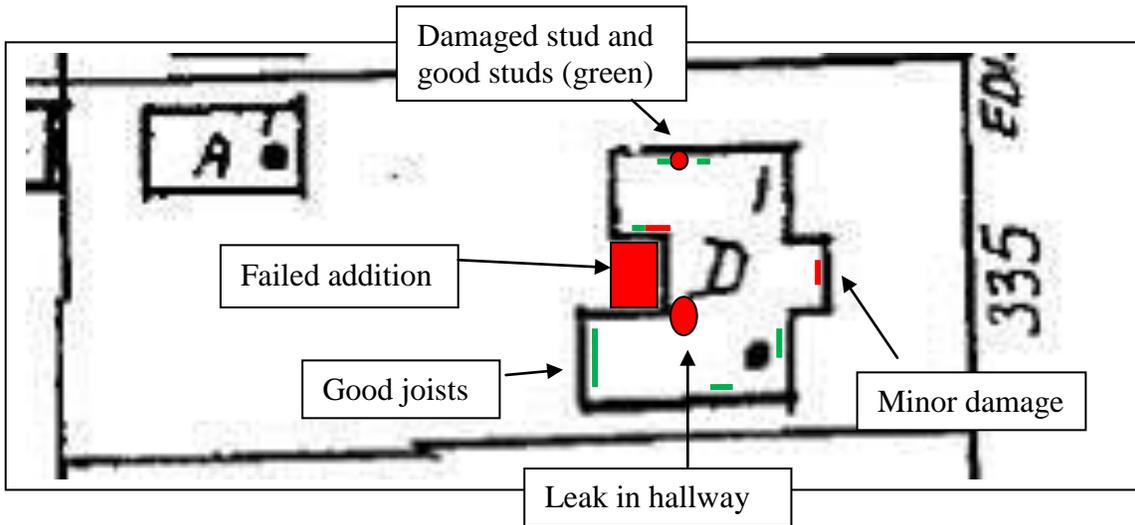
Staff's observations regarding the condition of the home, as visible through the crawl space and recently opened holes in the walls.

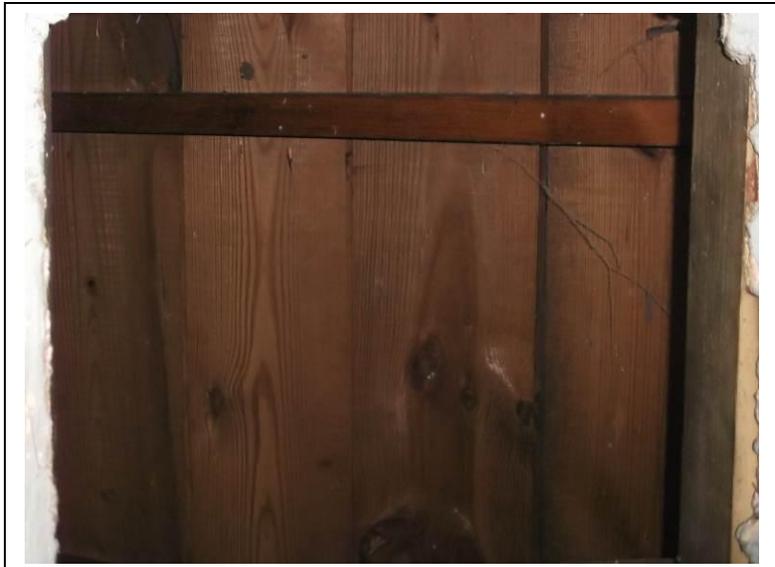
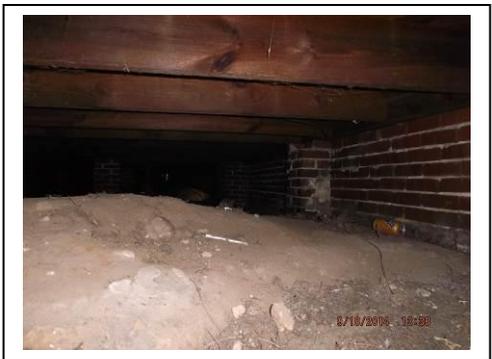
At left: view of roof sheathing and joist in the kitchen  
Above: view under house  
Below: rear elevation  
Below left: intact window
