## D/DRC Case

2211 Bull Street

Cottontown/Bellevue Architectural Conservation District

**DESIGN/DEVELOPMENT REVIEW COMMISSION  
DESIGN REVIEW DISTRICT  
REGULAR AGENDA  
EVALUATION SHEET  
Case #1**

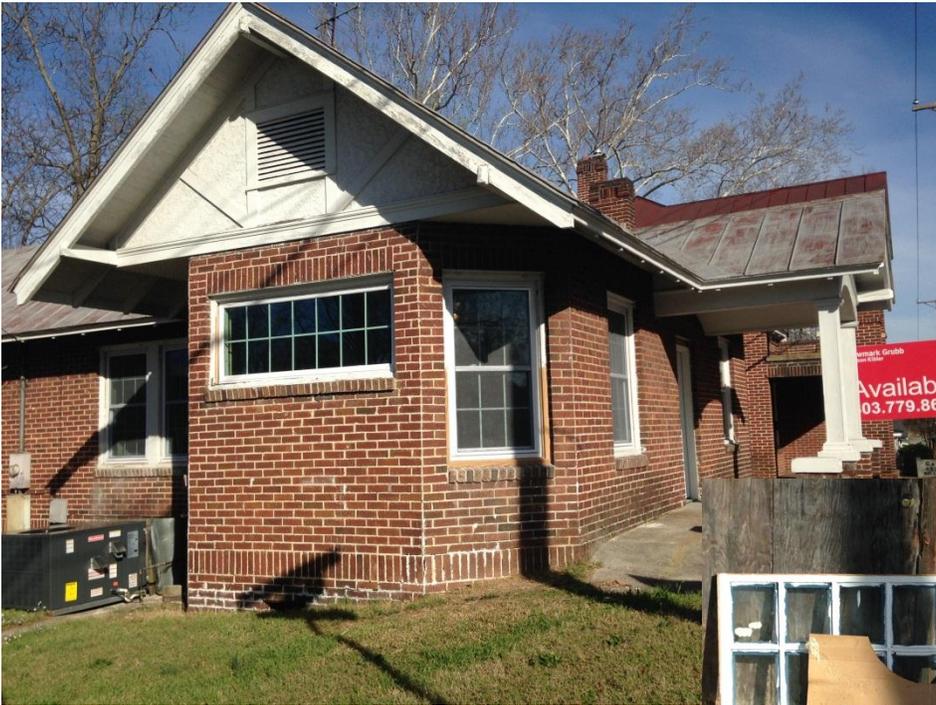
2211 Bull Street

The applicant is in the process of restoring the interior of the property. On March 16, 2015, staff was notified that the historic wood 6/6, 8/8, and fixed 14 pane windows were being replaced with vinyl windows without staff approval or city permit. Staff contacted the owner of the property, who agreed to retain the historic windows being replaced, until the project came before DDRC. The applicant noted that several of the windows at the Bull street property had already been replaced with vinyl prior to acquiring the property. Staff does not know when those historic windows were taken out, but it likely occurred prior to the implementation of guidelines. The applicant also notes that many buildings on the block of Bull Street also have vinyl windows. Staff acknowledges the presence of vinyl windows within the block, but this work is not in keeping with the guidelines and was likely performed prior to the formation of the Cottontown/Bellevue Architectural Conservation District in 2010.

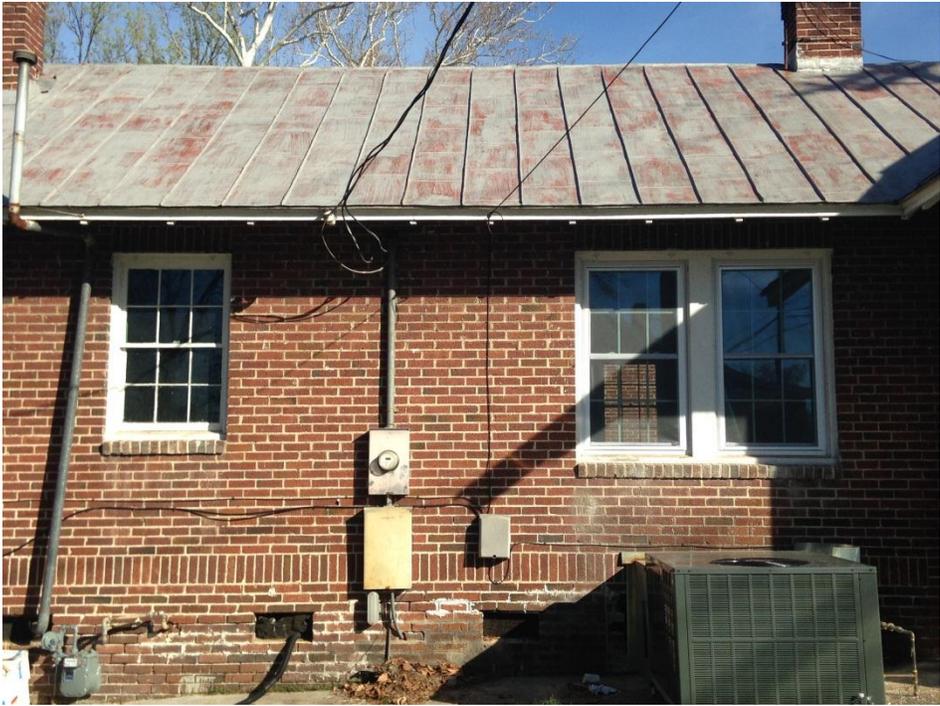
Replacement and original window
