D/DRC Case

914 Gregg Street

University Hill Architectural Conservation District

DESIGN/DEVELOPMENT REVIEW COMMISSION
DESIGN REVIEW DISTRICT
HISTORIC AGENDA
EVALUATION SHEET
Case #7

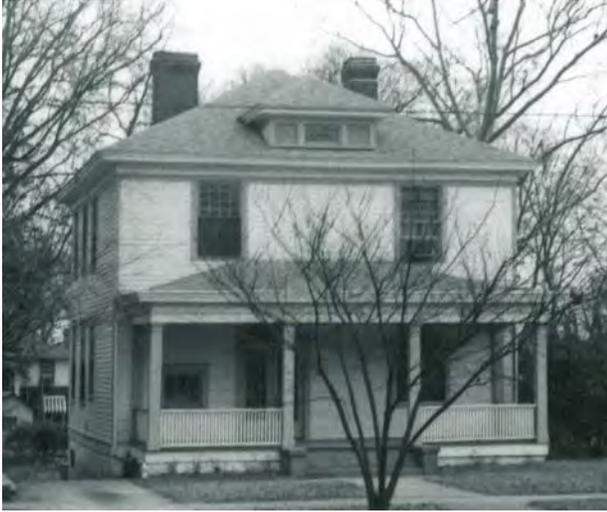
February 1967 – prior to porch enclosure

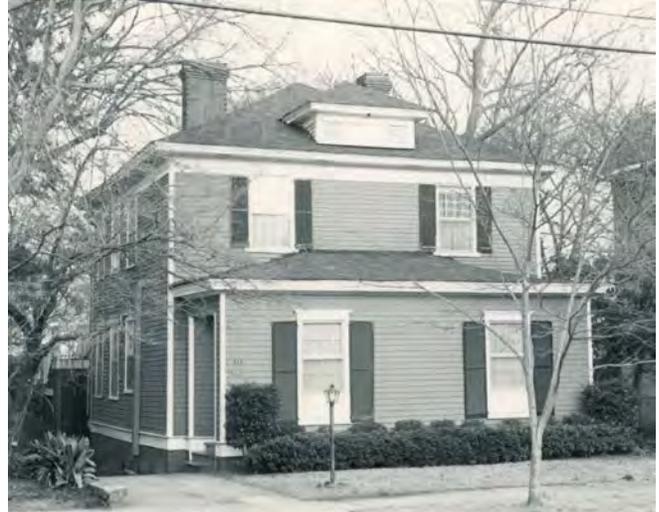
1993 view showing porch enclosure

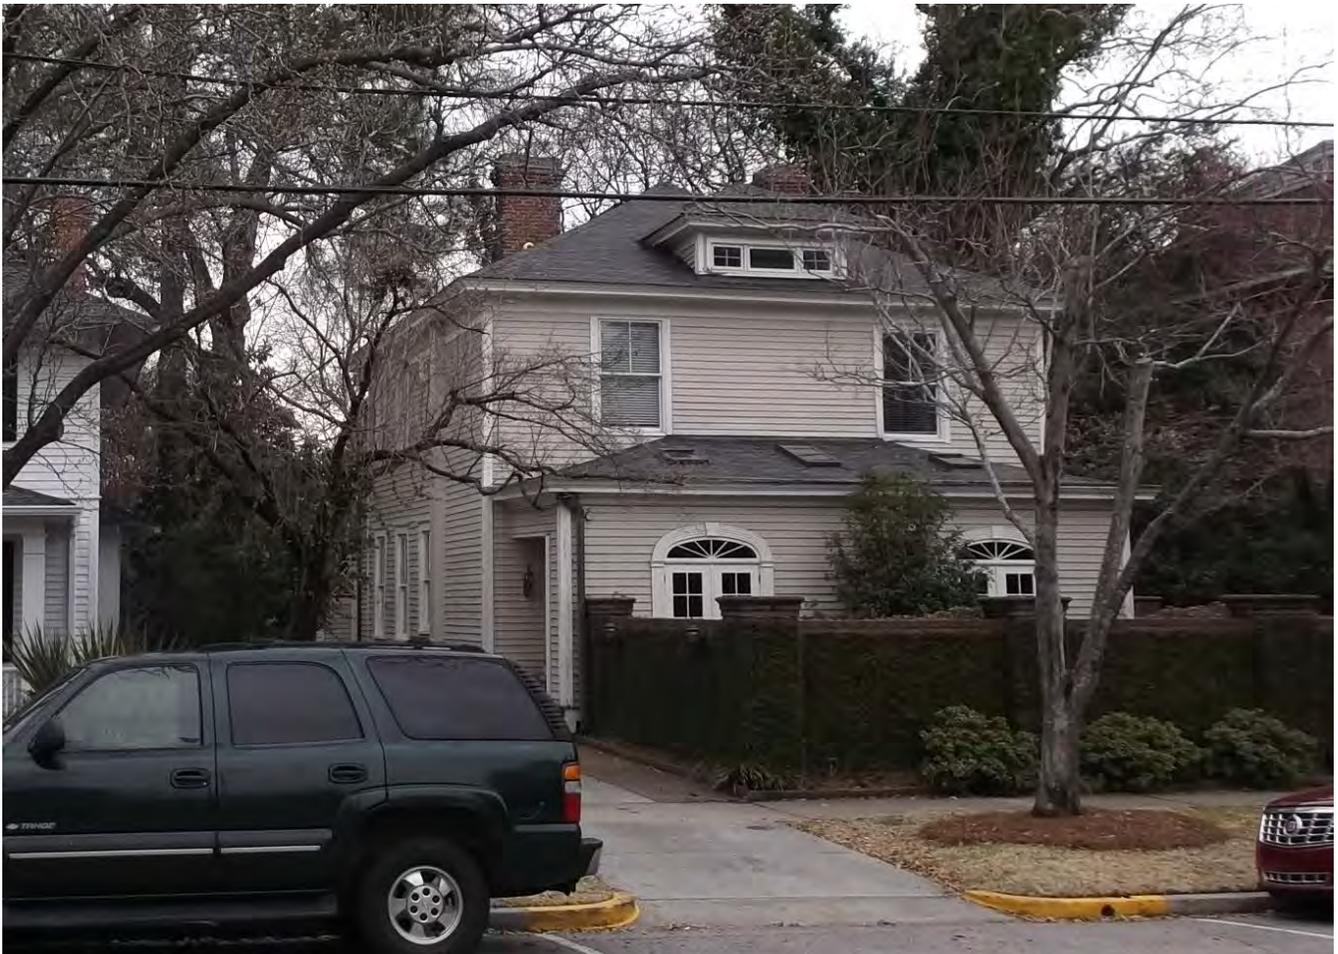
2014 view showing revised porch enclosure with skylights

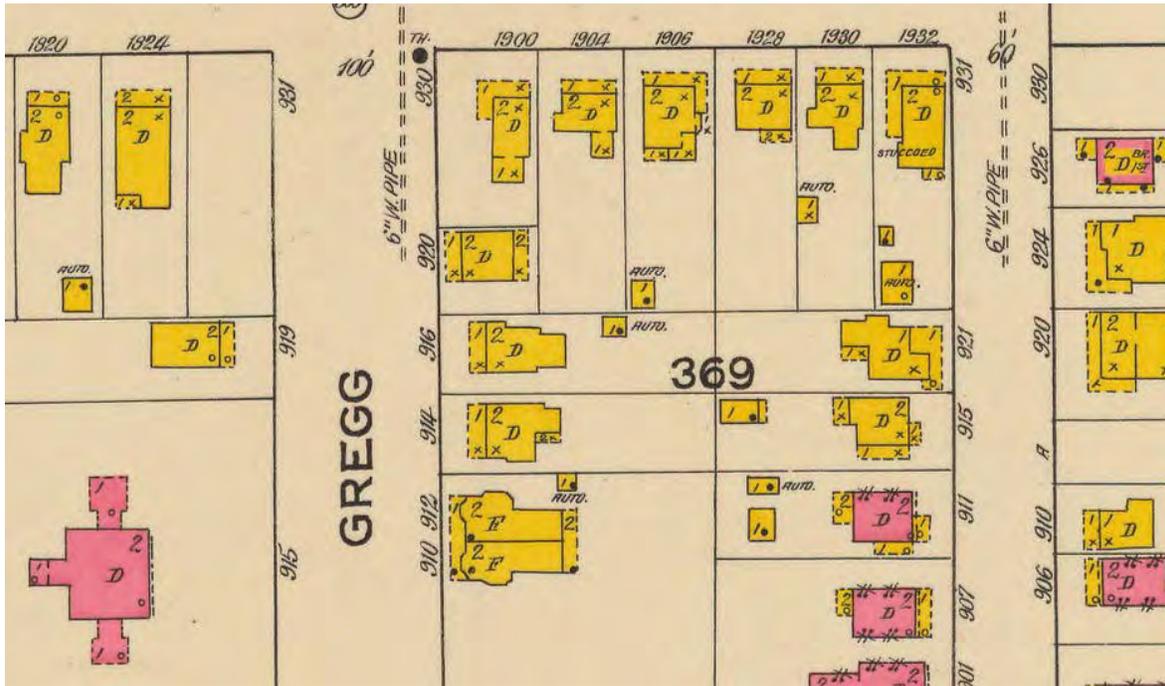
June 1919 Sanborn Fire Insurance Map

Most of the houses on Pendleton and Gregg streets featured wood shingle roofs as indicated by "X" marked on the building footprints above (see key below).

Based on early Sanborn Fire Insurance Maps, staff has determined that 914 Gregg Street originally featured wood shingles on the main roof and the front porch roof. This is also the case for most of the houses on the same block. The applicant has submitted photographs of other houses in the district that use metal roofing features. All of the houses shown in these photographs, with the exception of 1816 Senate Street, use metal roofing or accents in a way that is consistent with their original architectural form. The house at 1816 Senate Street originally featured slate tiles on the main and porch roofs, but staff approved a standing seam copper roof for use on the front and side 1-story porches in 2007 in order to preserve the main roof. At the time, the main slate roof needed major repairs and matching new slate with the unusual color of the historic slate proved very difficult. Staff determined that it was more architecturally important to have a visually consistent main roof, and permitted the slate tiles on the 1-story porches to be removed in order to provide enough matching original material to repair the damaged areas on the main roof. Copper was chosen as the material of choice for the porch roofs due to its historic complementary use with slate roofs and the difficulties of trying to match old and new slate.

As shown on the 1919 Sanborn map included with this evaluation, the historical roofing material for 914 Gregg Street was most likely wood shingles. As such, the original roofing material is no longer extant. The house currently features asphalt shingles on both the main roof and the 1-story porch roof.

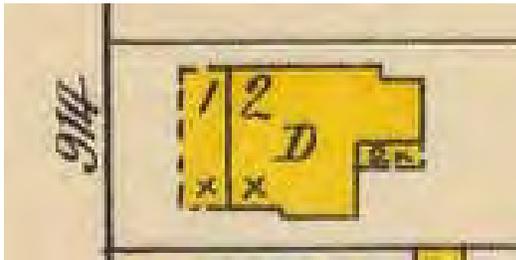
Close-up view of 914 Gregg Street

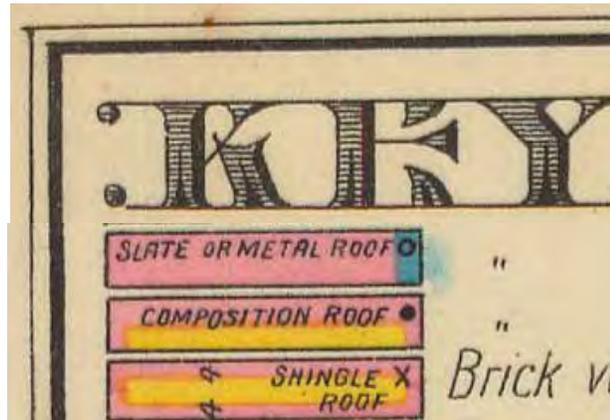
Sanborn key to roofing materials

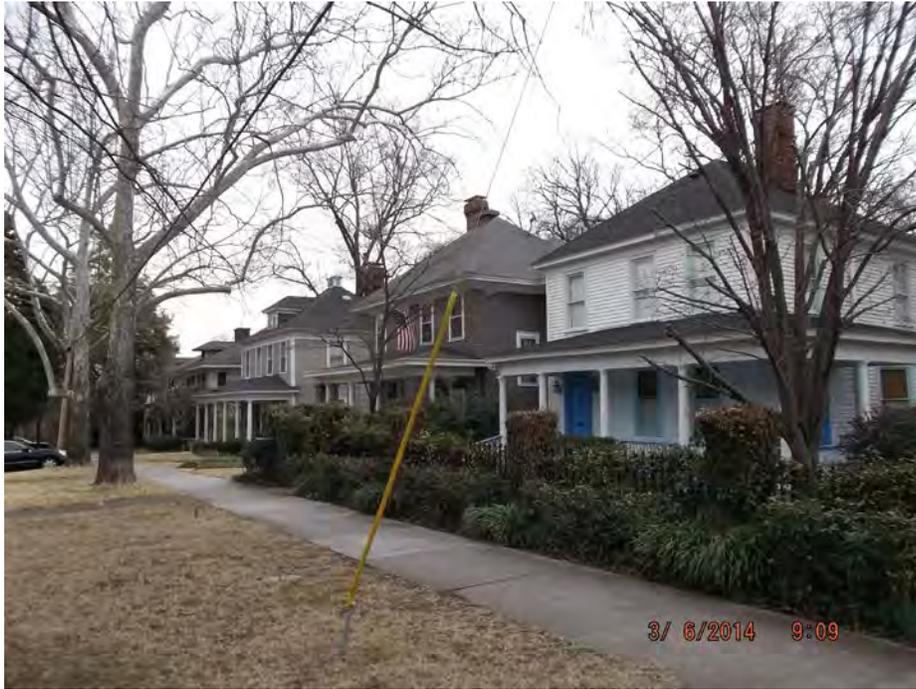
Houses on Pendleton Street within the same block and just around the corner from 914 Gregg Street.

All houses feature similar roof pitches and consistent roofing materials.

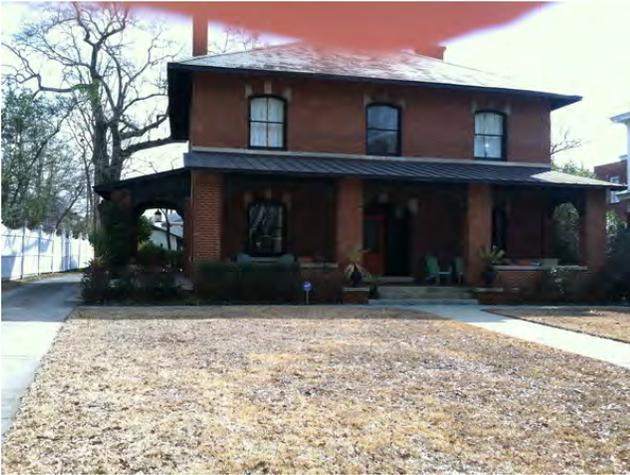
1816 Senate Street

Non-original metal porch roof – Approved by staff in 2007 in order to preserve the main slate roof.

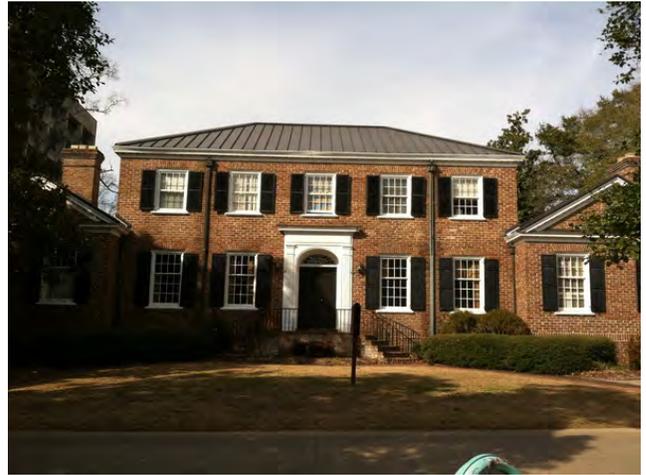
1731 College Street

Full metal roof – The building originally featured a pressed metal sheet roof.

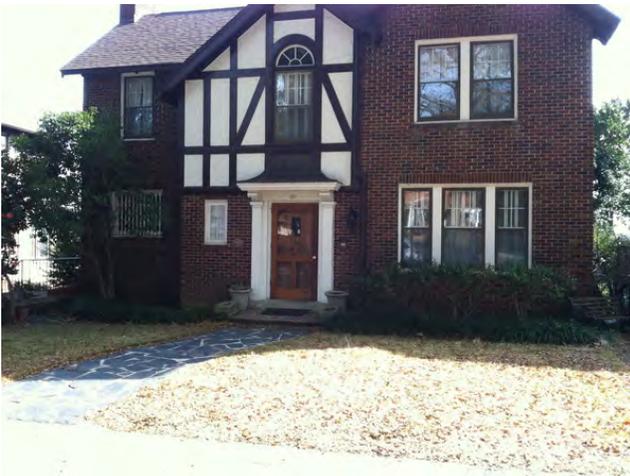
20 Gibbes Court

Small, decorative standing seam metal accent roof above front entryway – Typical of architectural style.

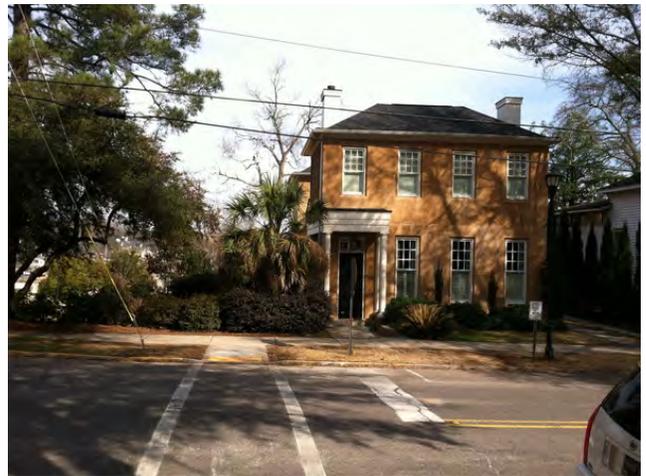
830 Laurens Street

New construction – Small, low-sloped metal accent above front entryway. Main roof is asphalt shingles.
