D/DRC Case

S/S Longleaf Road

Melrose Heights/Oak Lawn Architectural Conservation District

NATURE OF REQUEST: Request Certificate of Design Approval for new construction of single-family house

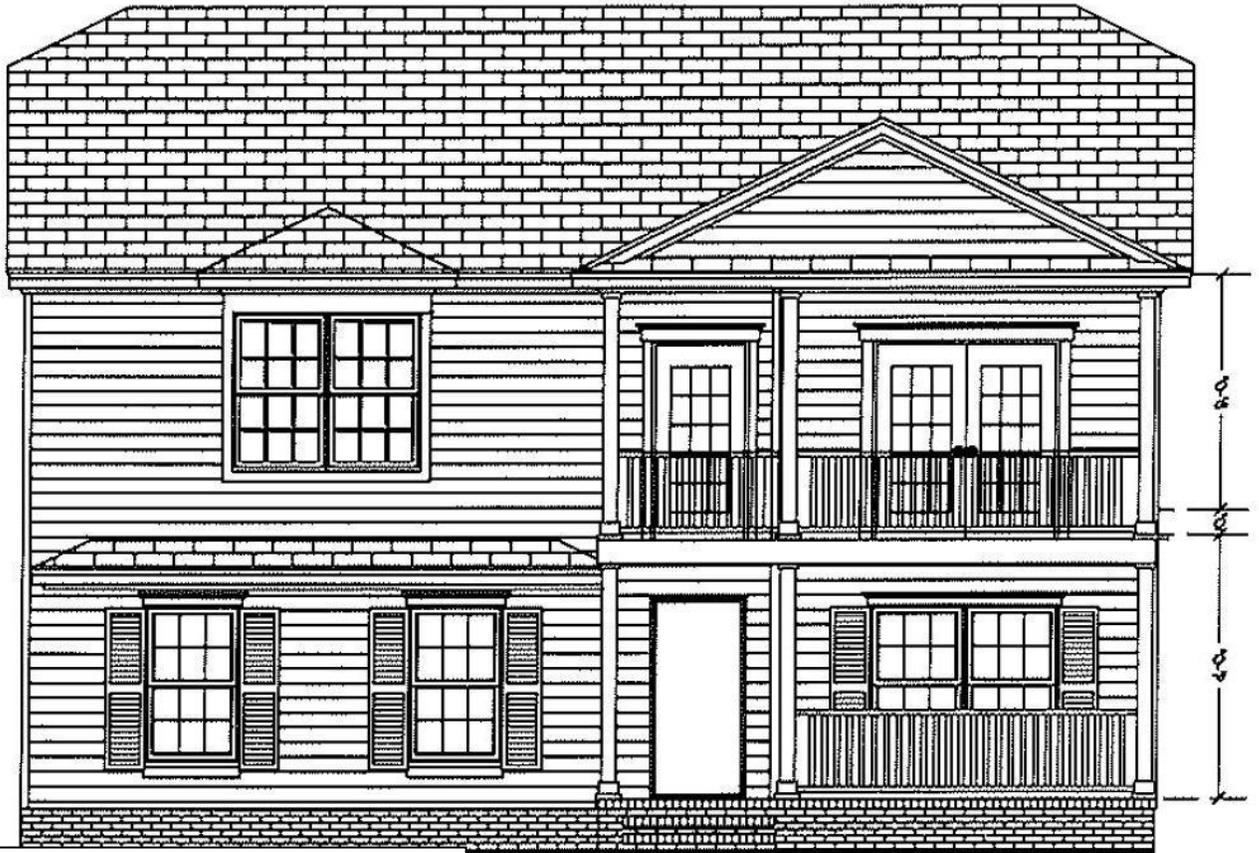
Façade submitted by applicant (flipped by staff)

Foundation Height: The elevations provided show a very short, brick foundation wall, which is not what is being proposed in terms of height. The applicant has indicated that they plan to do grading at the site but has not specified exactly how that will affect the proposed house. Due to the slope of the lot the proposed foundation height along the façade will be about 5'-4" at left to 4'-8" at right; the left side will be about 5'-4" at front to 3'-4" at the rear; and the right side will be about 4'-4" at front to 1'-8" at rear. These measurements are approximate.

Foundation heights in the district appear to be around two to three feet on average. The tall foundation heights presented here on the facades are taller than what is typical for the area. The increased height requires a longer and therefore more prominent front set of front steps, rather than the typical shorter set of steps found in much of the district. Part of

The rhythm of openings on the façade is somewhat consistent with rhythm of openings found on historic buildings, with at least one opening in each of the defined bays. The right elevation also creates a rhythm of openings that is compatible with historic buildings. The left elevation does not achieve the same rhythm. It has two single windows on the second story, spaced well apart, but the first story has only one large opening. The large double-car garage door opening is unlike any feature found in the rhythm of openings in historic buildings in the district. Openings of that size disrupt the established patterns found in the area; therefore the proposed rhythm of openings does not meet the guideline.

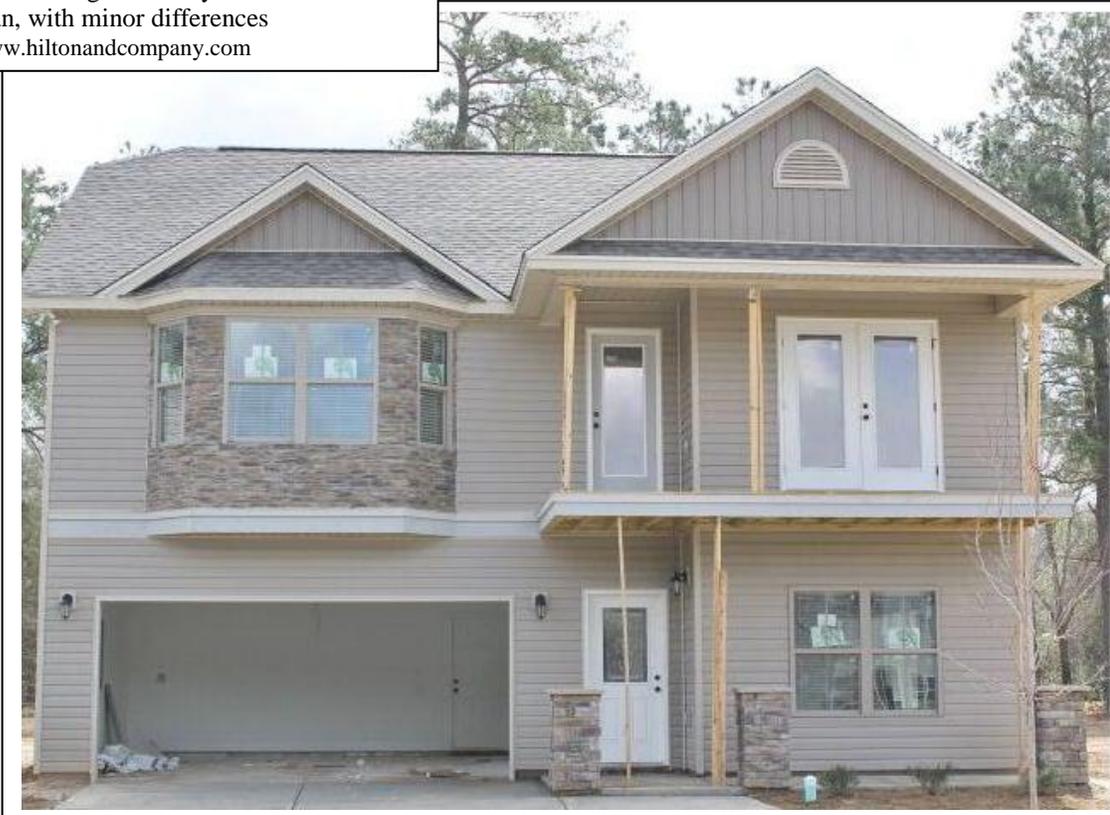
Online image found by staff of the same plan, with minor differences
www.hiltonandcompany.com

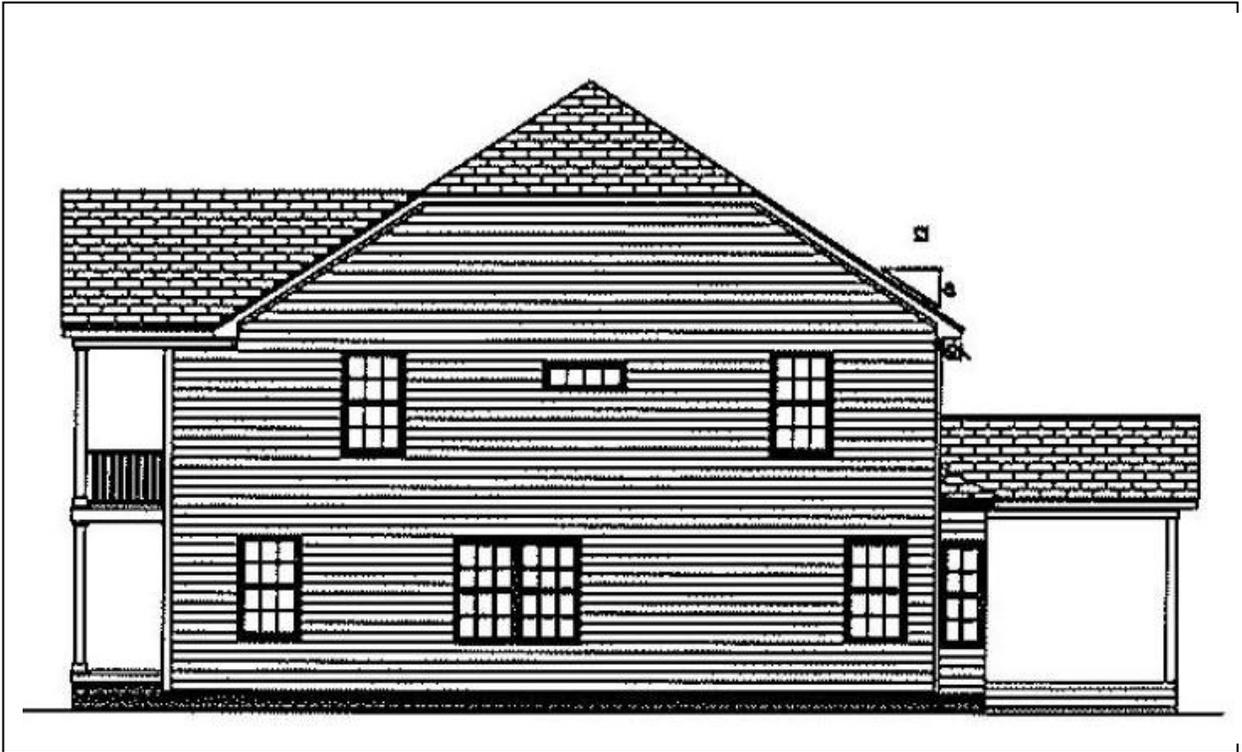
Right elevation, provided by applicant, flipped by staff

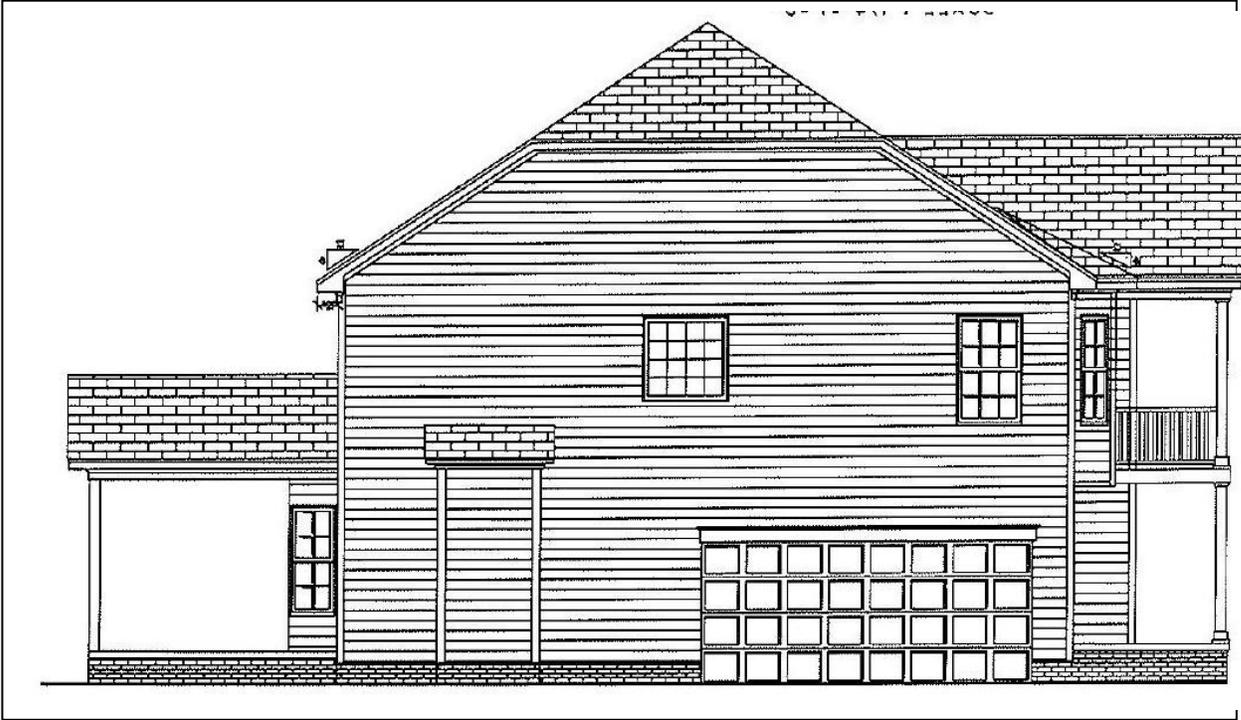
Left elevation, provided by applicant, flipped by staff

On the left elevation the first floor has a large, double-car garage door. This oversized opening is not found on historic buildings. Although the applicant moved the garage door from the façade to a side elevation, the side elevations of historic buildings in the district still do not feature such oversized openings. The large amount of solid space on this elevation is also not typical of the area. The garage door opening is also inconsistent with the massing of openings due to its requirement to disrupt the foundation wall. Openings in historic buildings are located within the wall plane, not the foundation wall. Due to the slope of the lots, the garage door will interrupt a somewhat tall foundation wall, and the top of the garage opening will be lower than typical window heights along the side elevation.

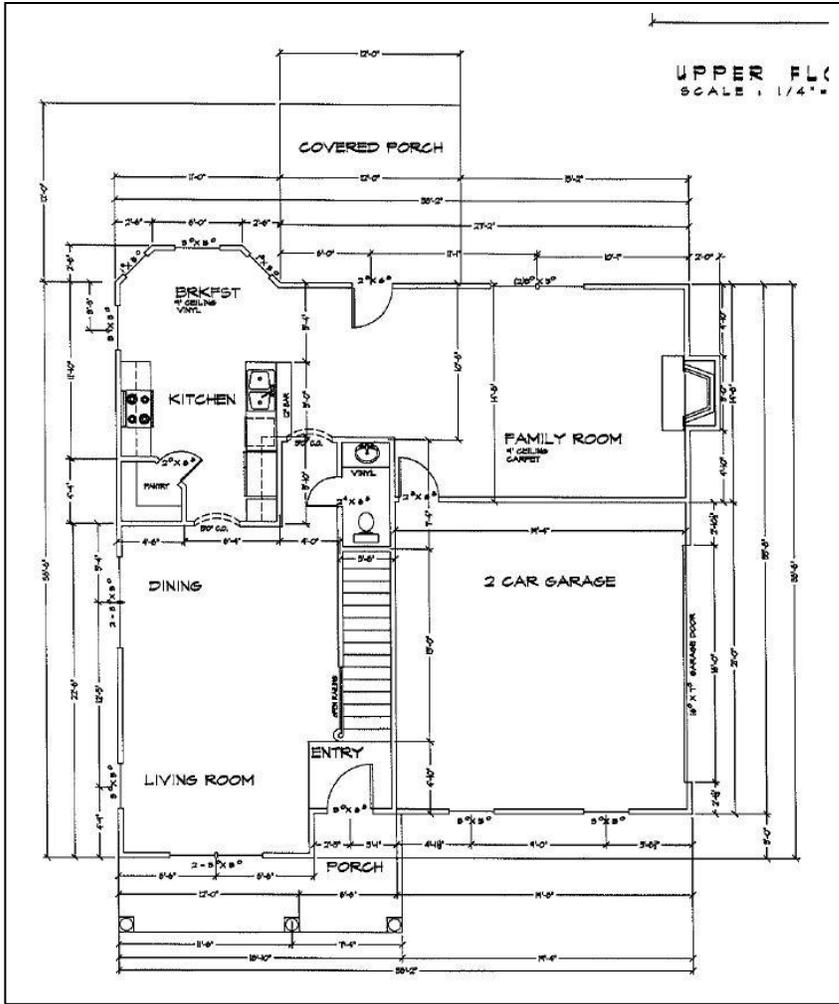
Plans submitted by applicant. These have not been flipped.
