DESIGN/DEVELOPMENT REVIEW COMMISSION
DESIGN REVIEW DISTRICT
HISTORIC AGENDA
EVALUATION SHEET
Case # 8

ADDRESS: S/S Longleaf Road, 3000 block

REVIEW DISTRICT: Melrose Heights/Oak Lawn Architectural Conservation District

NATURE OF REQUEST: Request Certificate of Design Approval for new construction

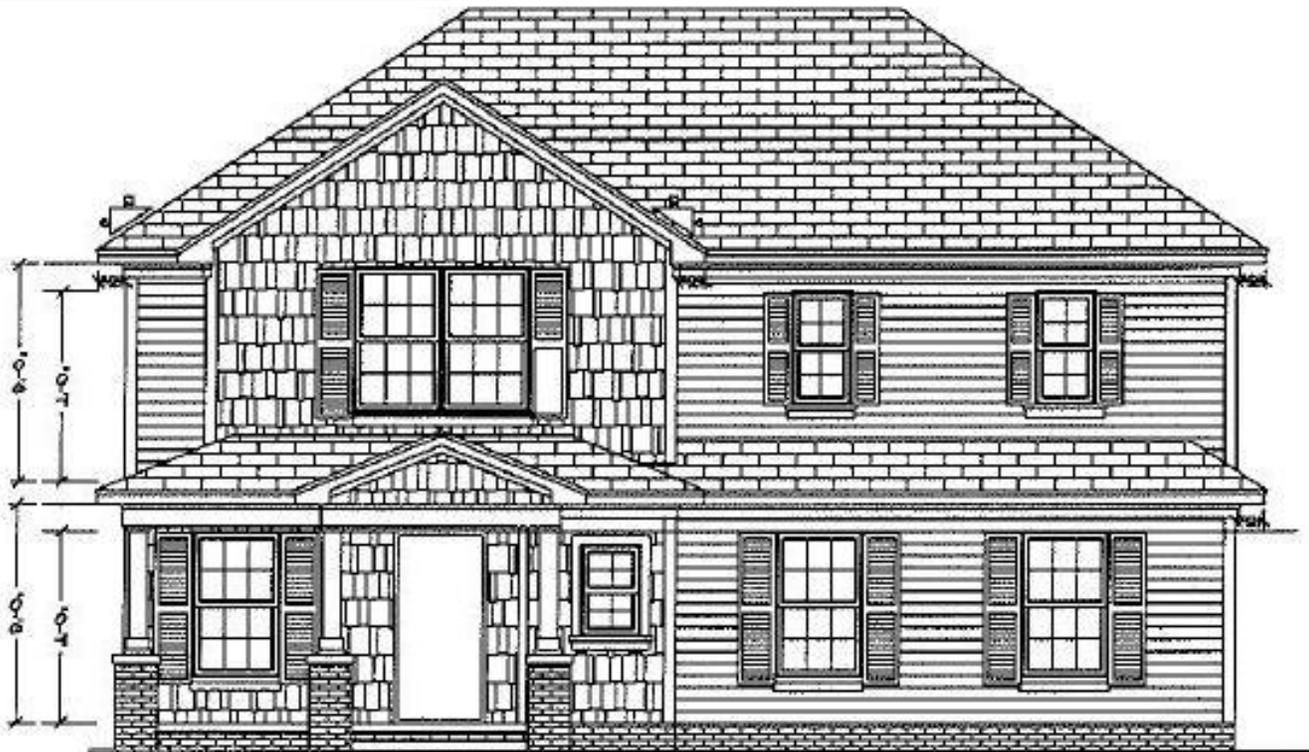
Façade submitted by applicant
(flipped by staff)

The rhythm of openings on the façade is somewhat consistent with rhythm of openings found on historic buildings, with at least one opening in each of the defined bays. The left elevation also has a somewhat typical rhythm of openings, although there is a large span (approximately 12 feet) between the windows on the first floor that is wider than patterns typically found in the district. The right elevation does not have a rhythm of openings consistent with typical patterns; the two windows are centrally located in the upper floor, leaving large blank walls, and the first floor wall is blank for the entire half of the wall. The large double-car garage door opening is unlike any feature found in the rhythm of openings in historic buildings in the district. Openings that large disrupt the established patterns found in the area; therefore the rhythm of openings does not meet the guideline.

The porch roof appears to introduce some unusual complexity and creates junctures between the various roof shapes that are not found in the area, for instance the hip roof of the porch is off-center in the projecting bay above it.

The shed or pent roof that stretches across the left half of the house above the first story is not found in the district. The proposed roof shapes and locations do not meet the guideline.

Porch: The porch has an overly complex roof form, which was discussed above. The form is due to the unusual layout of the porch, which is recessed, but has portions extending past the façade and then a small enclosure projecting even further. The front gable projection on the porch is very shallow, leaving perhaps a foot between the right column and the wall of the enclosure, which is not a typical porch depth. This layout is not visually compatible with porches found on historic buildings in this district.

Door: The proposed door is fiberglass with an oval glass with etching. This type of door is not typical for the historic district. While the material will be indistinct once painted, the shape and character of the glass is not found on historic buildings nearby; therefore the proposed door does not meet the guideline.

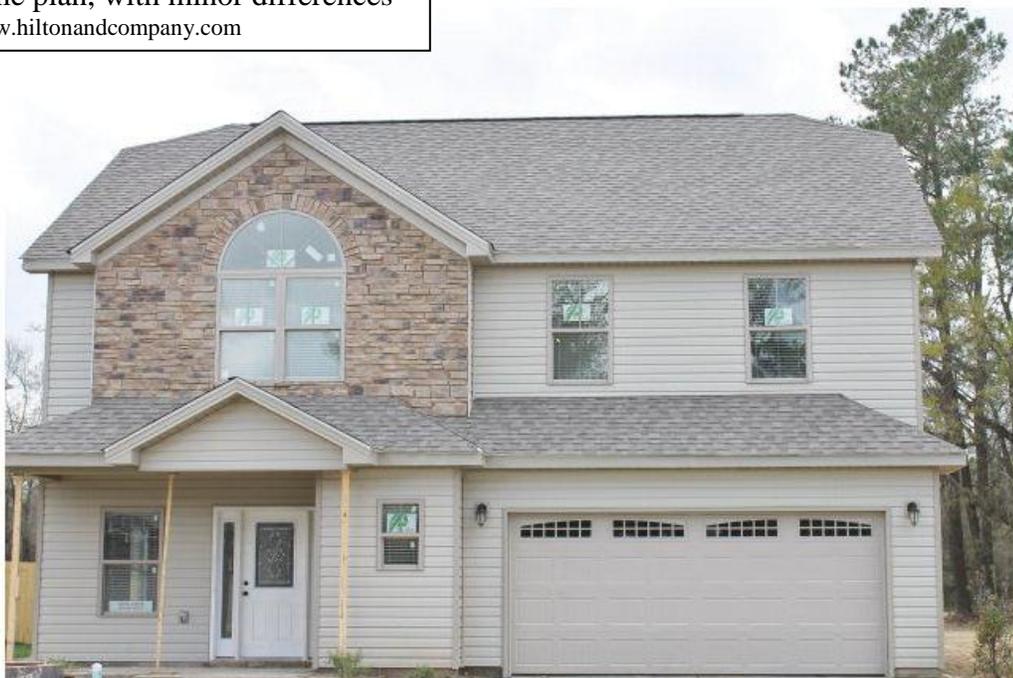
Online image found by staff of the
same plan, with minor differences
www.hiltonandcompany.com

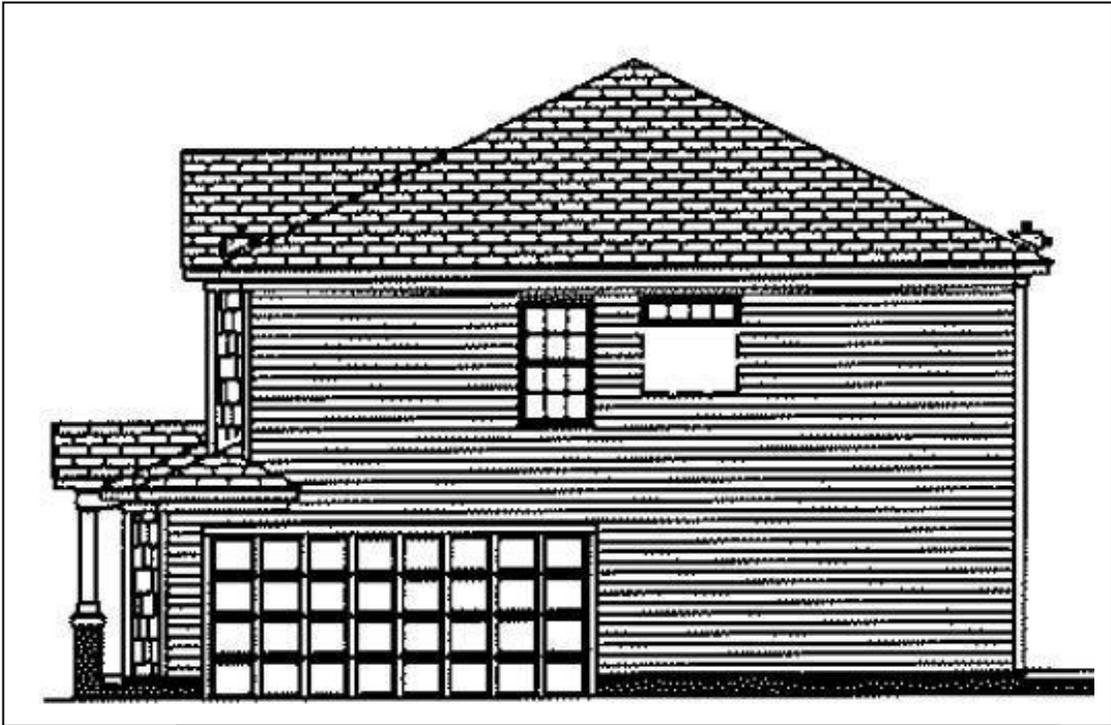
Right elevation, provided by applicant, flipped by staff

The large amount of solid space on the right elevation is also not typical of the area. Only two windows on this side are shown, one of them appears to be a ribbon window. These small horizontal windows are not generally found on a vast majority of historic buildings.

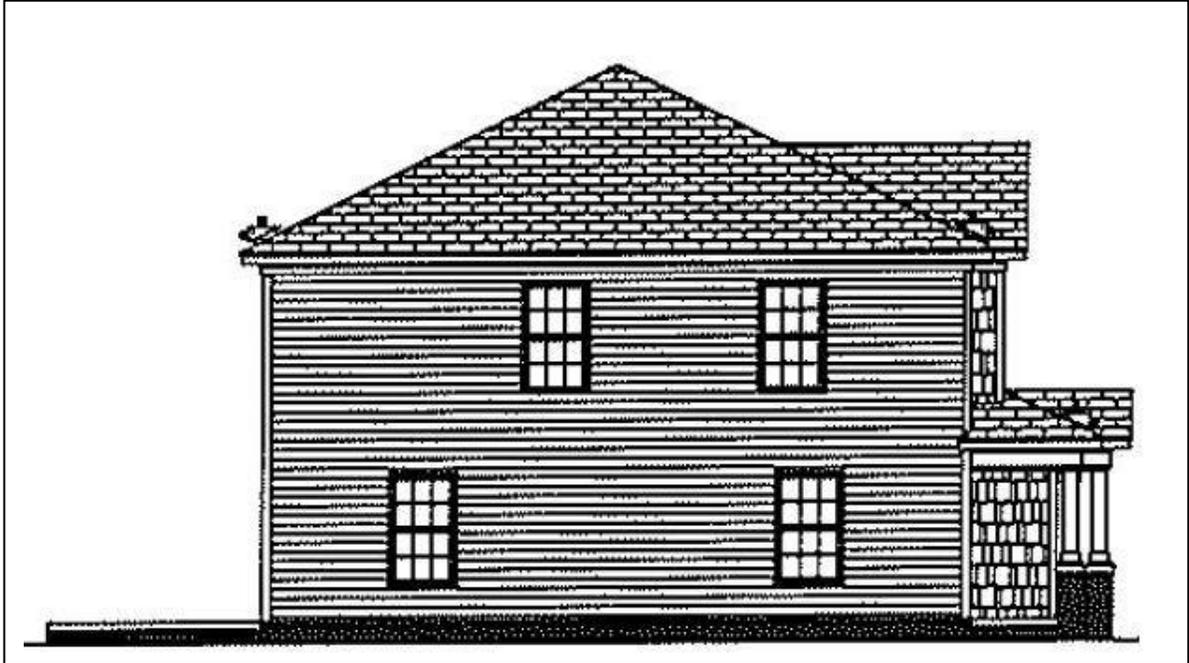
Left elevation, provided by applicant, flipped by staff

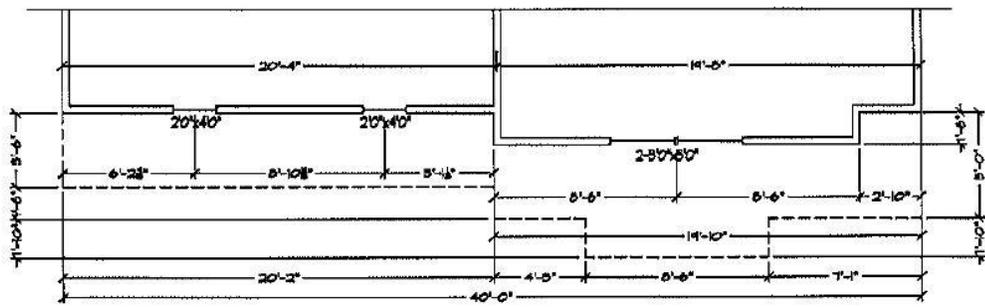
UPPER FLOOR ELEVATION "D"
 SCALE : 1/4" = 1'-0"

Elevation details provided by
 applicant, needs to be flipped to
 represent current proposal

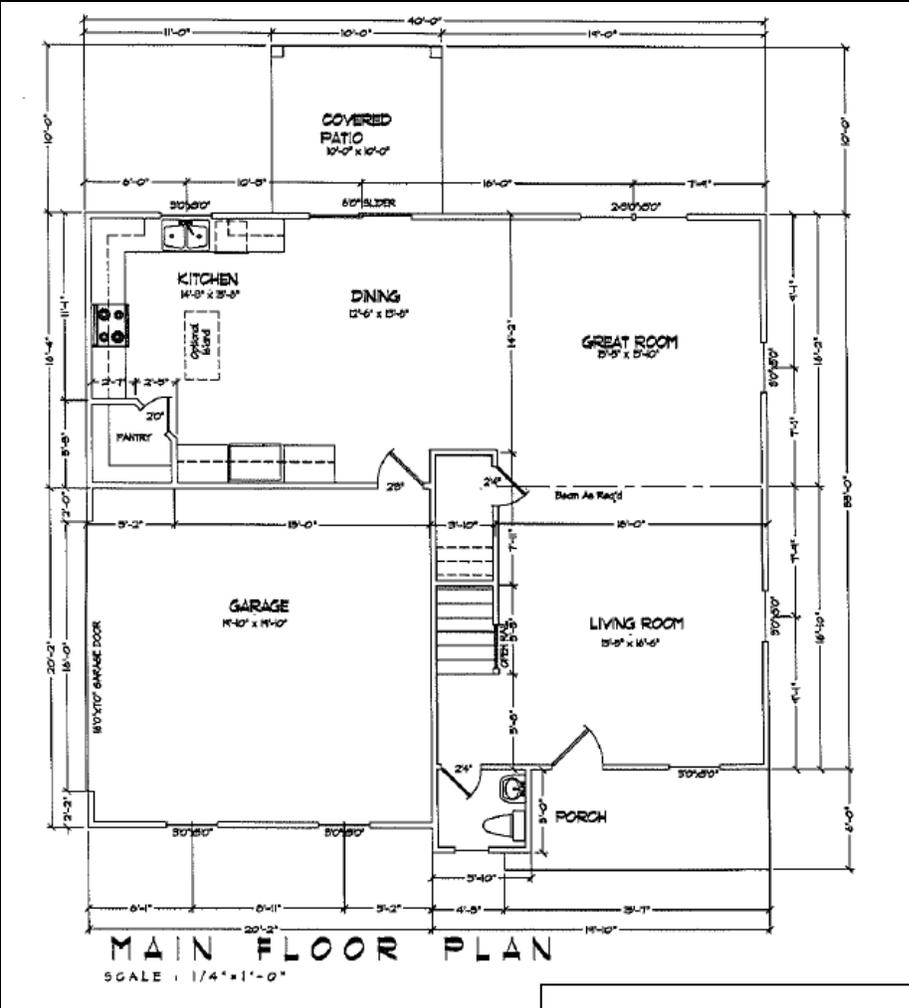
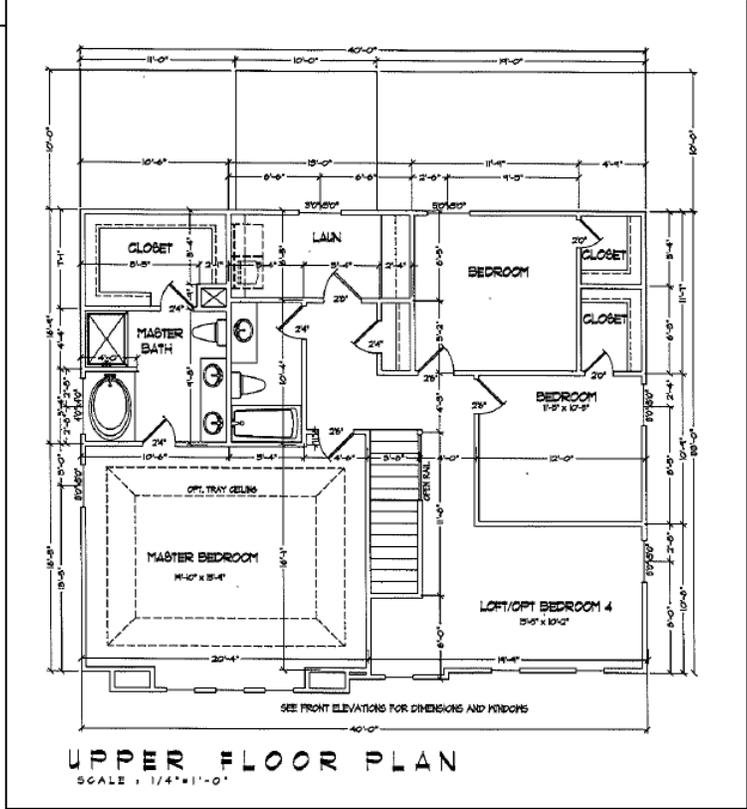
Floor plan submitted by applicant. This has not been flipped.
