DESIGN/DEVELOPMENT REVIEW COMMISSION
DESIGN REVIEW DISTRICT
HISTORIC AGENDA
EVALUATION SHEET
Case #4

ADDRESS: 2305 Lincoln Street

REVIEW DISTRICT: Elmwood Park Architectural Conservation District

NATURE OF REQUEST: Request Certificate of Design Approval for exterior changes and preliminary certification for the Bailey Bill.

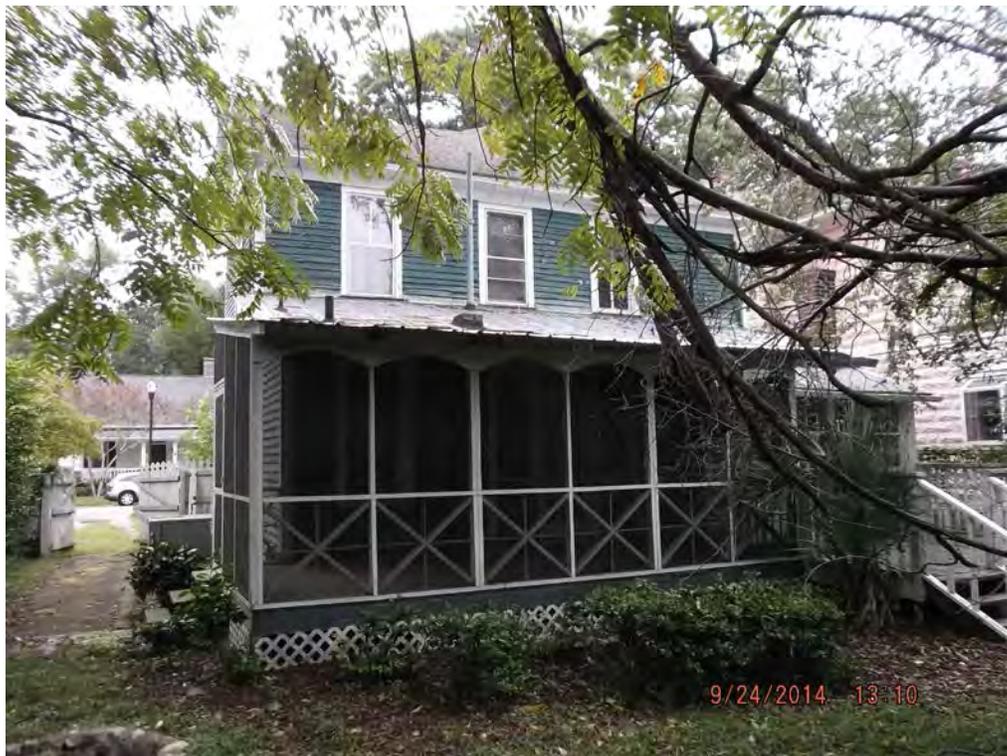
2305 Lincoln Street – rear view of non-historic screened porch

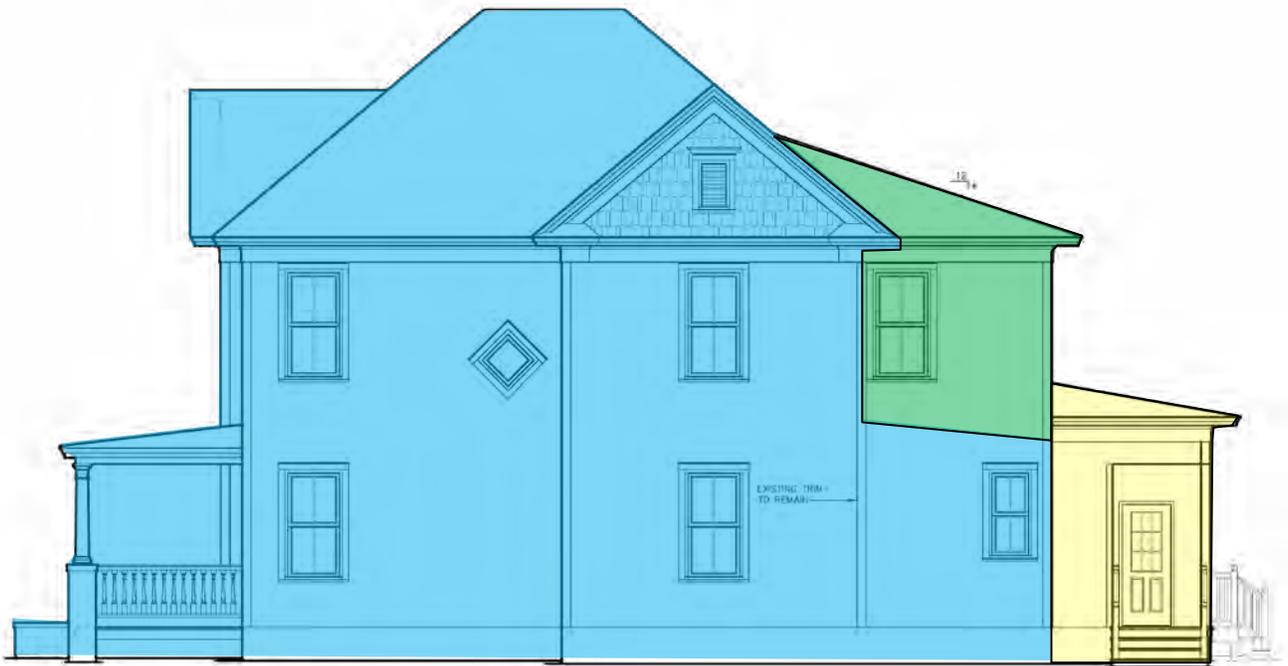
RIGHT ELEVATION 1/8" = 1'-0"

2305 Lincoln Street – Proposed additions

Staff typically recommends stepping additions in 8"-12" to differentiate the new from the old, but doing so in this case would cause an unusual construction detail for the 2-story addition since it will be placed directly on top of the existing 1-story section of the house. The proposed new 1-story laundry/mudroom addition on the right rear; however, could be stepped in without resulting in any unusual detailing. As proposed, the 1-story addition provides access to the house via a recessed entry/stoop. This area features a narrow wall that is on the same plane as the existing house. Staff recommends recessing this wall slightly to preserve the original right side corner and to differentiate the all-new 1-story addition from the existing house.

Staff also noticed that the proposed recessed entry has an additional header feature shown on the elevations. Staff would recommend removing this element to make the entry/stoop more architecturally compatible with the front porch.

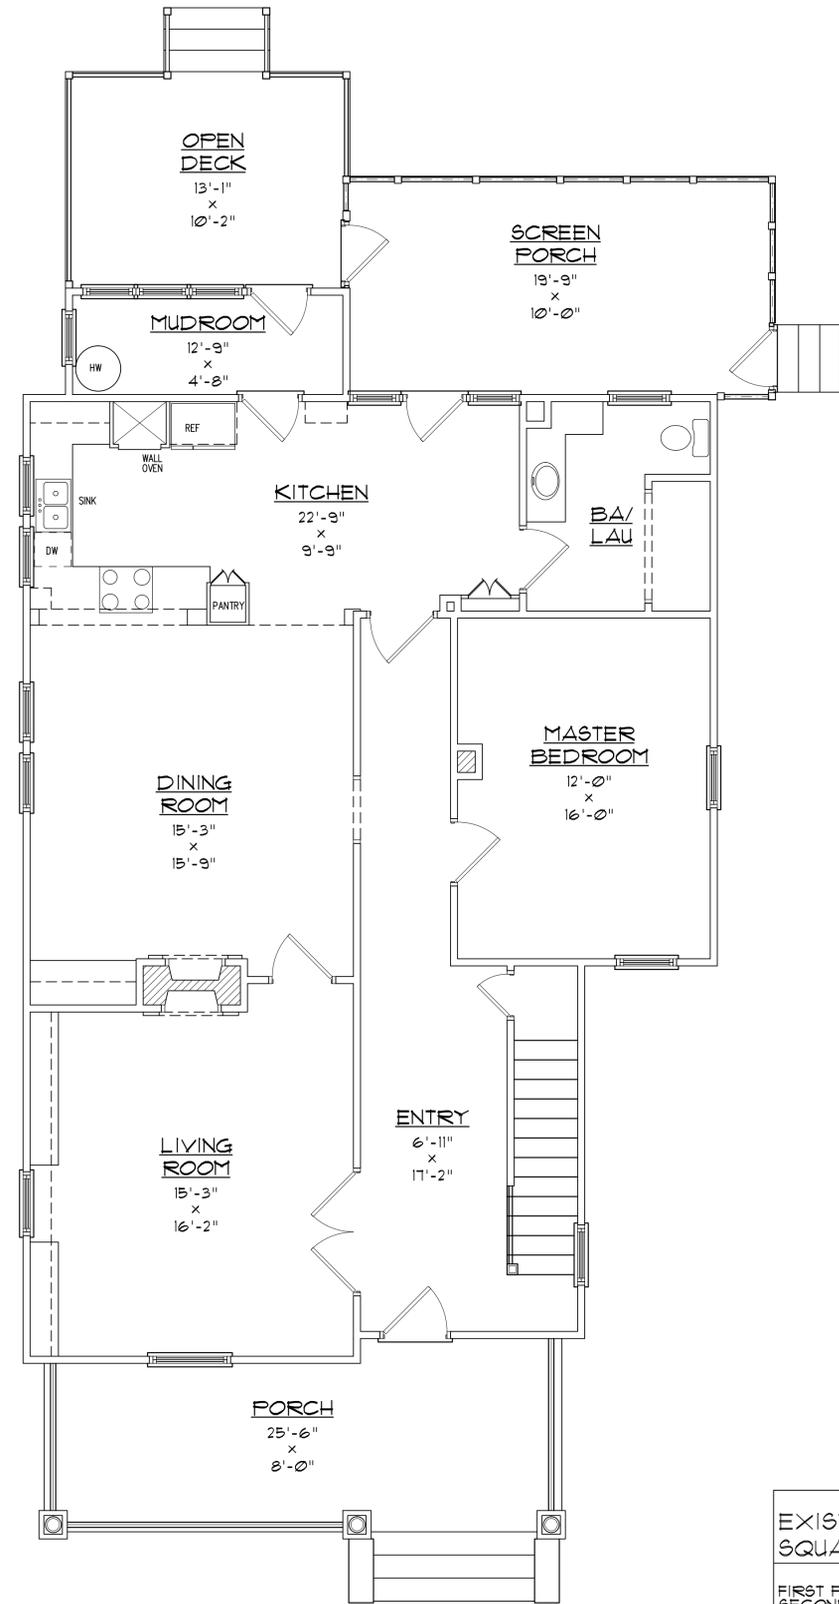
FIRST FLOOR PLAN 1/4"=1'-0"

EXISTING SQUARE FOOTAGE:	
FIRST FLOOR	1428 SQ. FT.
SECOND FLOOR	1029 SQ. FT.
TOTAL	2457 SQ. FT.
FRONT PORCH	204 SQ. FT.

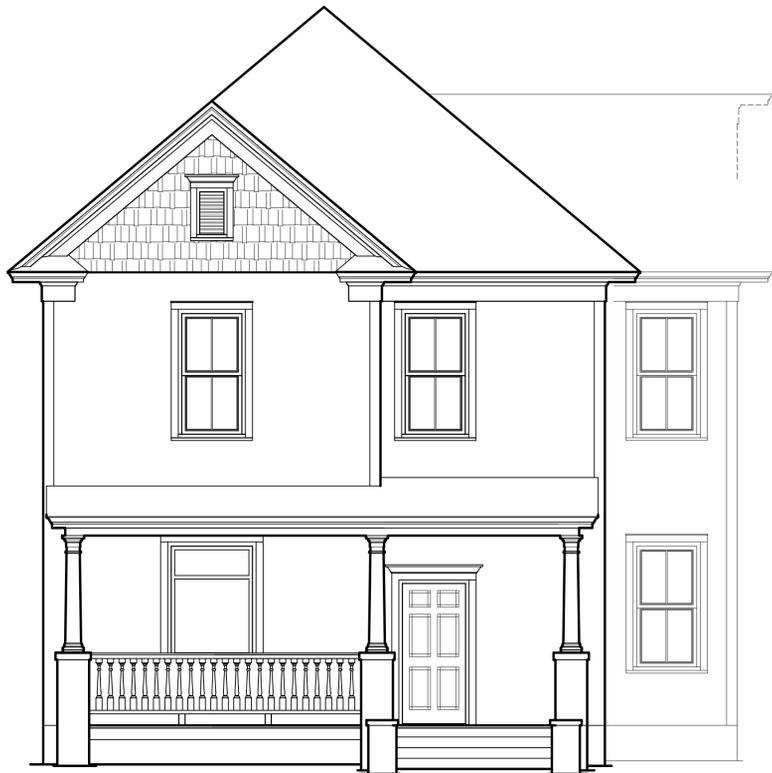
EXISTING
 FRONT ELEVATION 1/4"=1'-0"

8'-5" FIN. WIN. HGT.
 10'-1 1/2" CL. NG./FLT. HGT.
 (AT FIRST FLOOR)

8'-2" FIN. WIN. HGT.
 9'-7" CEILING HGT.
 (AT SECOND FLOOR)

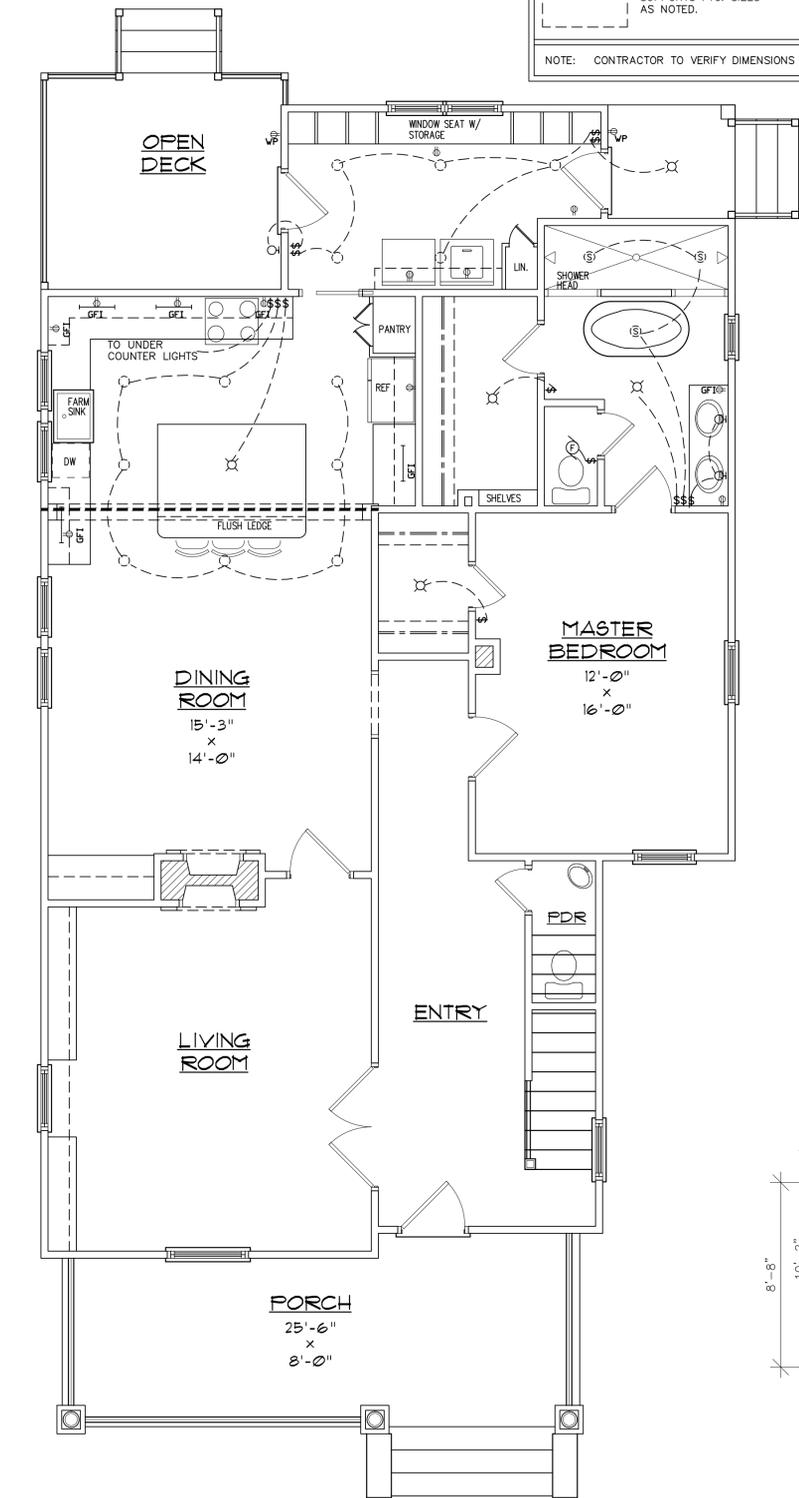
ELECTRICAL LAYOUT 1/4" = 1'-0"

PROVIDE ARC FAULT CIRCUIT INTERRUPTERS (AFCI) AS REQUIRED BY THE NATIONAL ELECTRIC CODE

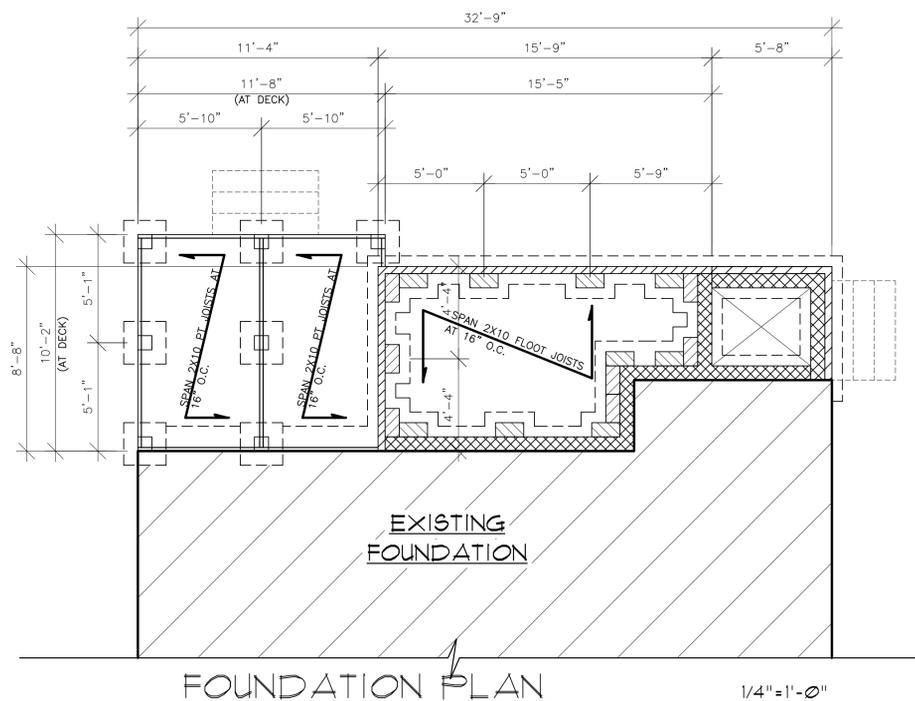
FOUNDATION PLAN 1/4" = 1'-0"

FOOTING LEGEND	
	NOTE: PROVIDE 3/4" PLYWD. SUBFLR AT ALL AREAS
	8" X 16" BRICK PIER W/20" X 28" CONC. FTG. (TYP.)
	8" X 16" BRICK PIER W/20" X 28" CONC. (DROPPED 9 1/4" TYP.)
	THICKENED CONC. FTG. TO RECEIVE BEAM /HEADER SUPPORTS FTG. SIZES AS NOTED.
NOTE: CONTRACTOR TO VERIFY DIMENSIONS

Foundation: The 1-story laundry/mudroom addition will require a new foundation. Staff recommends a brick foundation to match the existing historic brickwork.

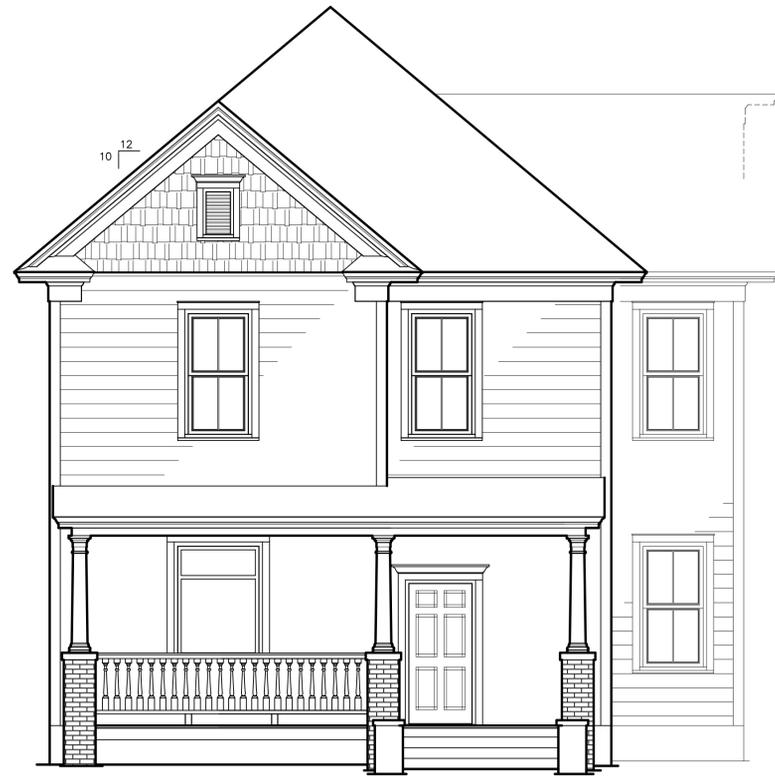
FRONT ELEVATION 1/4"=1'-0"

8'-5" FIN. WIN. HGT.
10'-1 1/2" CLING/PLT. HGT.
(AT FIRST FLOOR)

8'-2" FIN. WIN. HGT.
9'-7" CEILING HGT.
(AT SECOND FLOOR)

Door: The existing front door is not original. The applicant would like to replace the door with one that is more compatible with the style of the house and more consistent with historic houses in the district. Staff recommends using a wood half- to three-quarter glass door. Frosted, leaded or stained glass is not consistent with the character of the neighborhood.

Porch columns: The existing porch columns will be retained and repaired. The existing balustrade is missing balusters and is spaced too far apart to meet current building codes. Staff will work with the applicant on determining the best approach for a new balustrade with appropriately sized turned balusters.

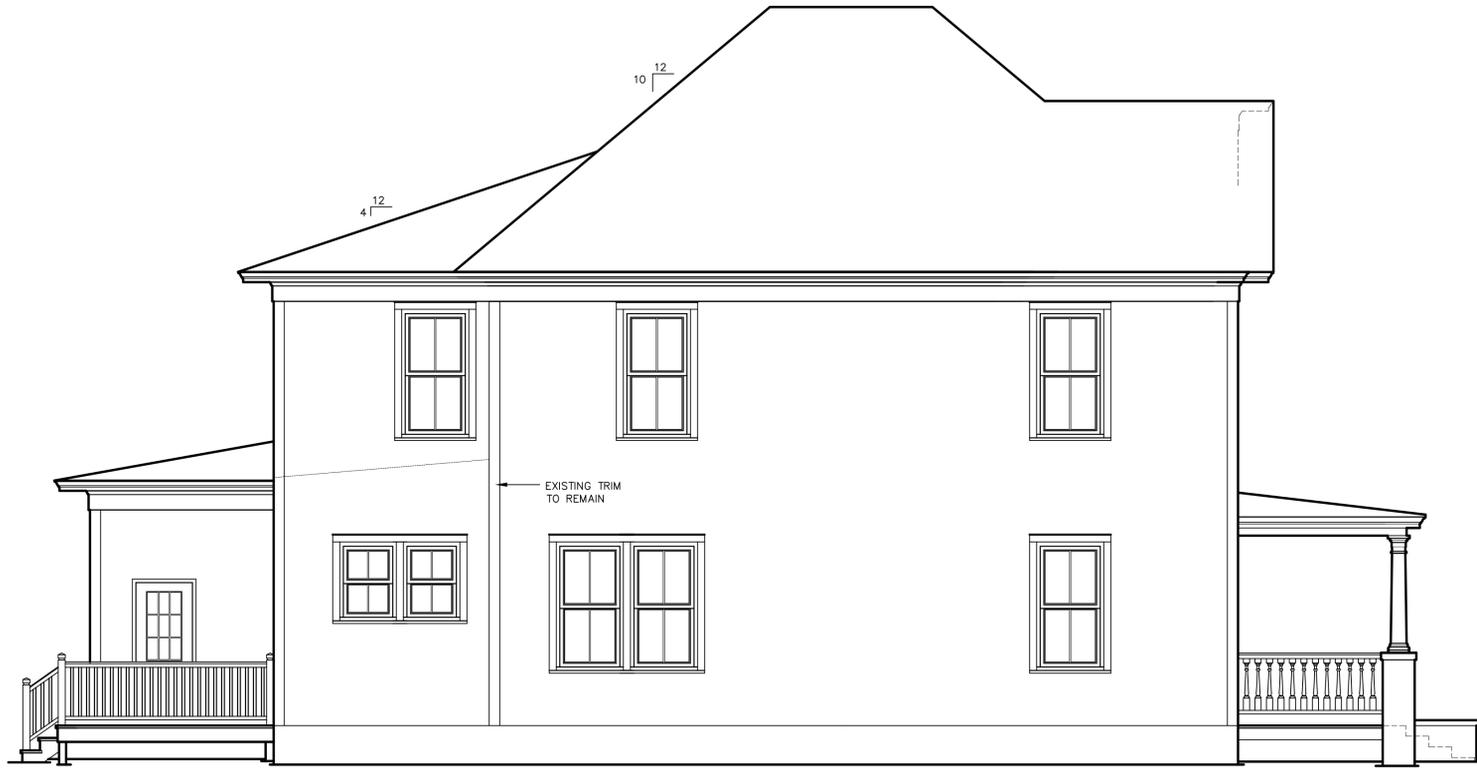
LEFT ELEVATION 1/4"=1'-0"

8'-5" FIN. WIN. HGT.
10'-1 1/2" CLING/PLT. HGT.
(AT FIRST FLOOR)

8'-2" FIN. WIN. HGT.
9'-7" CEILING HGT.
(AT SECOND FLOOR)

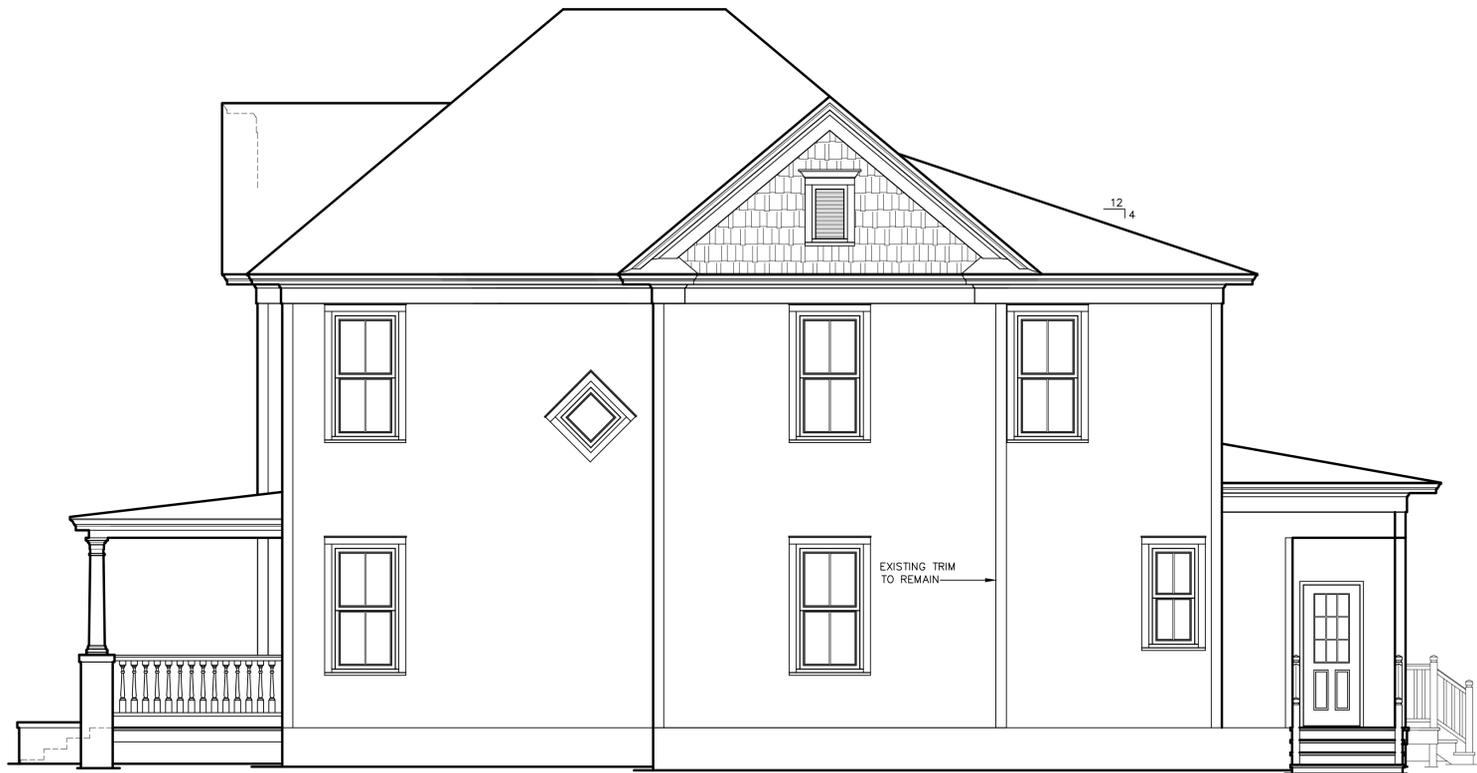
RIGHT ELEVATION 1/4"=1'-0"

8'-5" FIN. WIN. HGT.
10'-1 1/2" CLING/PLT. HGT.
(AT FIRST FLOOR)

8'-2" FIN. WIN. HGT.
9'-7" CEILING HGT.
(AT SECOND FLOOR)
