DESIGN/DEVELOPMENT REVIEW COMMISSION
DESIGN REVIEW DISTRICT
EVALUATION SHEET
Case # 1

ADDRESS: 1447 Hampton Street

NATURE OF REQUEST: Request for Certificates of Design Approval for new construction of YMCA fitness facility

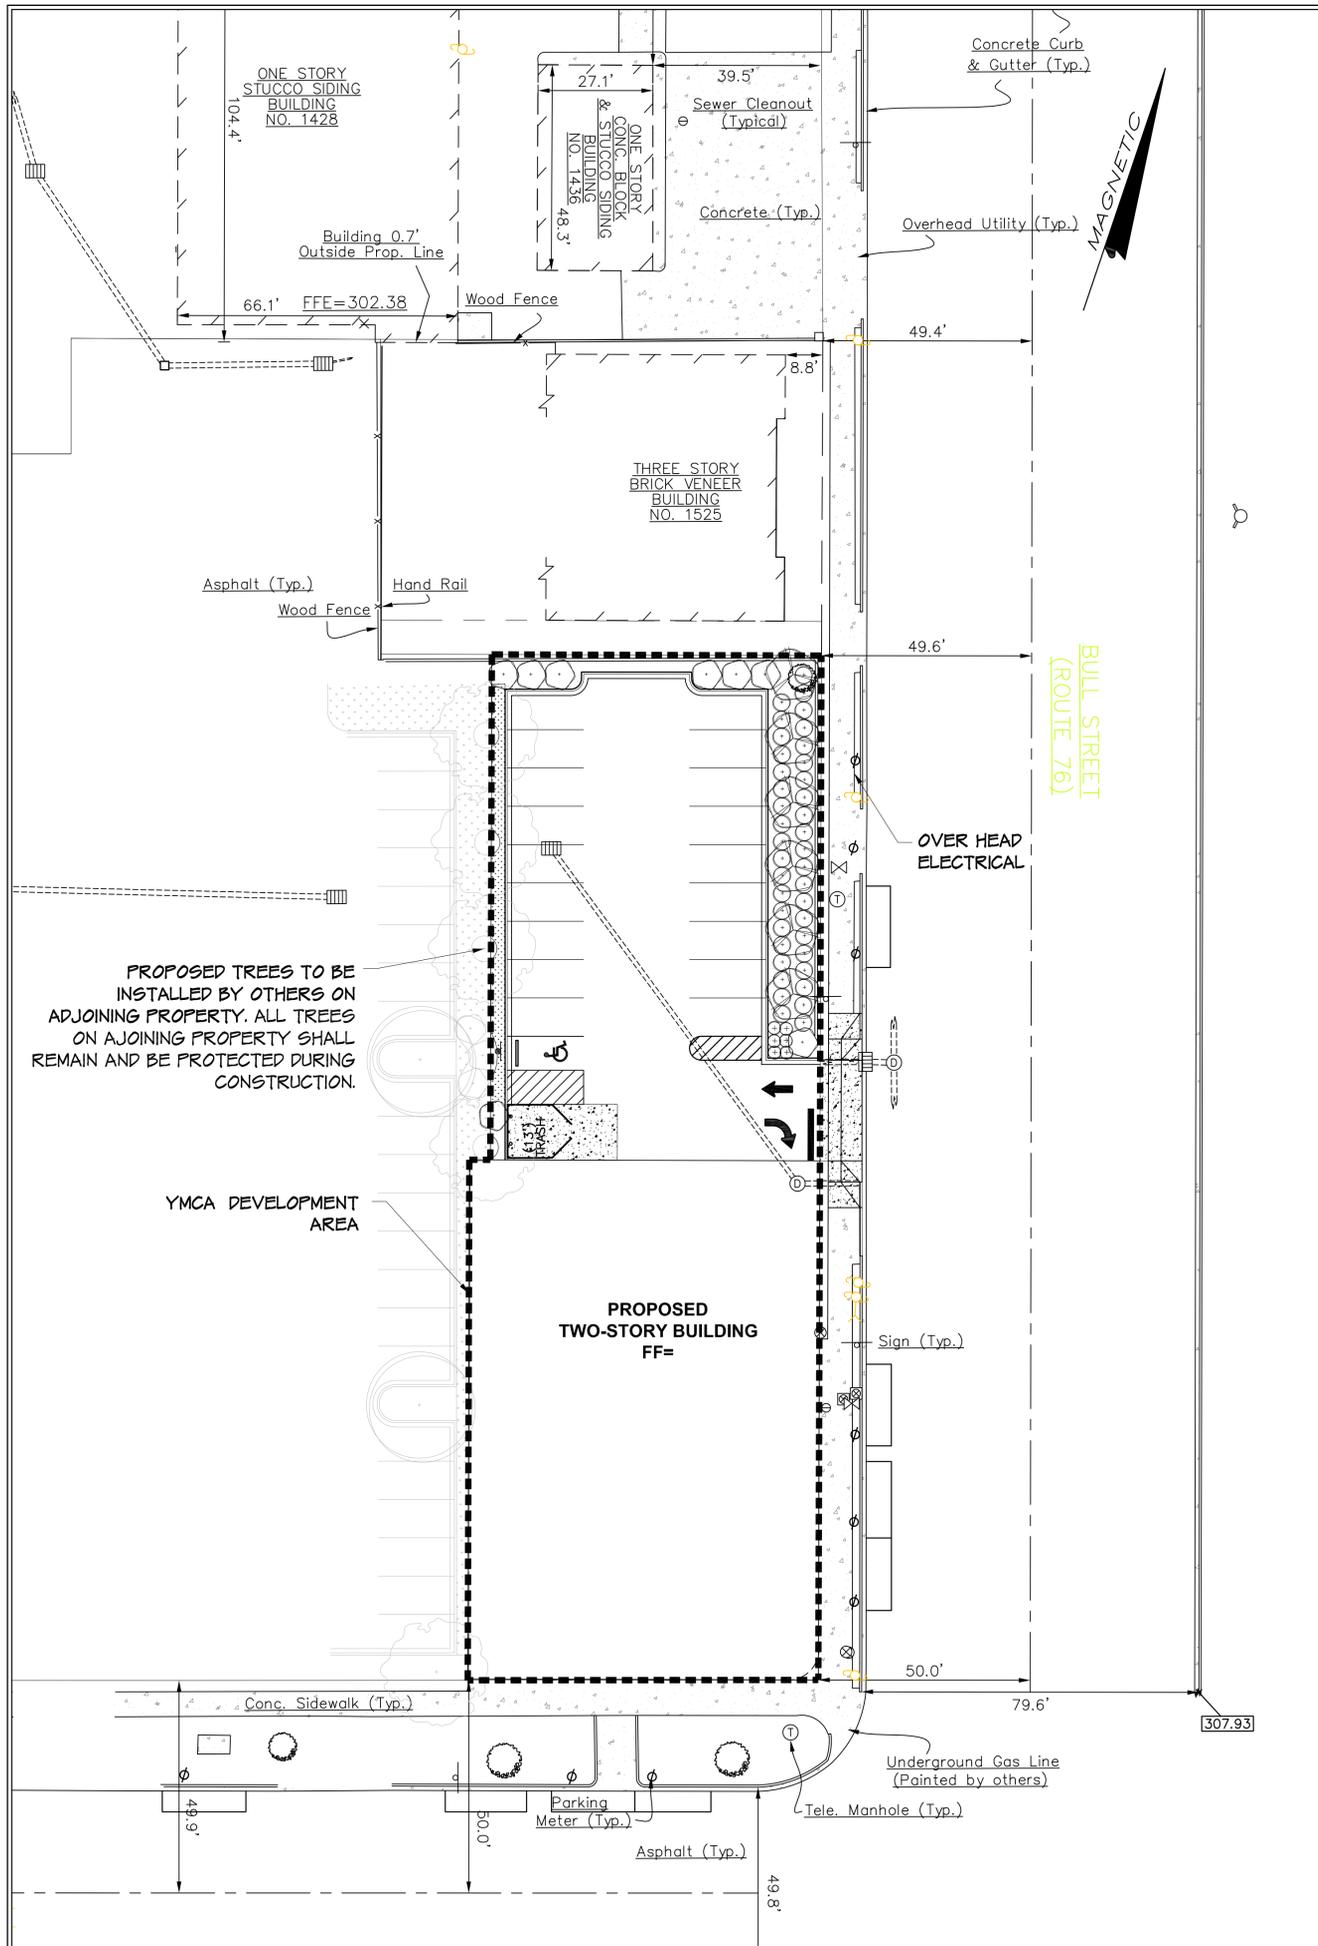
TOTAL SQUARE FOOTAGE OF PARKING AREA = 7,263 SF
 TOTAL SQUARE FOOTAGE OF LANDSCAPED AREA = 1,961 SF
 1,961 / 7,263 = 27% DEDICATED TO LANDSCAPED AREAS

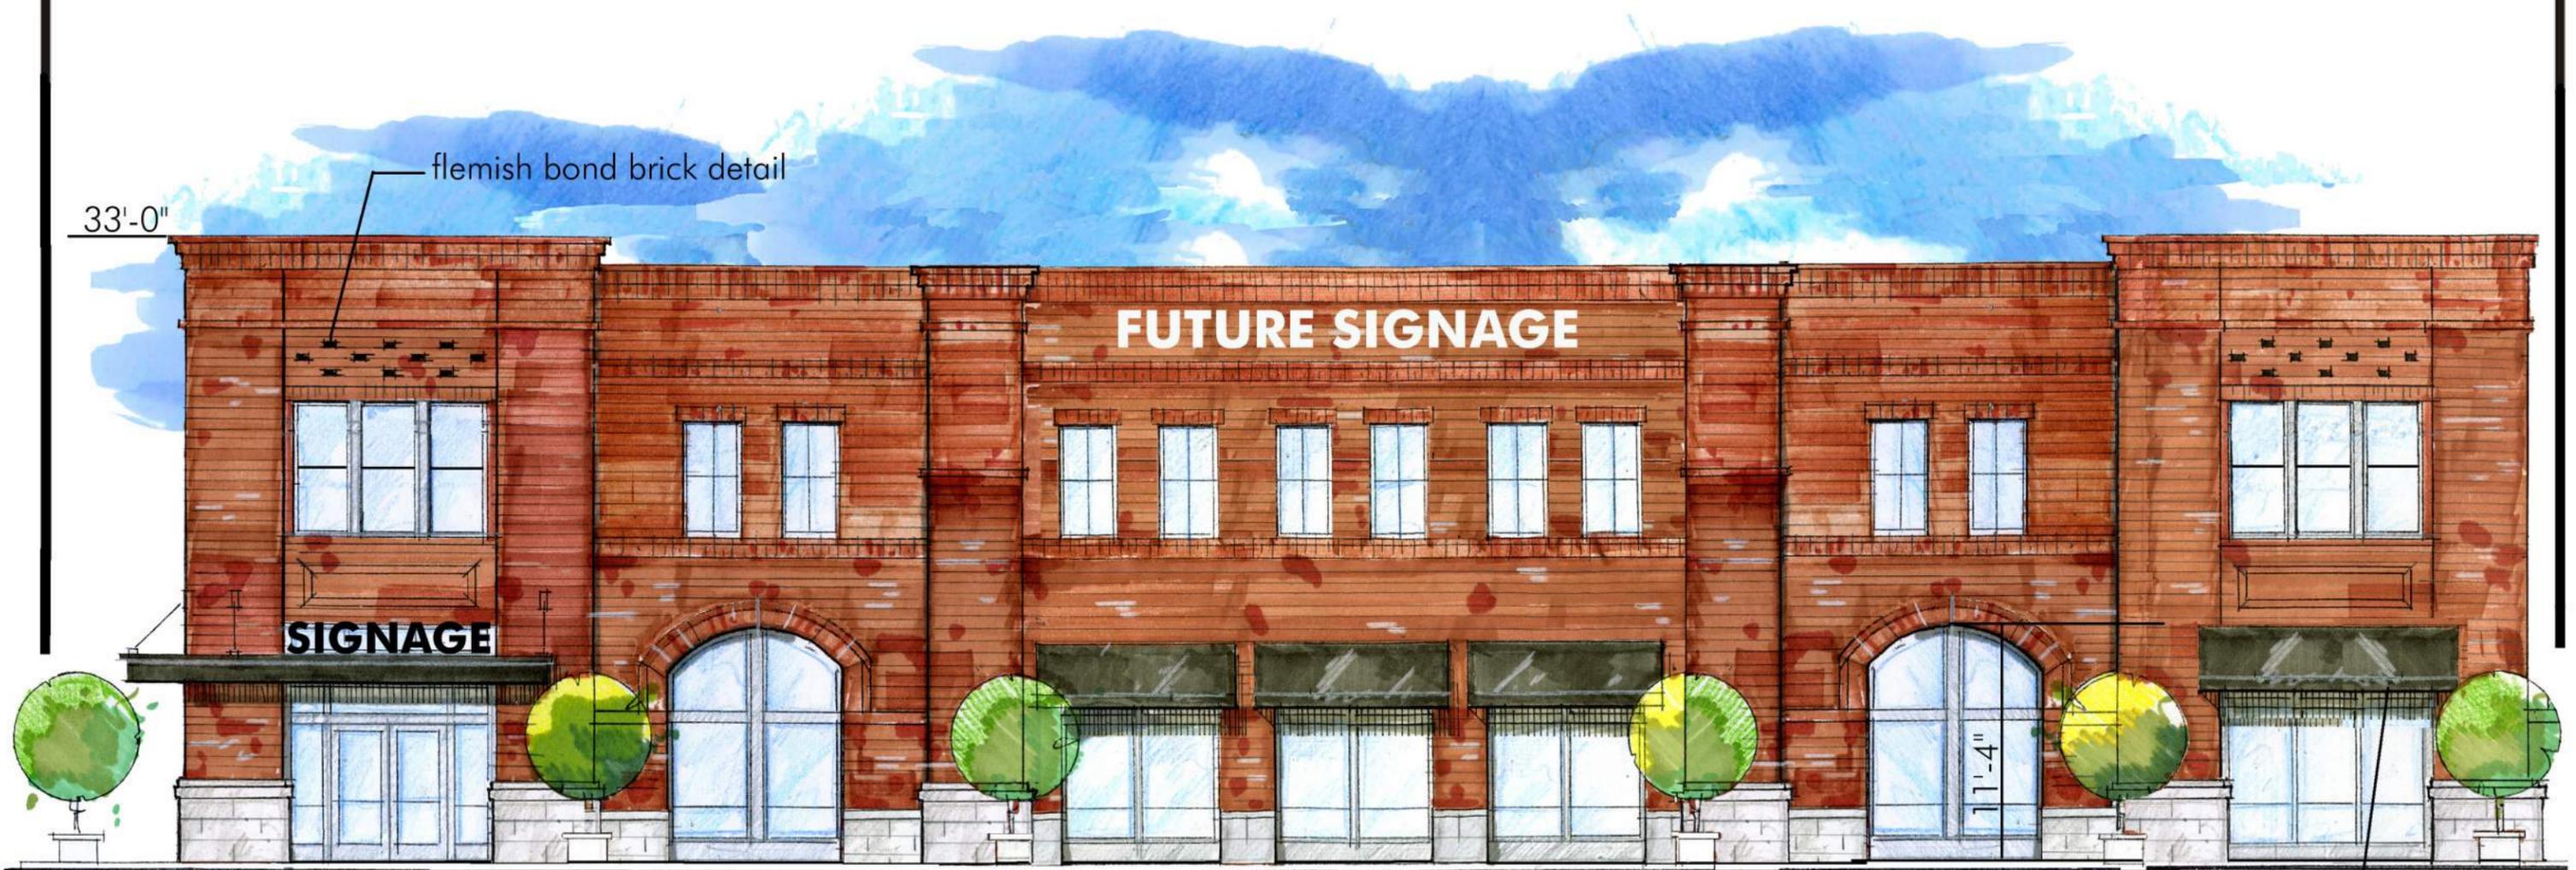
stone base

clear anodized storefront windows

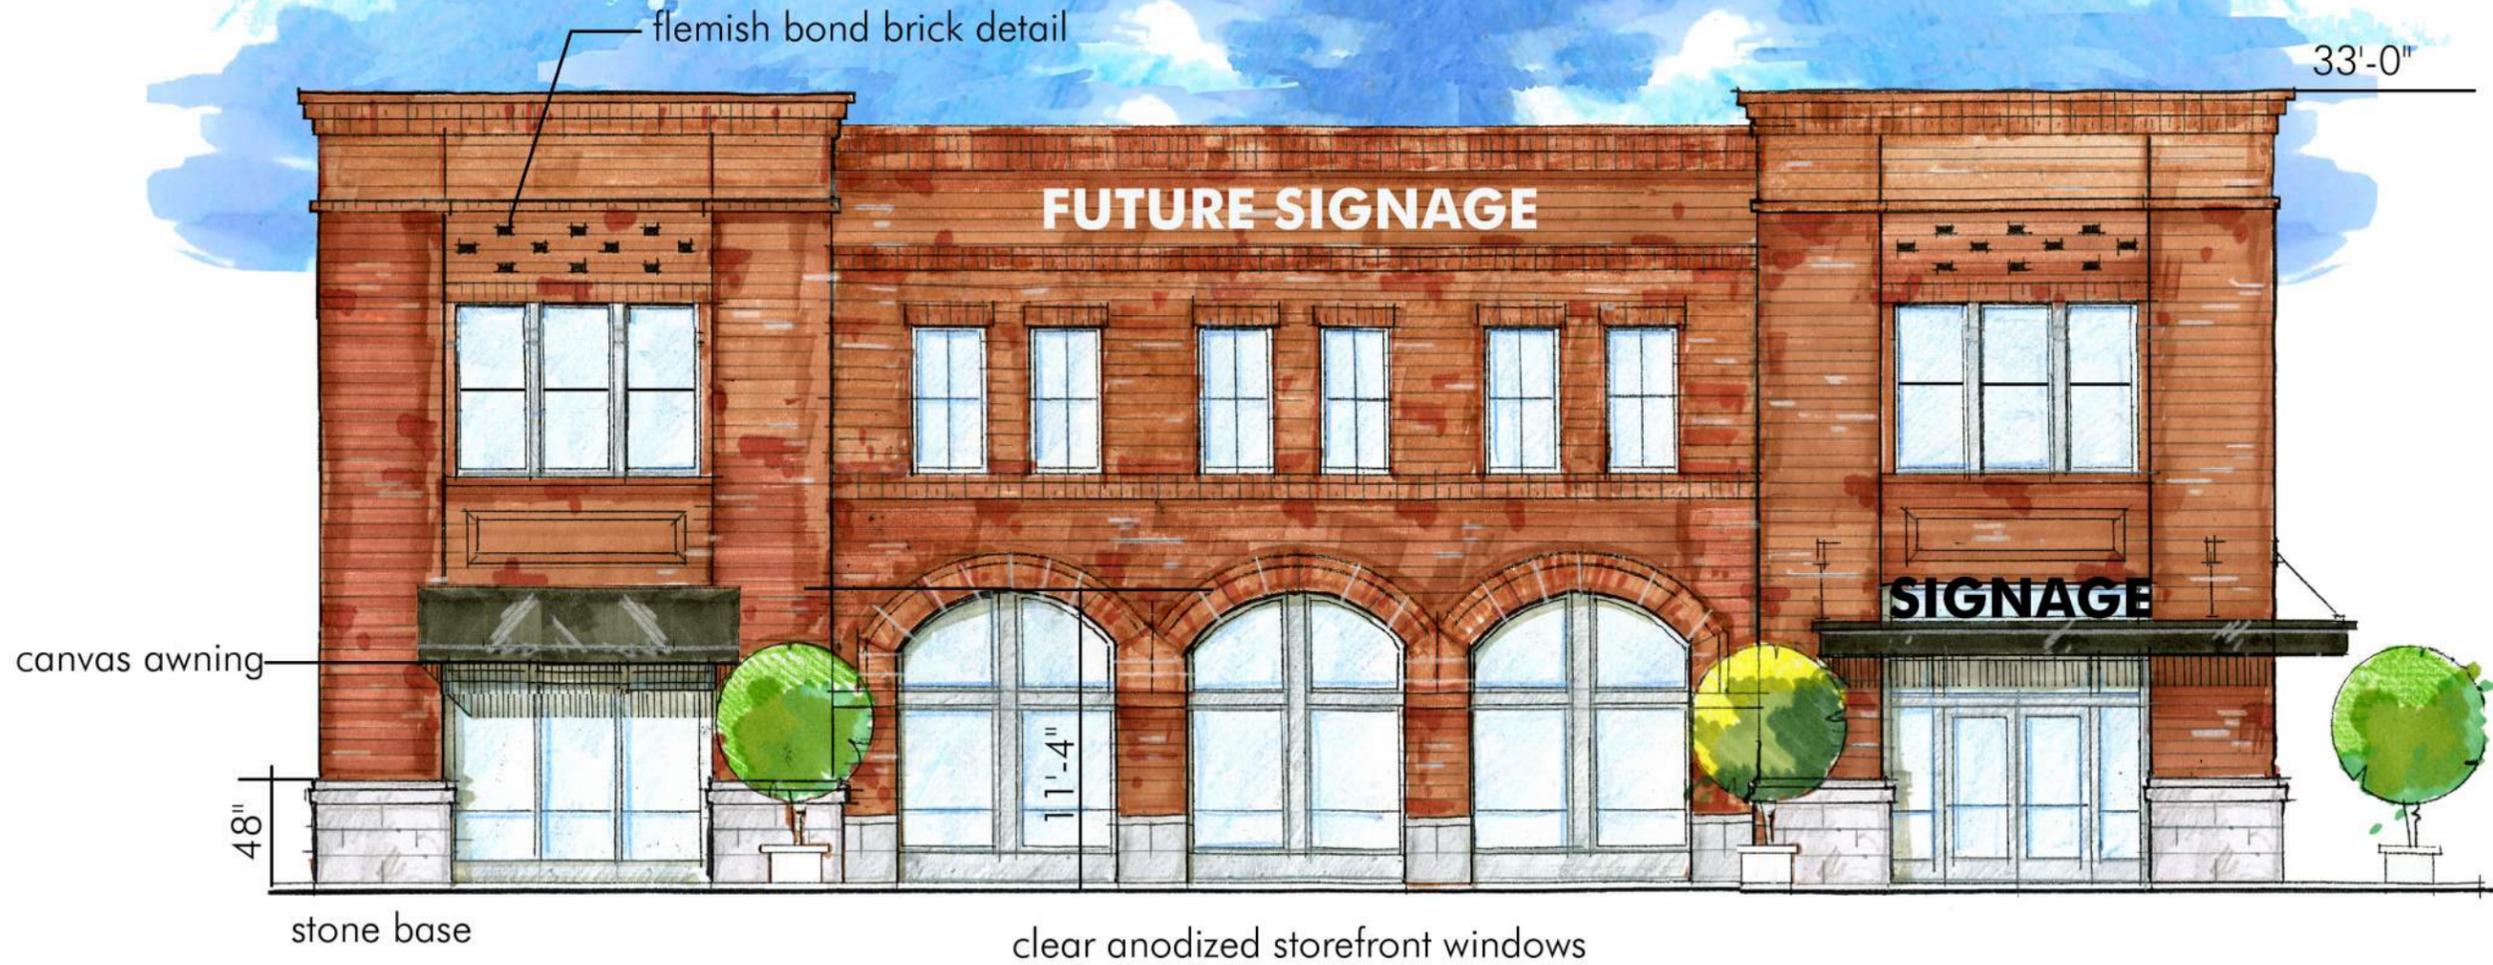
hampton street elevation

FUTURE SIGNAGE

stucco color 1

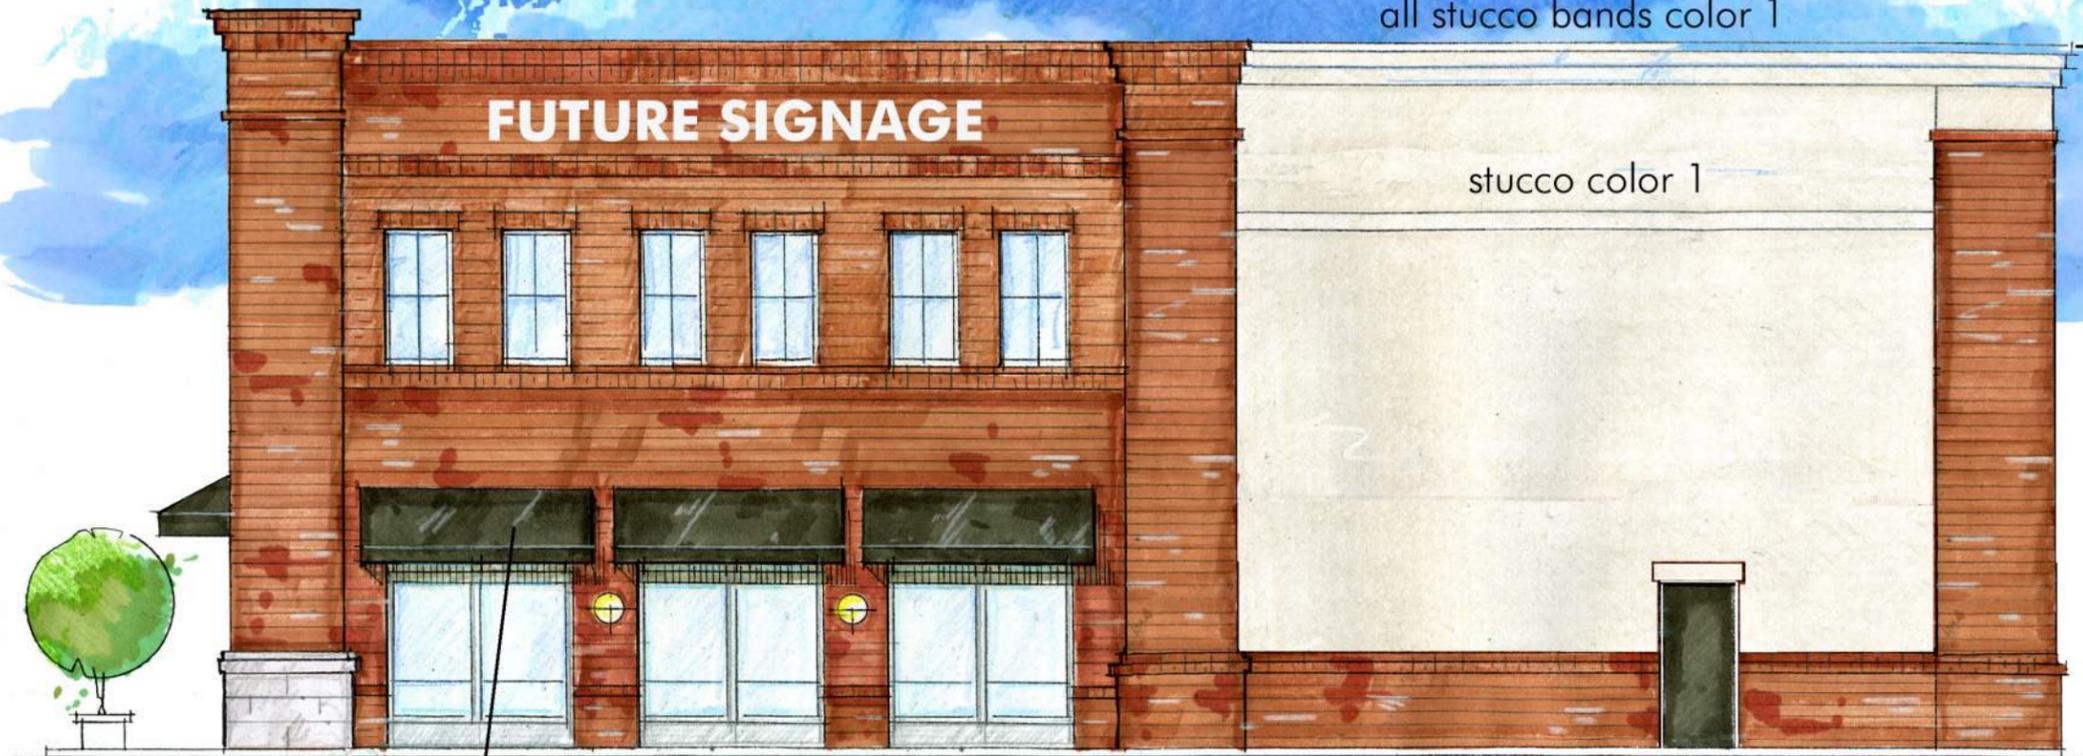
canvas awning

clear anodized storefront windows

control joints

mural wall

The awnings and canopy at the corner provide articulation and also a sense of scale for the pedestrian.
