# D/DRC Case

1907 Henderson Street

**DESIGN/DEVELOPMENT REVIEW COMMISSION**  
**DESIGN REVIEW DISTRICT**  
**HISTORIC AGENDA**  
**EVALUATION SHEET**  
**Case # 5**

**NATURE OF REQUEST:** Request Certificate of Design Approval for exterior changes and preliminary approval for the Bailey Bill

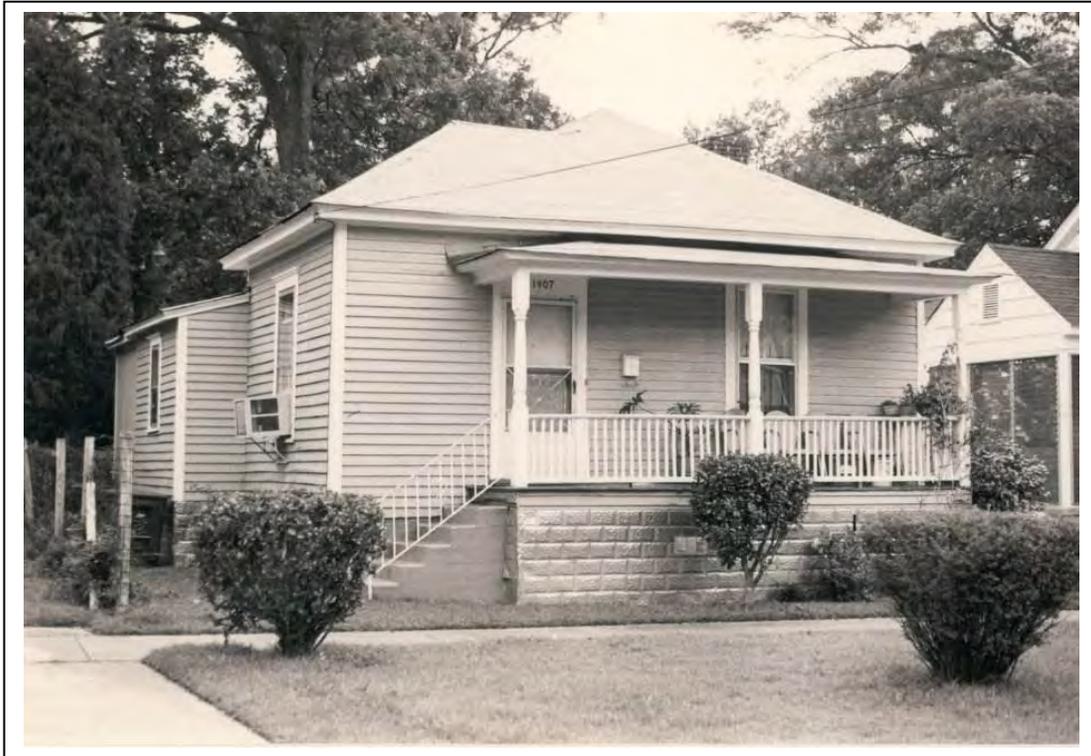
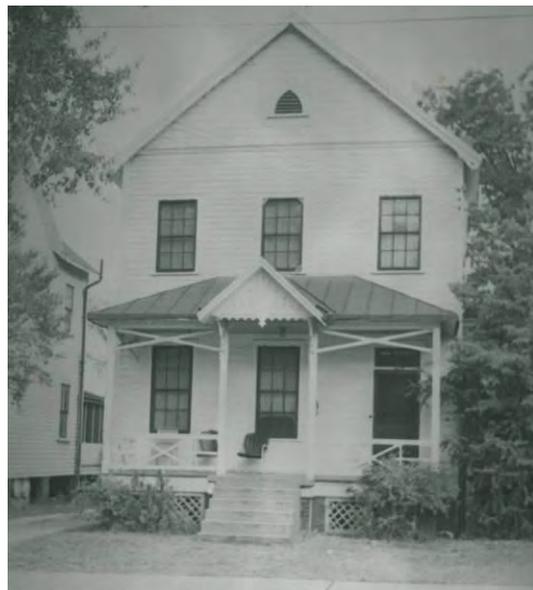
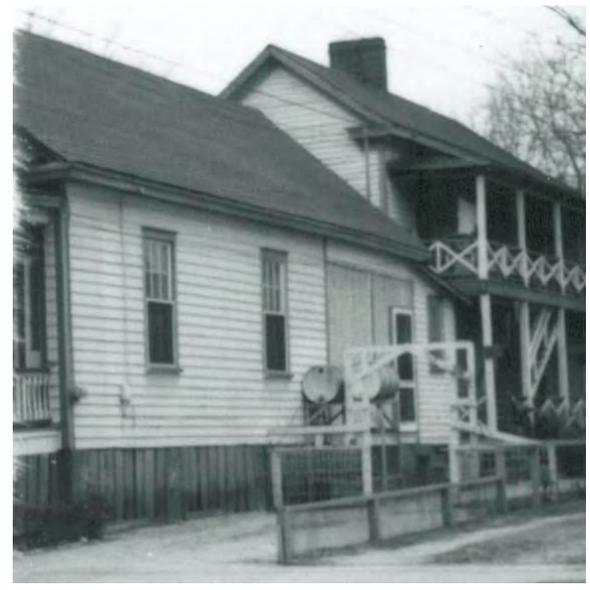
Above: Image of house in 1800 block of Henderson St. with lattice in foundation (City of Columbia)

Above Right: House in 1900 block of Henderson with vertical planks in foundation (City of Columbia)

Right: Typical open foundation in 1900 block of Pickens (Joseph Winter, City of Columbia, USC digital collections)

Historically, homes with brick pier foundations had nothing placed between the piers; the foundation was left open and allowed air to circulate under the building. As people installed duct work under houses and building codes changed to require enclosure of this area, it was filled in with masonry materials such as concrete block or brick, or with wood lattice. Some other methods of enclosing the area included slender, vertical wood planks, which is found in 1960s photos of two homes in the area. The house at 1907 Henderson gained a stamped metal underpinning made to look like decorative block at least 20 years ago.
