## D/DRC Case

2150 Harden Street

Individual Landmark and National Register Structure

**NATURE OF REQUEST:** Request for Certificate of Design Approval for exterior changes to a landmark and preliminary certification of the Bailey Bill

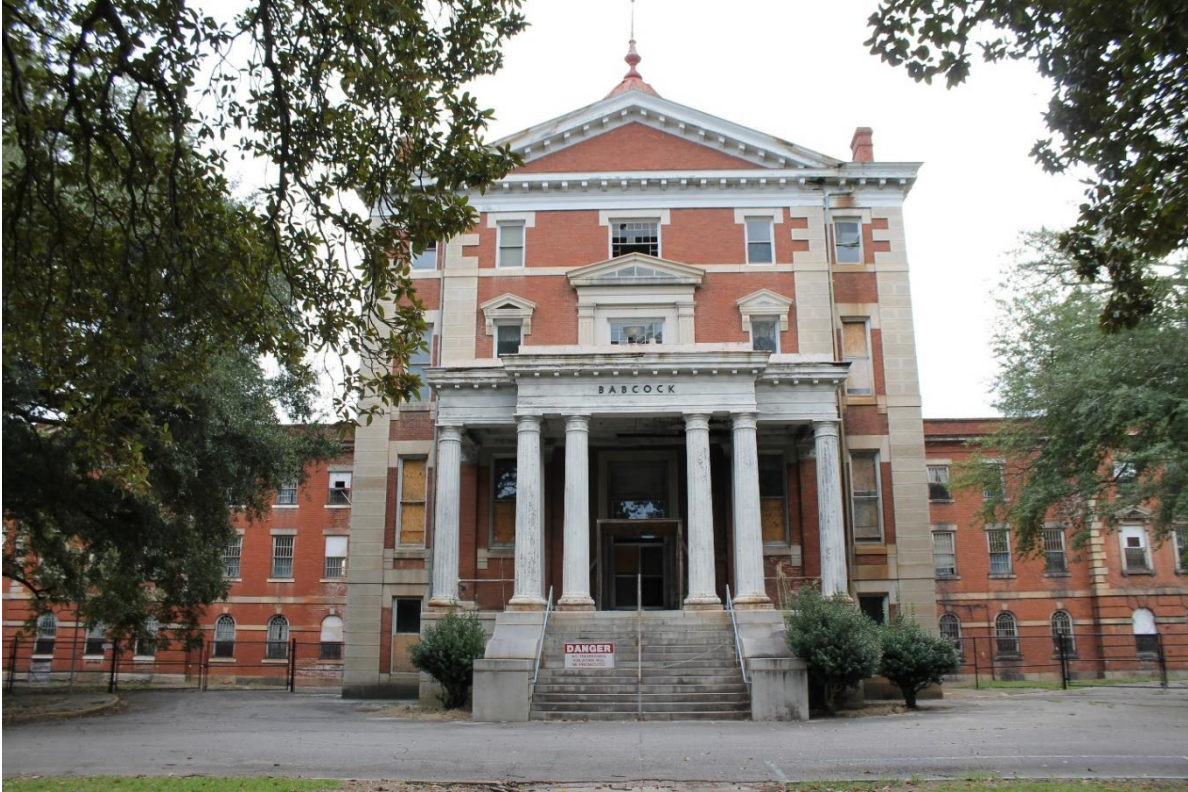
1. Center block, main entrance, view to the east

Aluminum storefront double doors are proposed to replace the non-original double front doors in the main entrance to the building. These are not compatible with the historic nature of the building and staff will need to work with the applicants on acceptable replacements. Wooden doors are recommended; research will be needed to determine an appropriate design of the doors which can be recognized as compatible with the building but not original to it.

Aluminum storefront double doors are proposed to replace the non-original double front doors in the main entrance to the building. These are not compatible with the historic nature of the building and staff will need to work with the applicants on

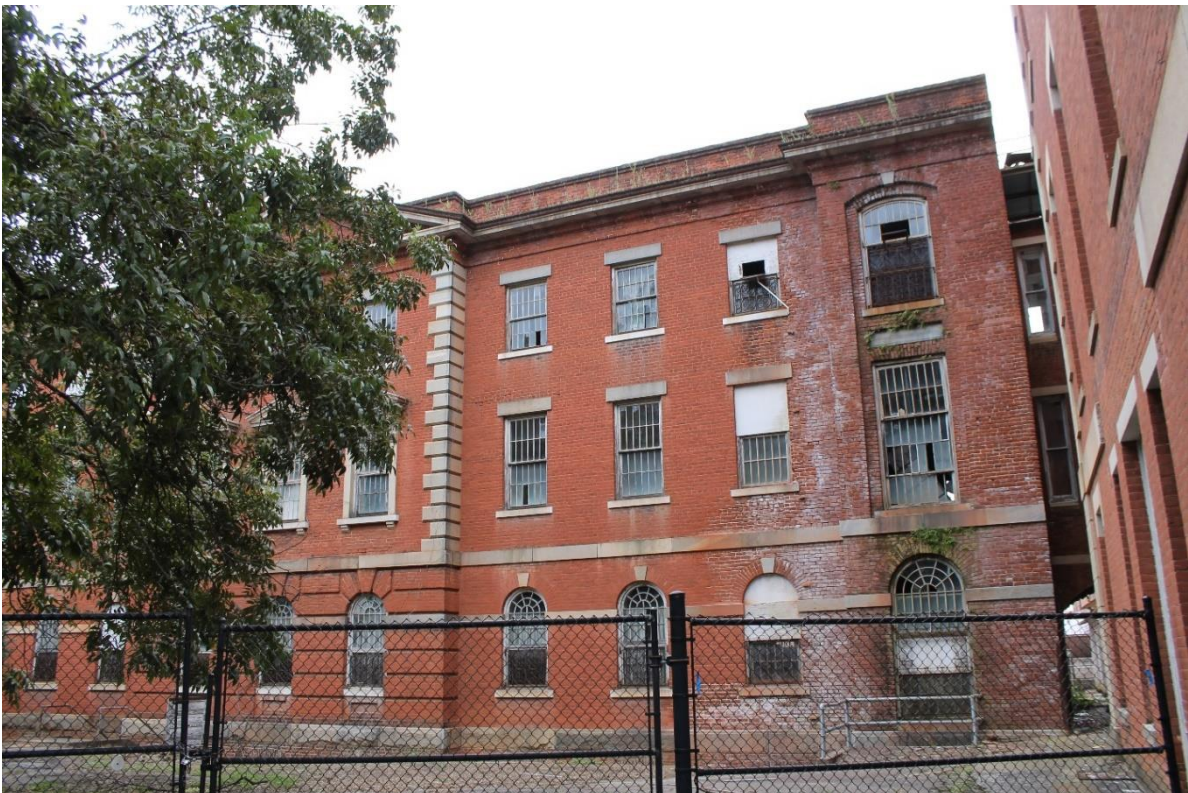
2. First northern north/south wing, view to the east

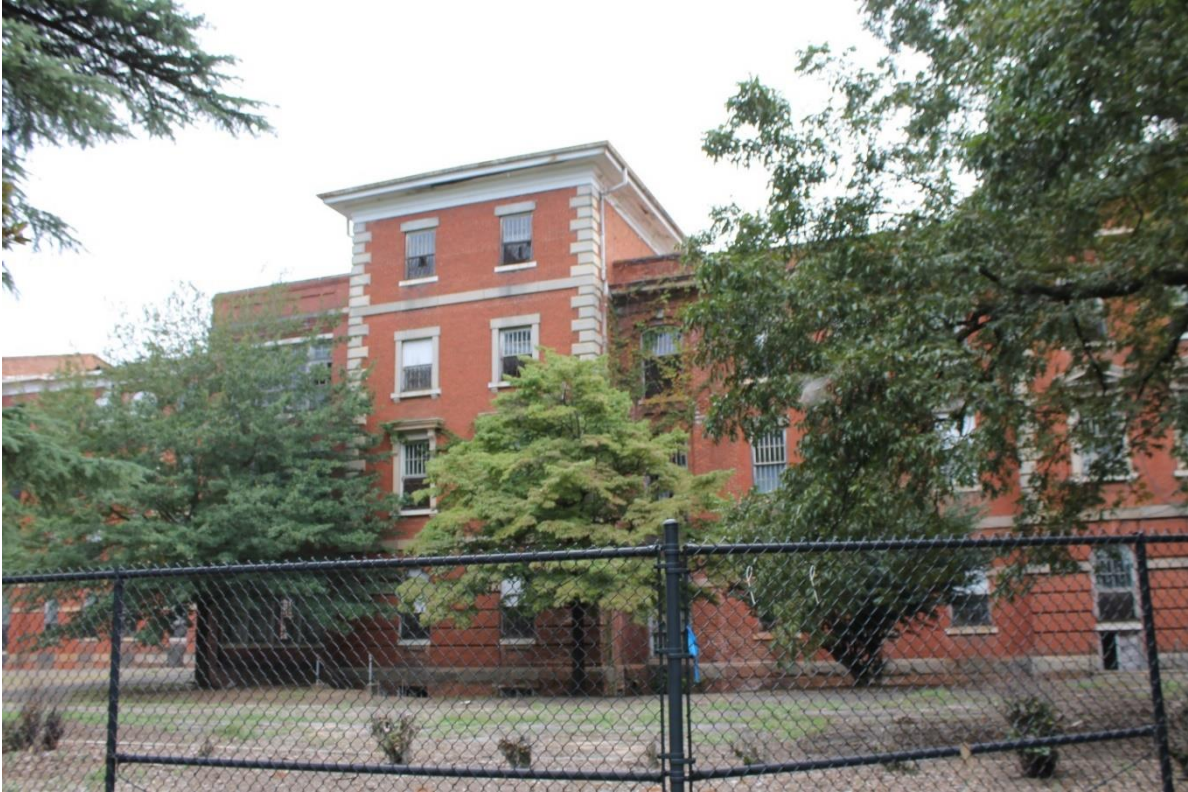
3. Northern north/south wing and first east/west block, view to the east

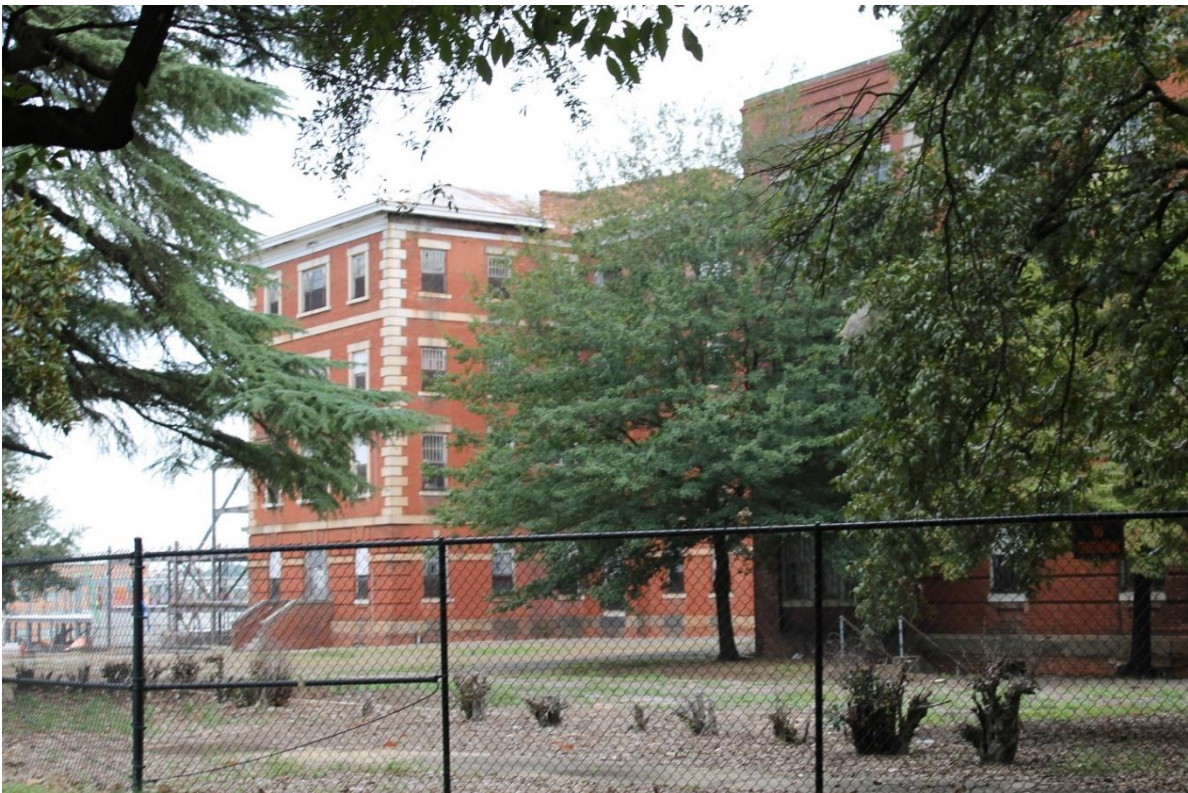
4. Northern terminal east/west block and north south wing, view to the northeast

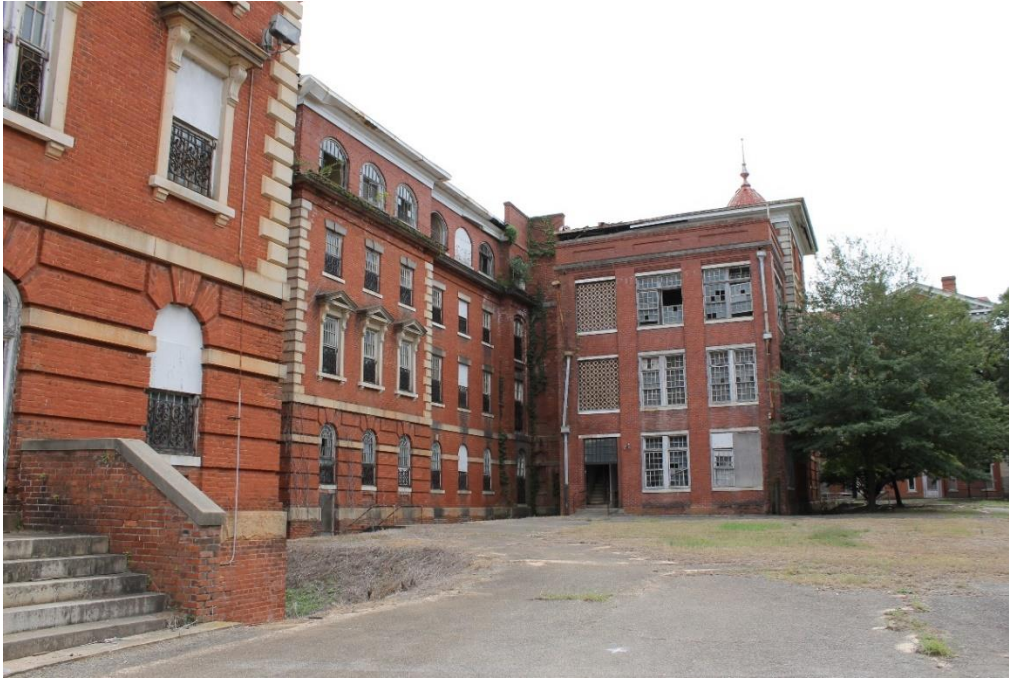
5. Northern terminal east/west block, north/south wing, and middle east/west block, view southeast

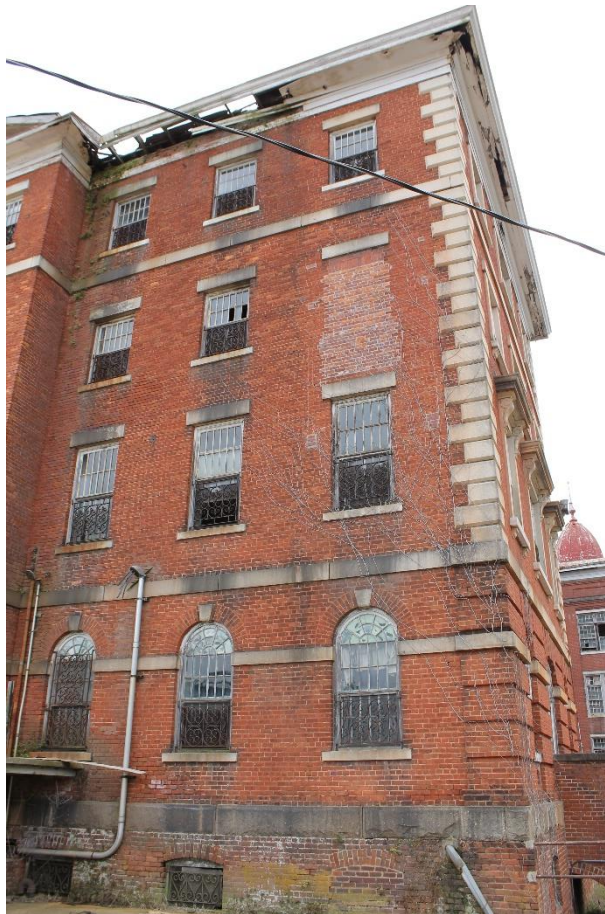
6. Northern terminal east/west block, north side and front, view to the south

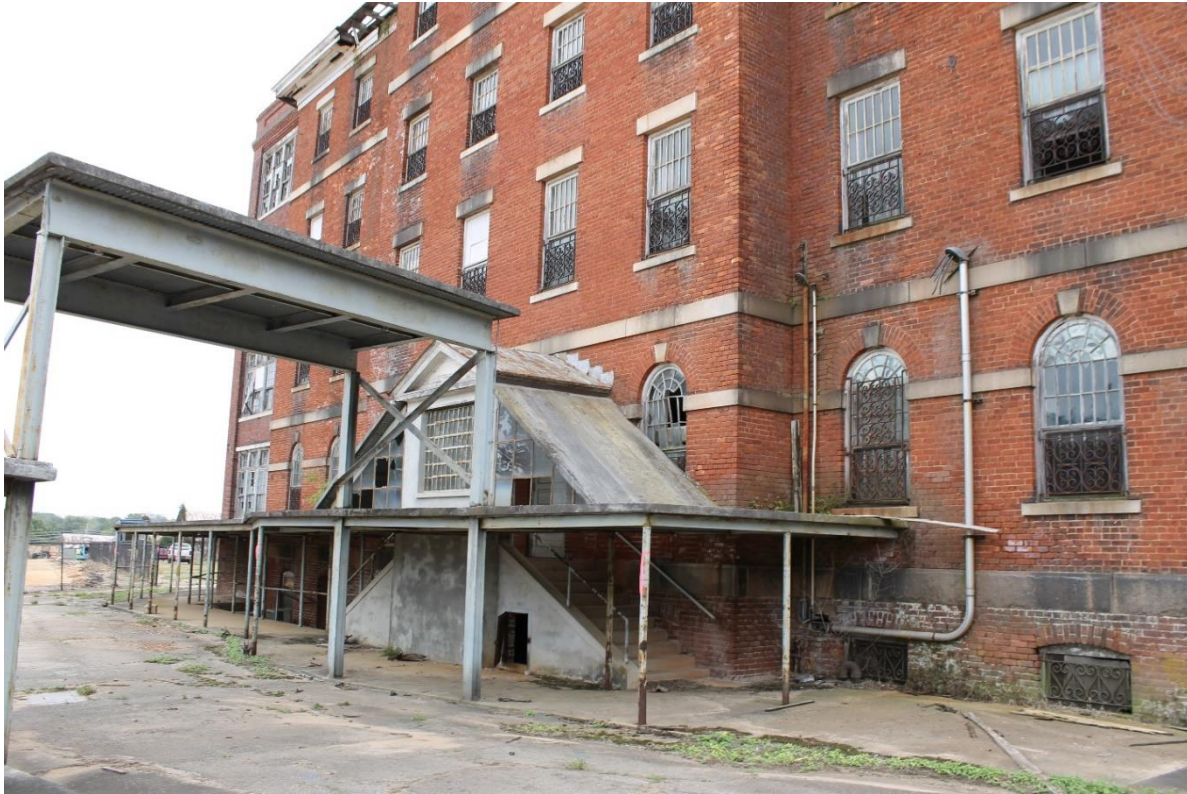
7. North side of northern terminal east/west block, view to the southeast

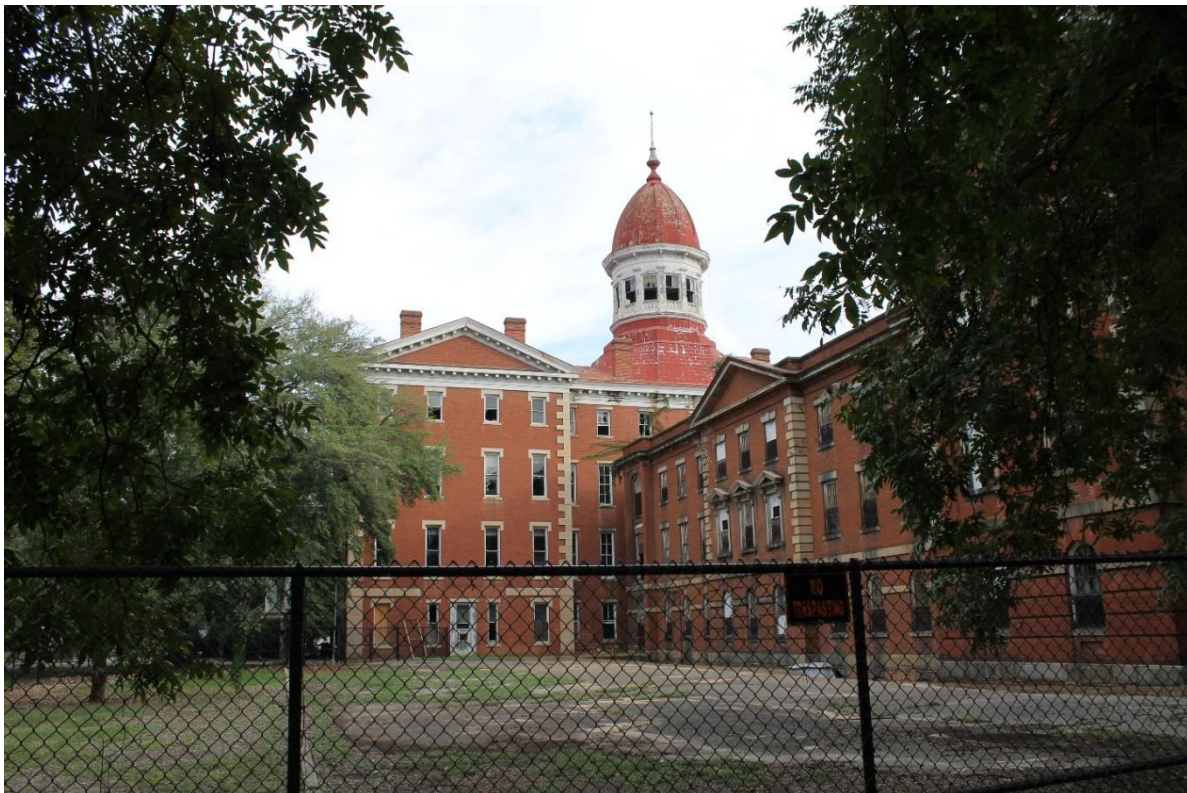
8. Center section and first southern north/south wing, view to the northeast

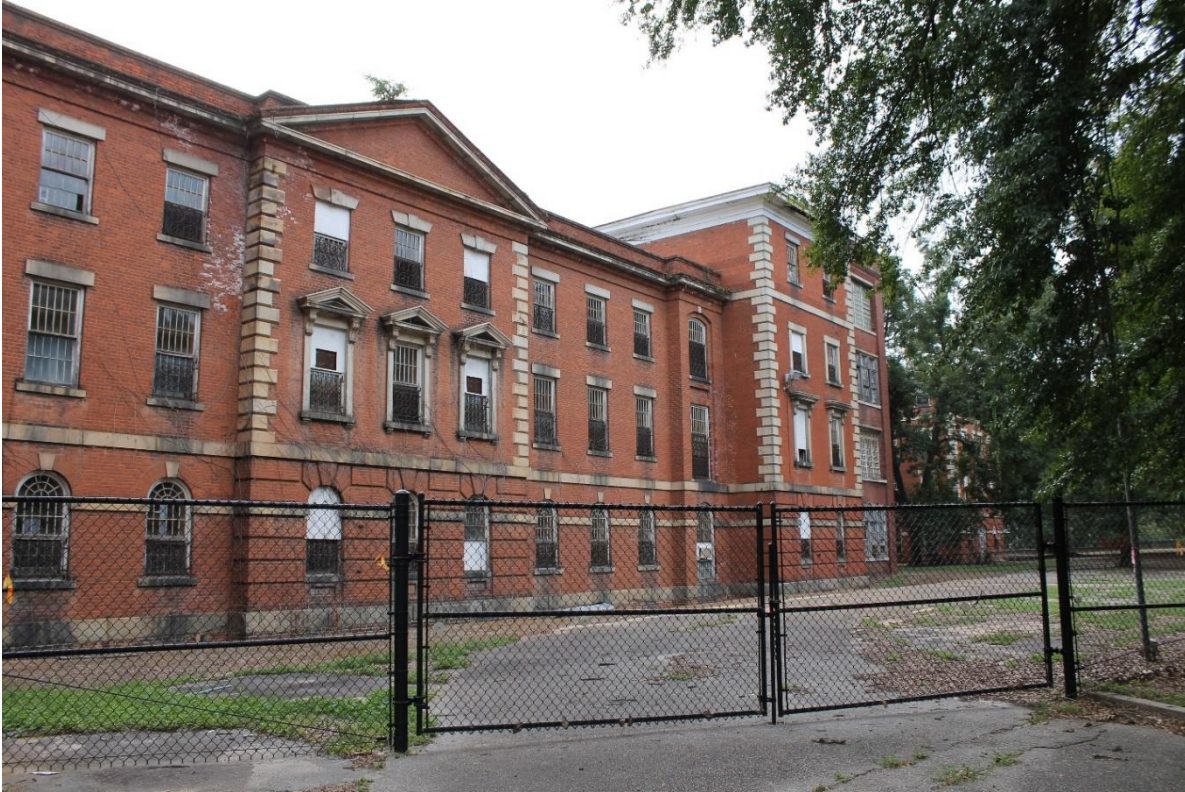
9. First southern north/south wing and middle east/west block, view to the southeast

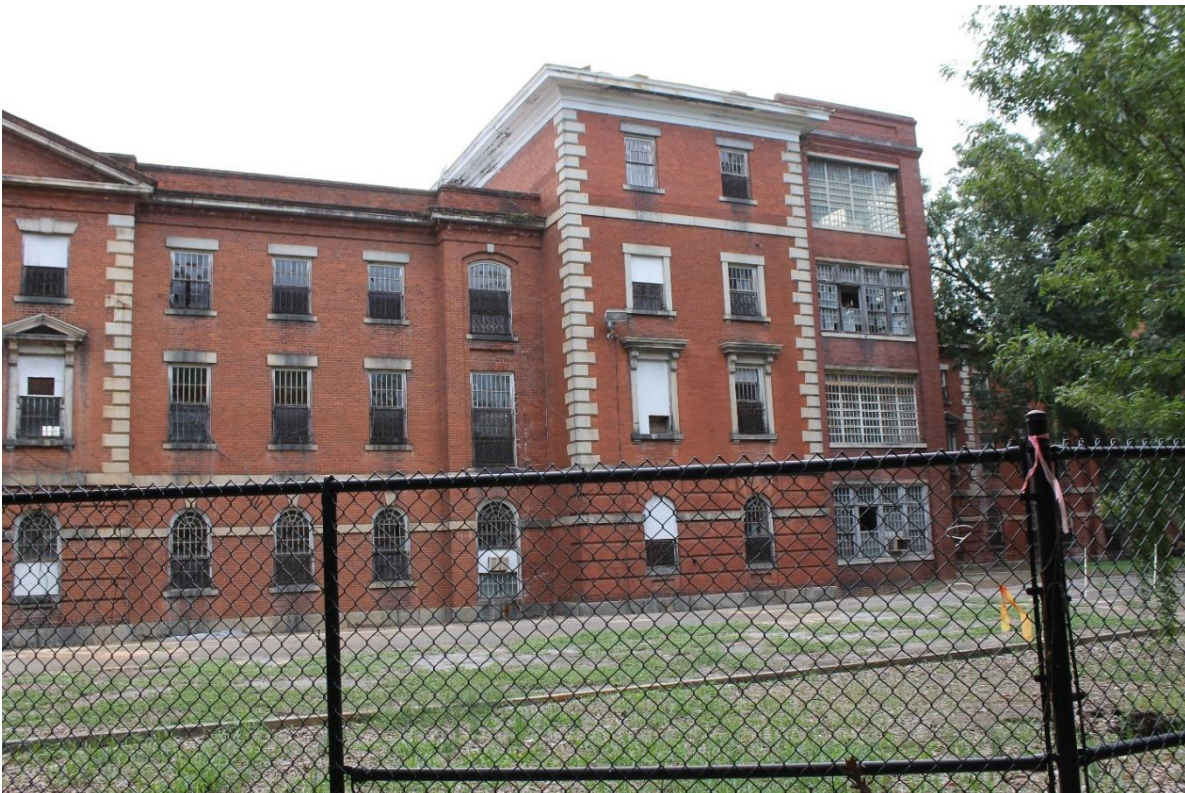
10. Middle southern east/west block and first north/south wing (on left), view to the southeast

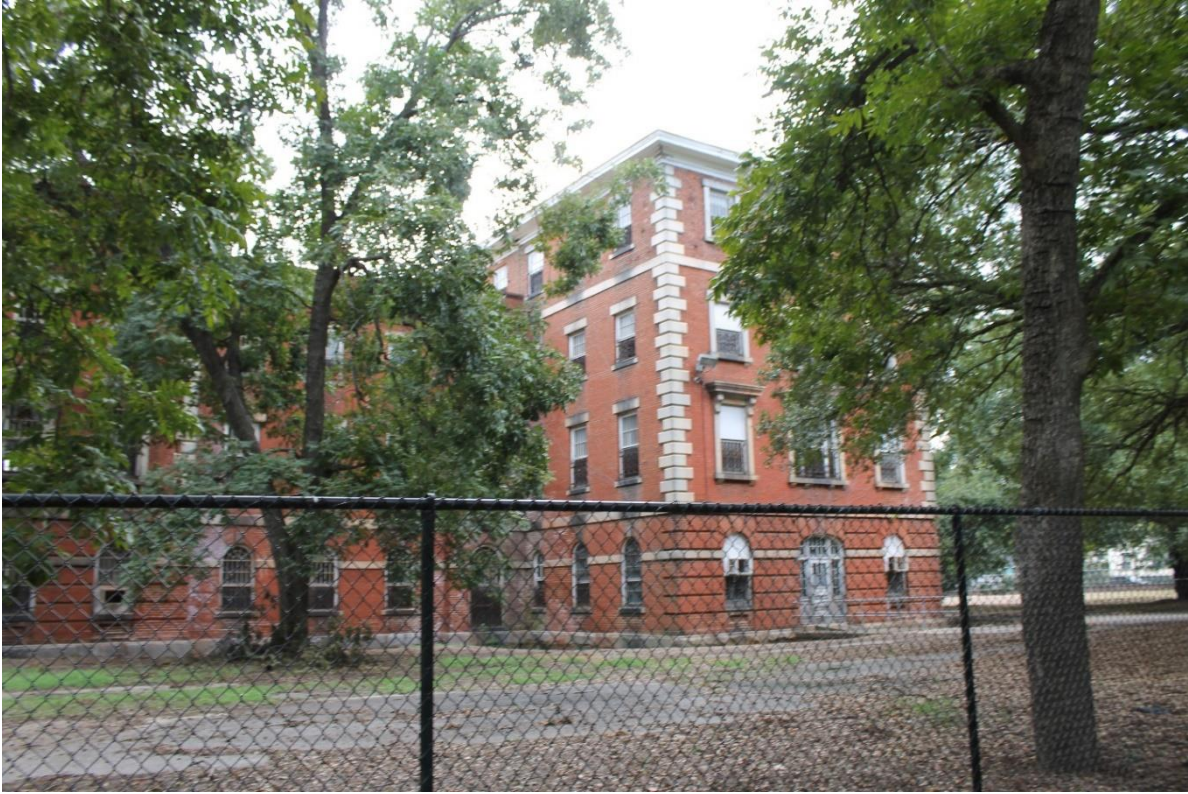
11. Southern terminal east/west block, view to the southeast

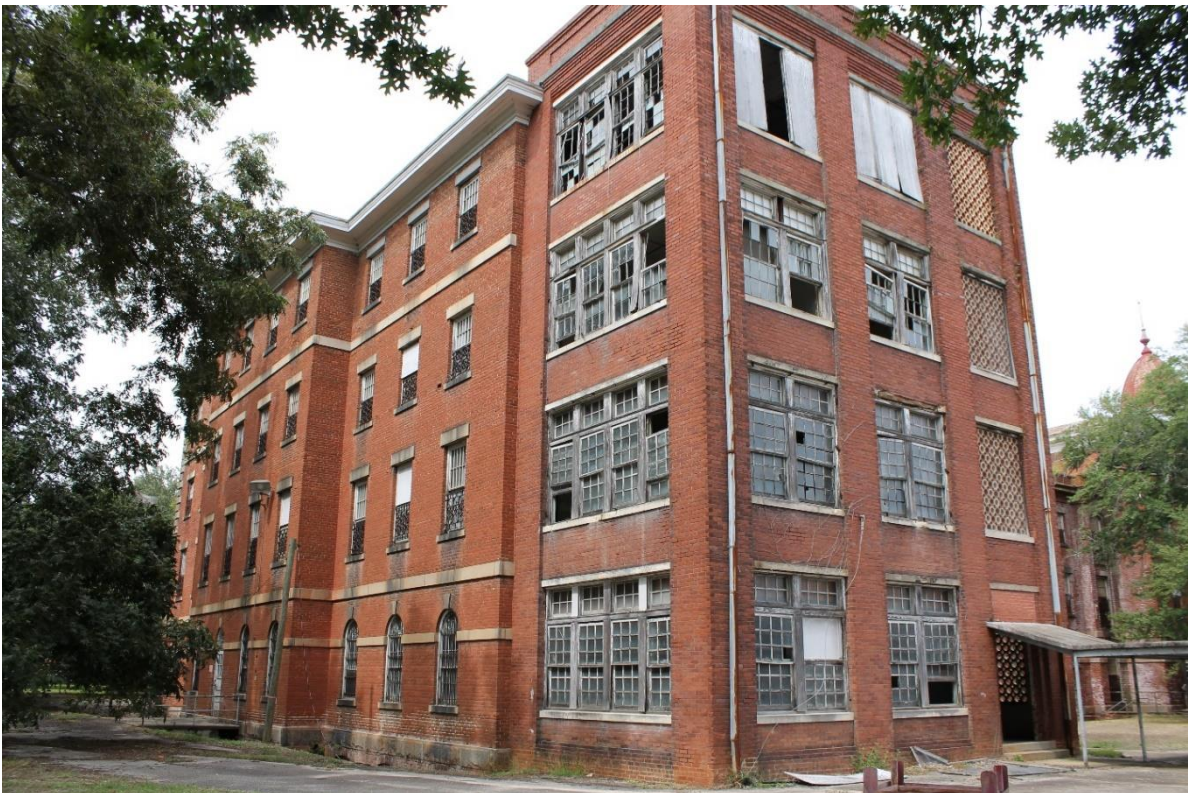
12. Southern side of southern terminal east/west block, view to the northwest

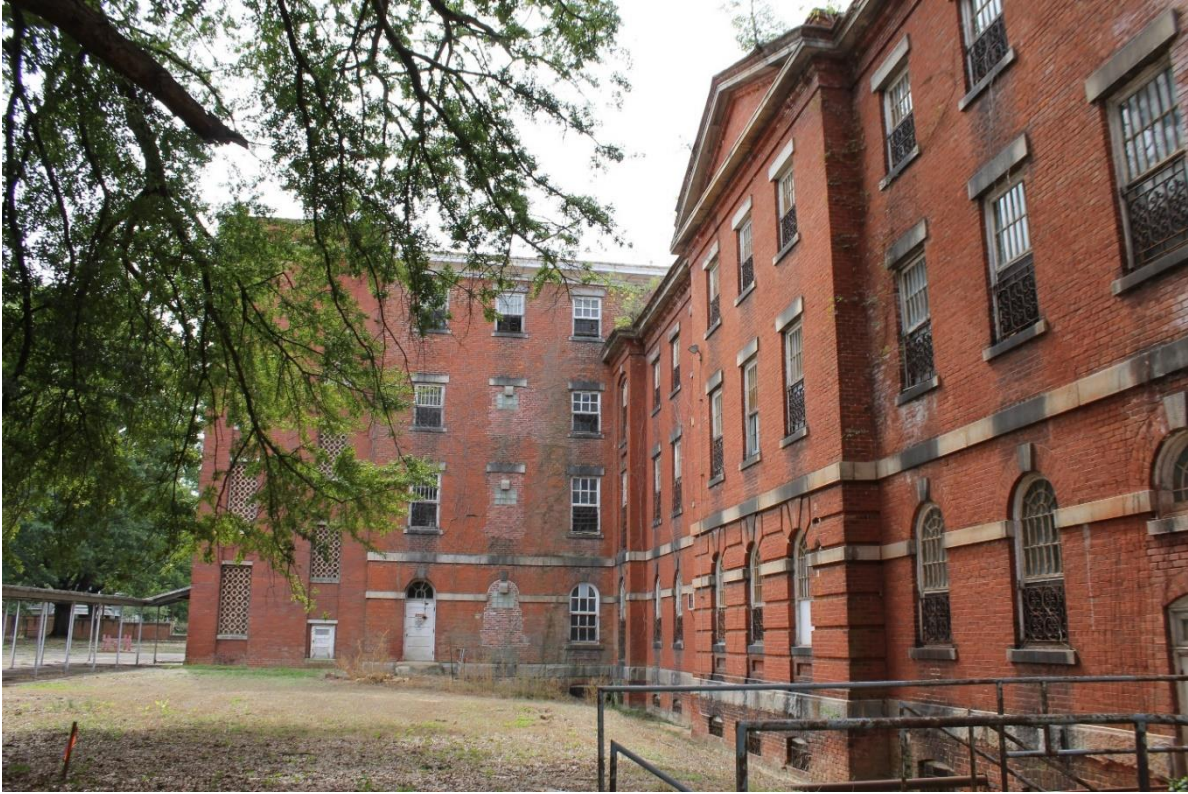
13. Northern side of southern terminal east/west block and rear (east side) of north/south wing, view to the southwest

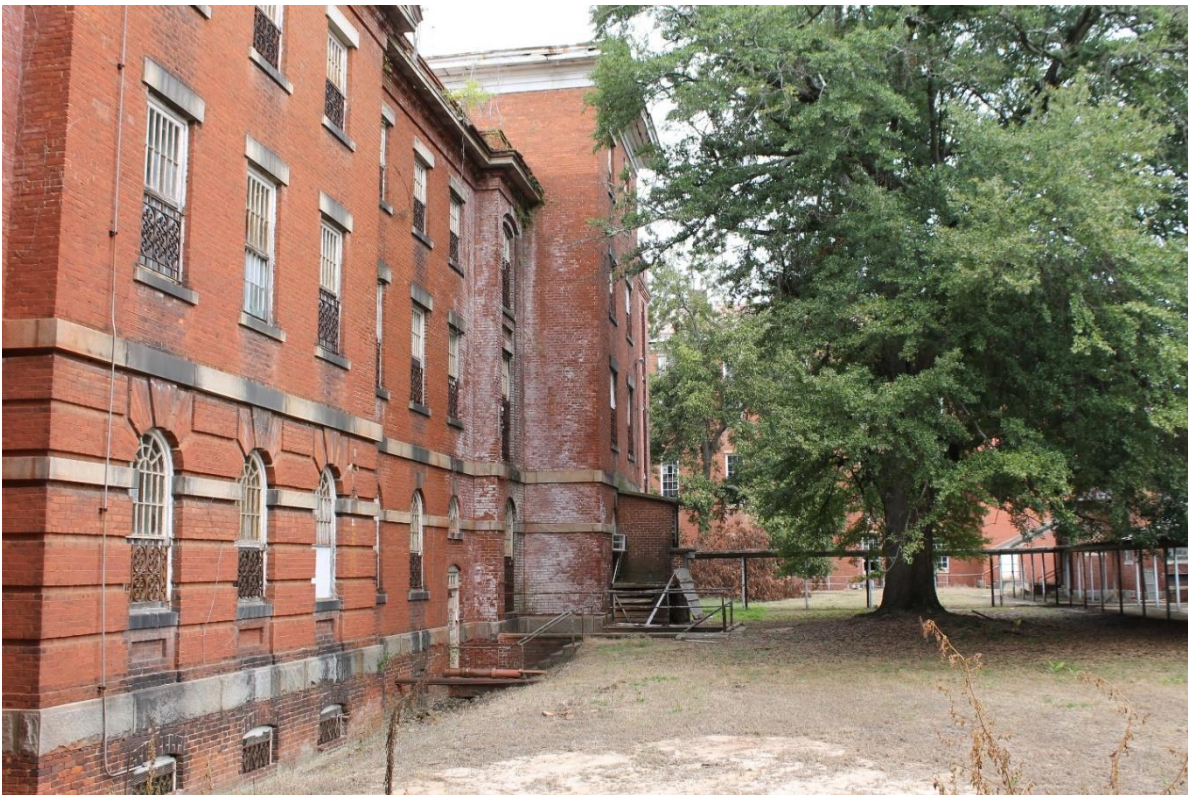
14. Rear of southernmost north/south wing and middle east/west block, view to the north

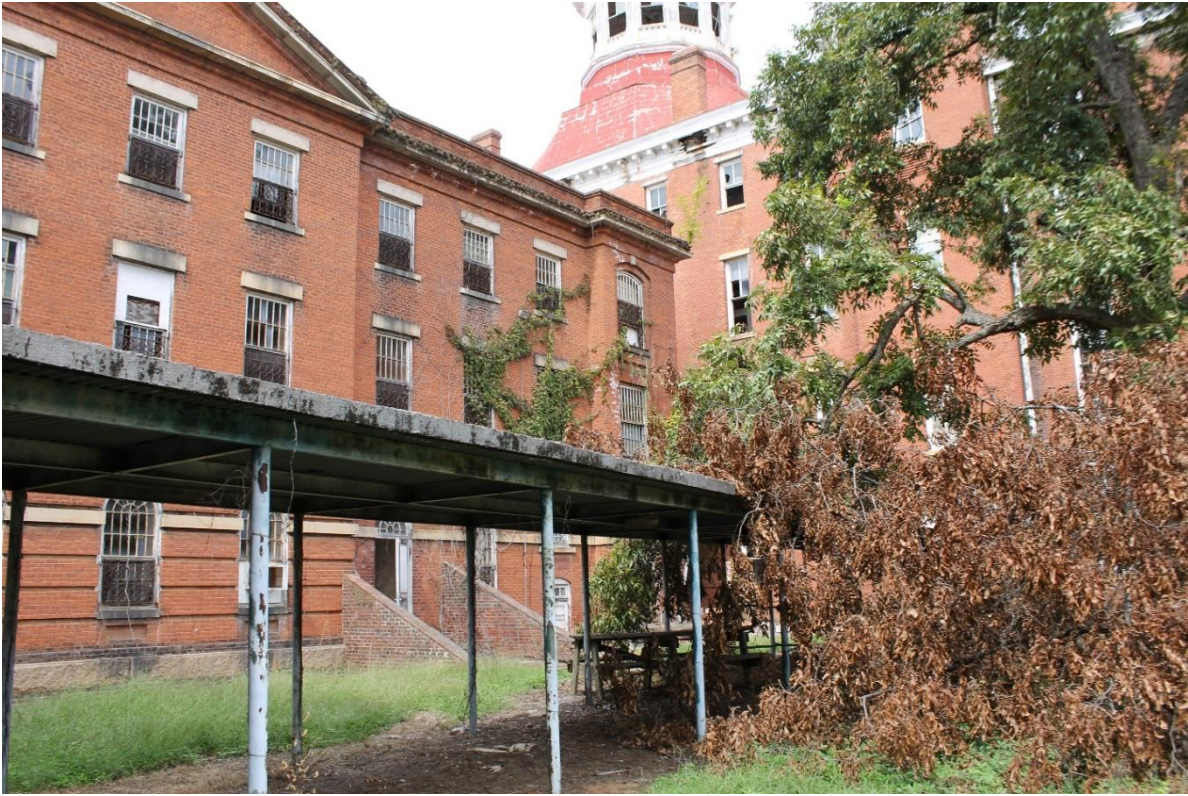
15. Rear of first southern north/south wing and center block, view to the northwest

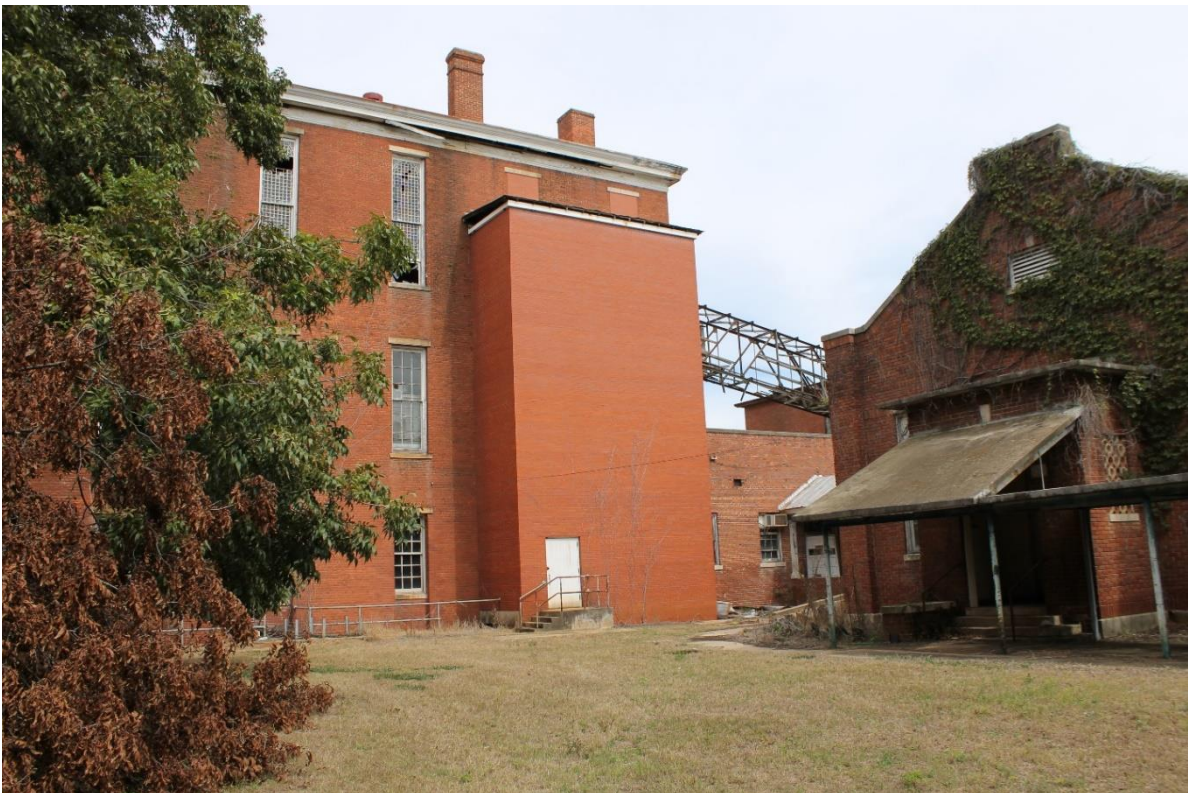
16. Southern side of center block and front of southern (men's) dining hall, view to the northeast

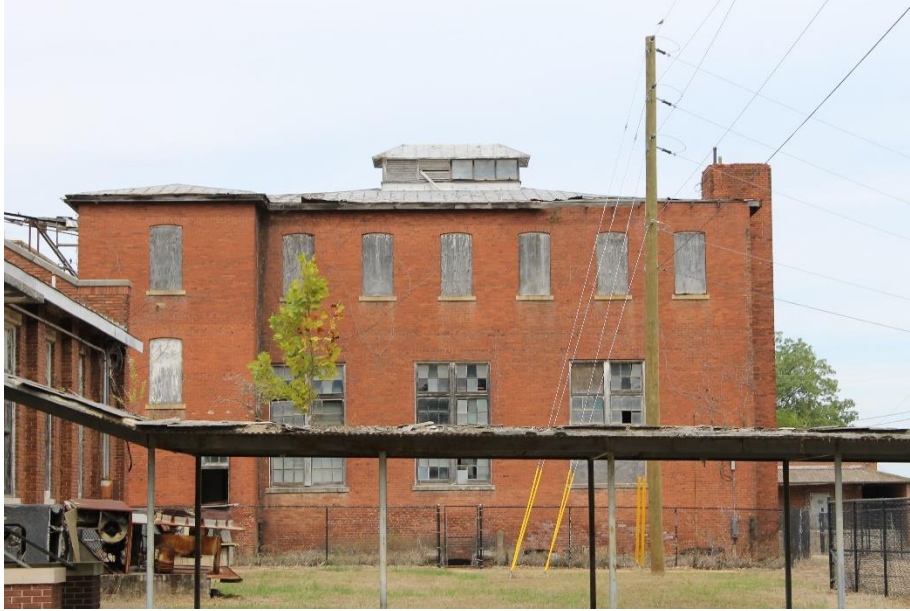
17. Southern side of center block – rear kitchen/laundry wing, view to the north

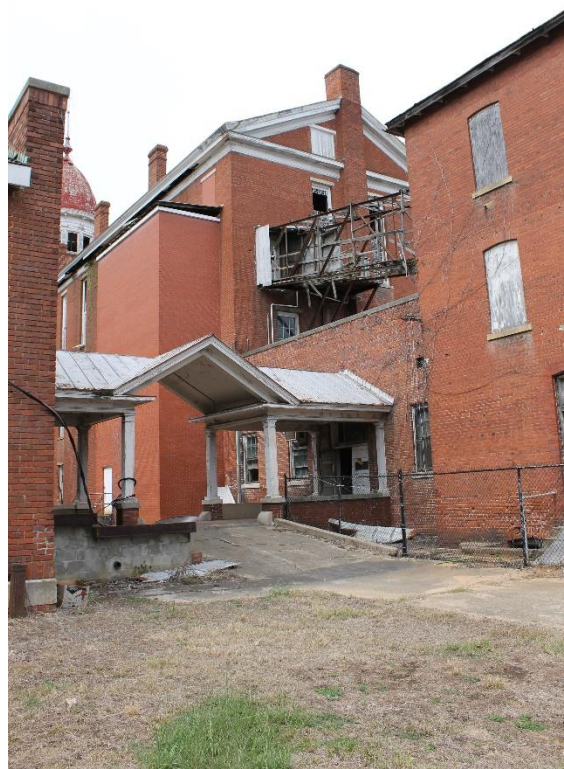
18. Center block – rear wing, view to the northwest

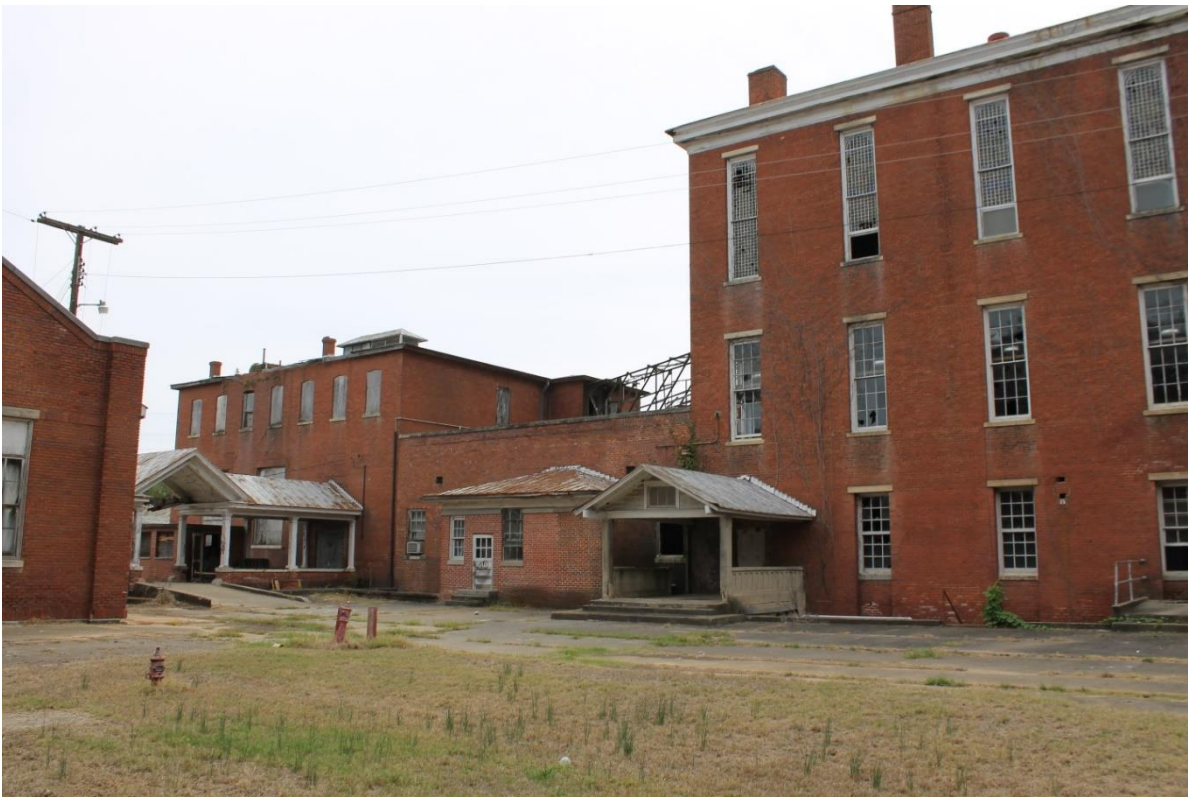
19. Northern side of center block and kitchen/laundry wing, view to the southeast

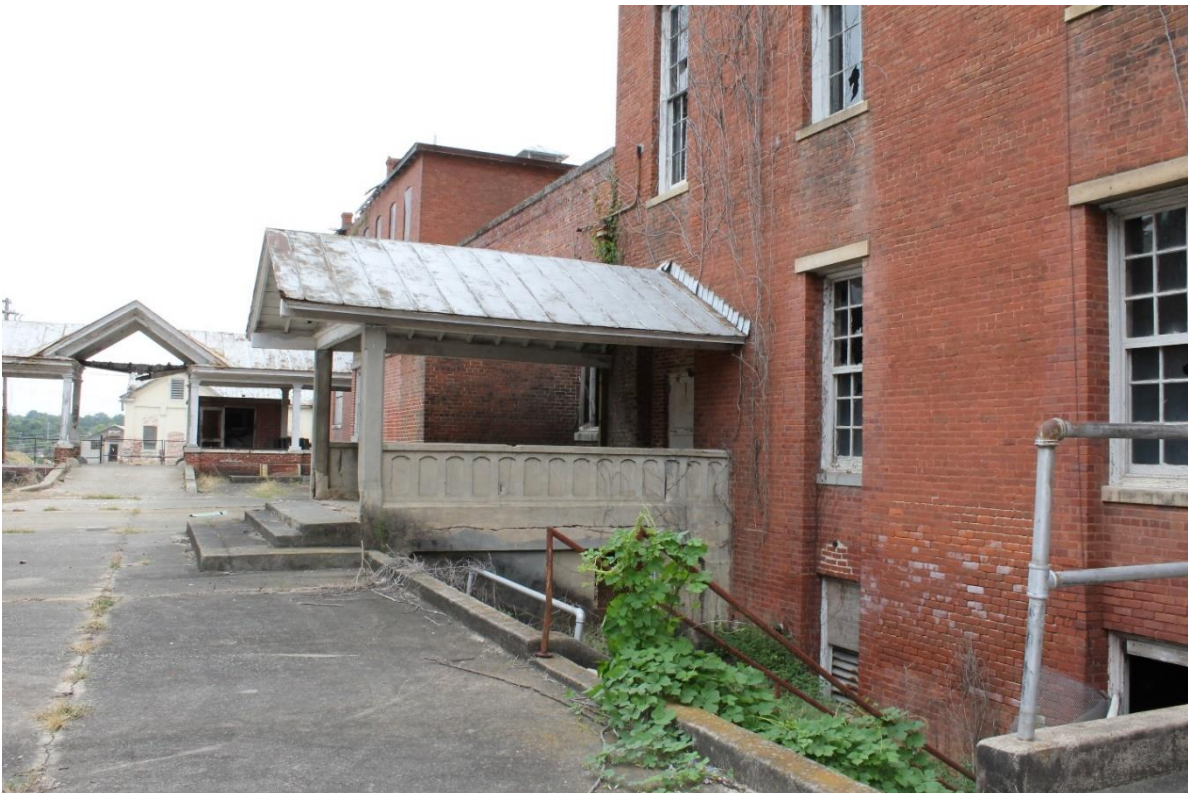
20. Porches on northern side of center block, view to the east

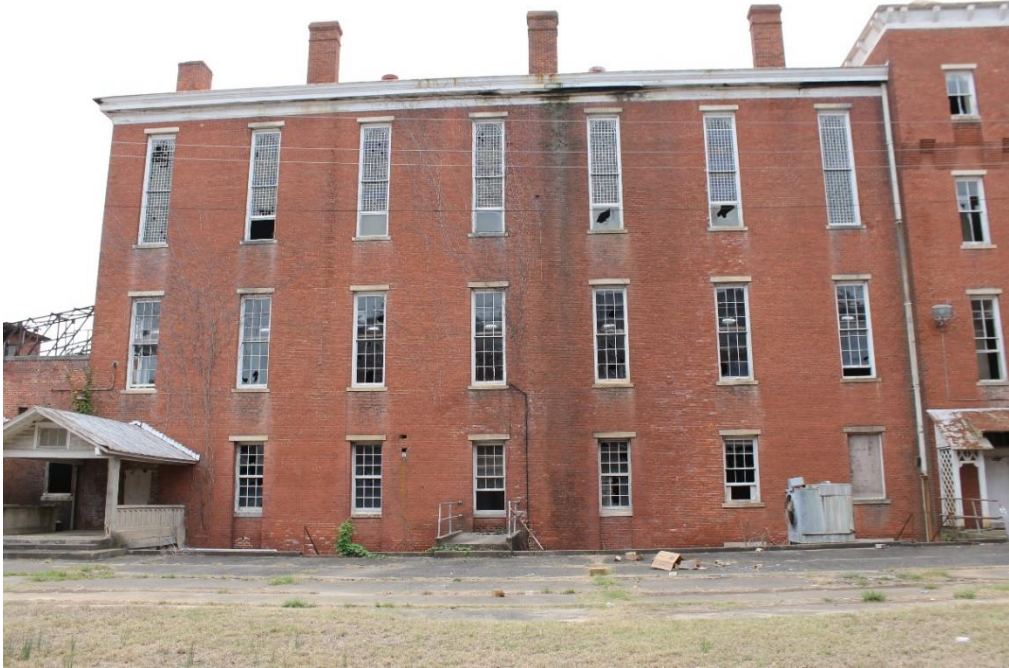
21. Northern side of center block, view to the south

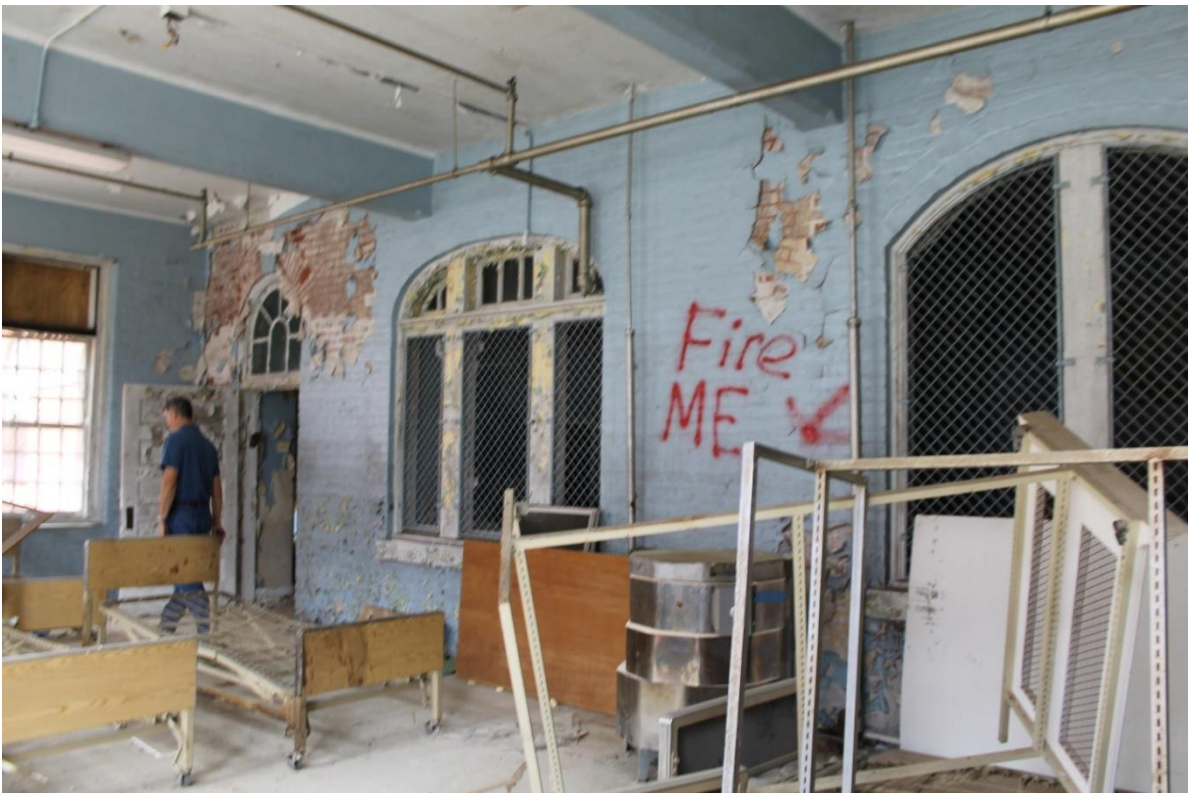
48. Northern section, east/west block, former exterior wall now in sunroom, view to the northwest

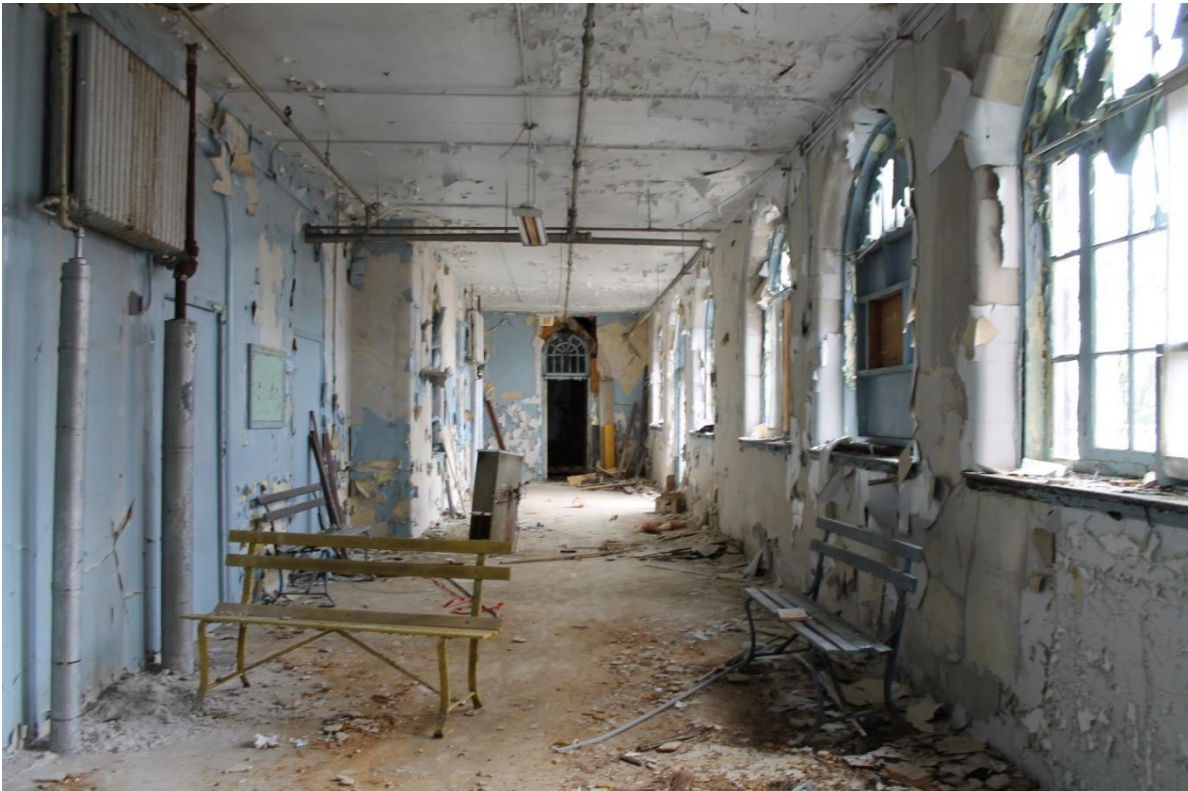
50. Northern section, sunporch added across rear of north/south wing, view to the north

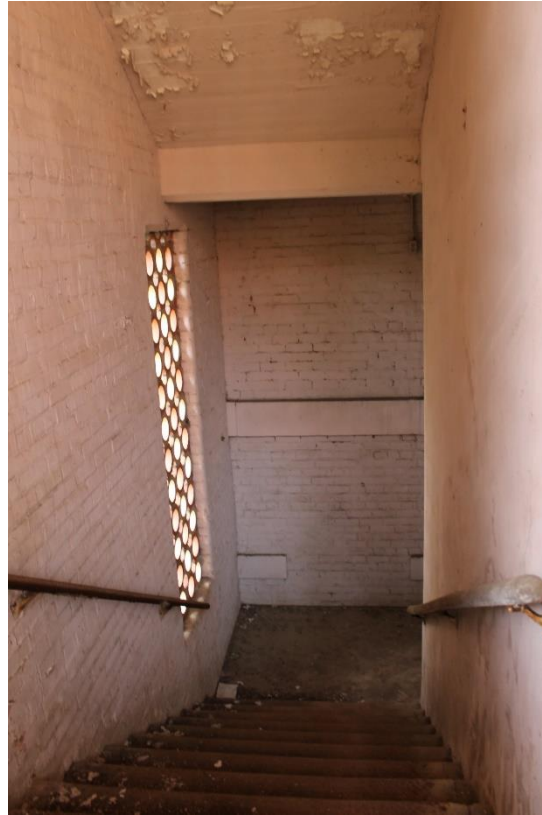
63. Sunroom addition stairs

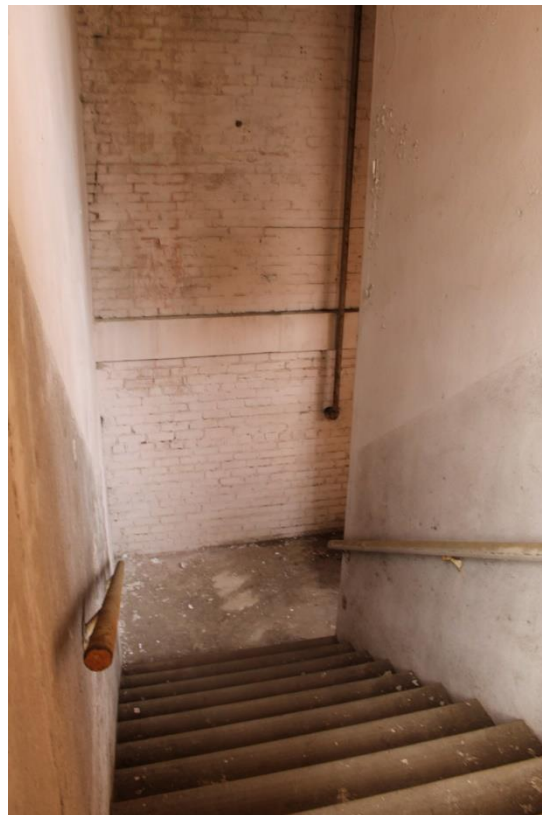
64. Stairs in sunroom addition

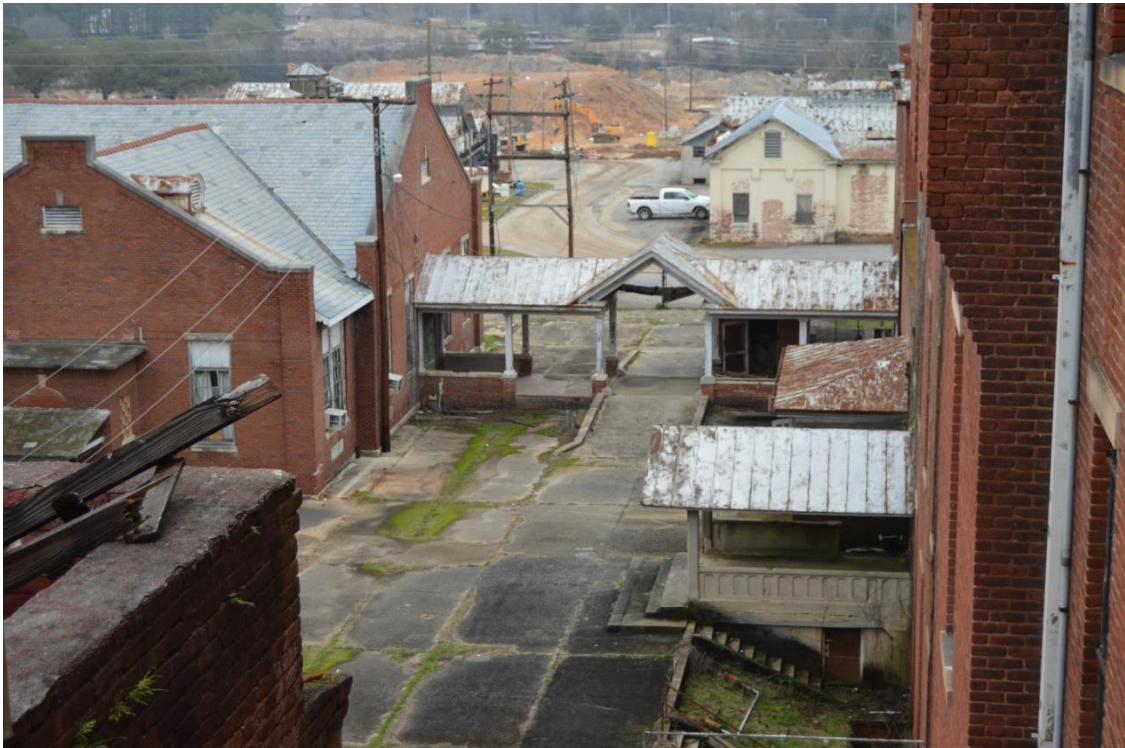
66. Hyphen between kitchen/laundry wing and women's dining hall, view to the east

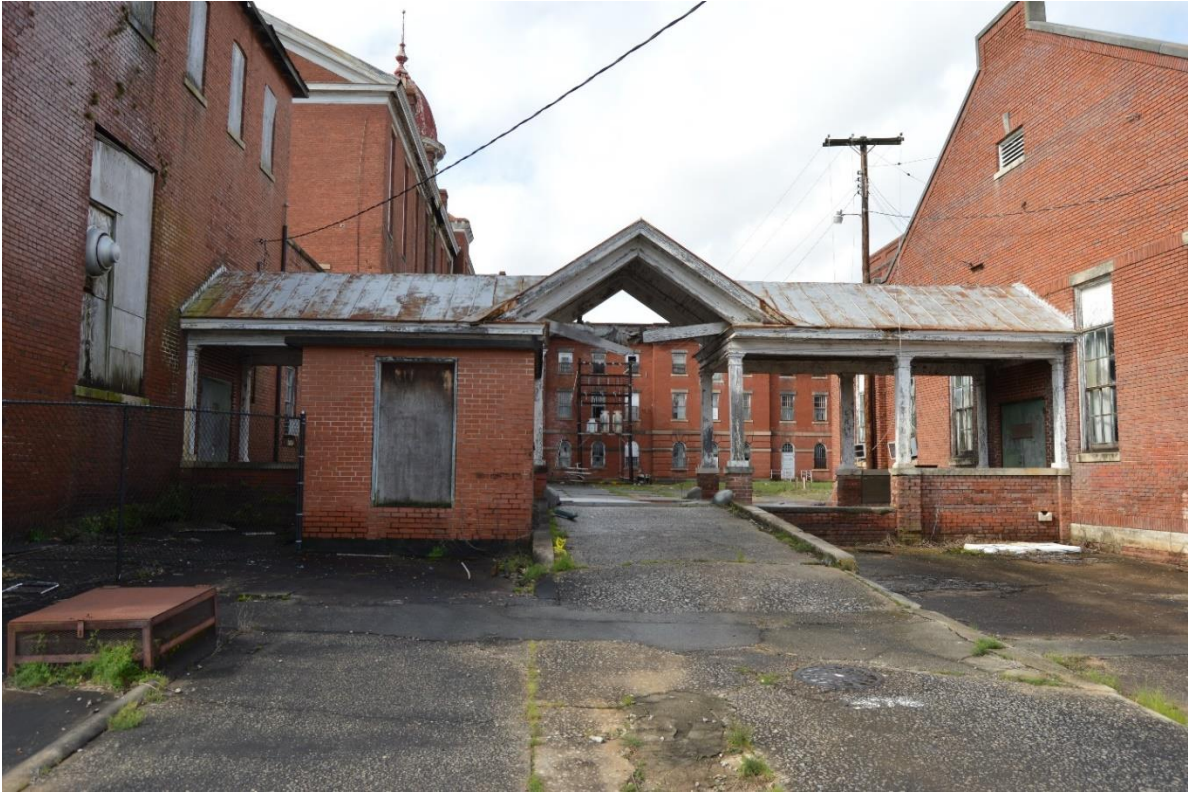
67. Rear view of hyphen between center kitchen wing and women's dining hall, view to the west
