## D/DRC Case

2150 Harden Street

Individual Landmark and National Register Structure

**NATURE OF REQUEST:** Request for Certificate of Design Approval for exterior changes to a landmark and preliminary certification of the Bailey Bill

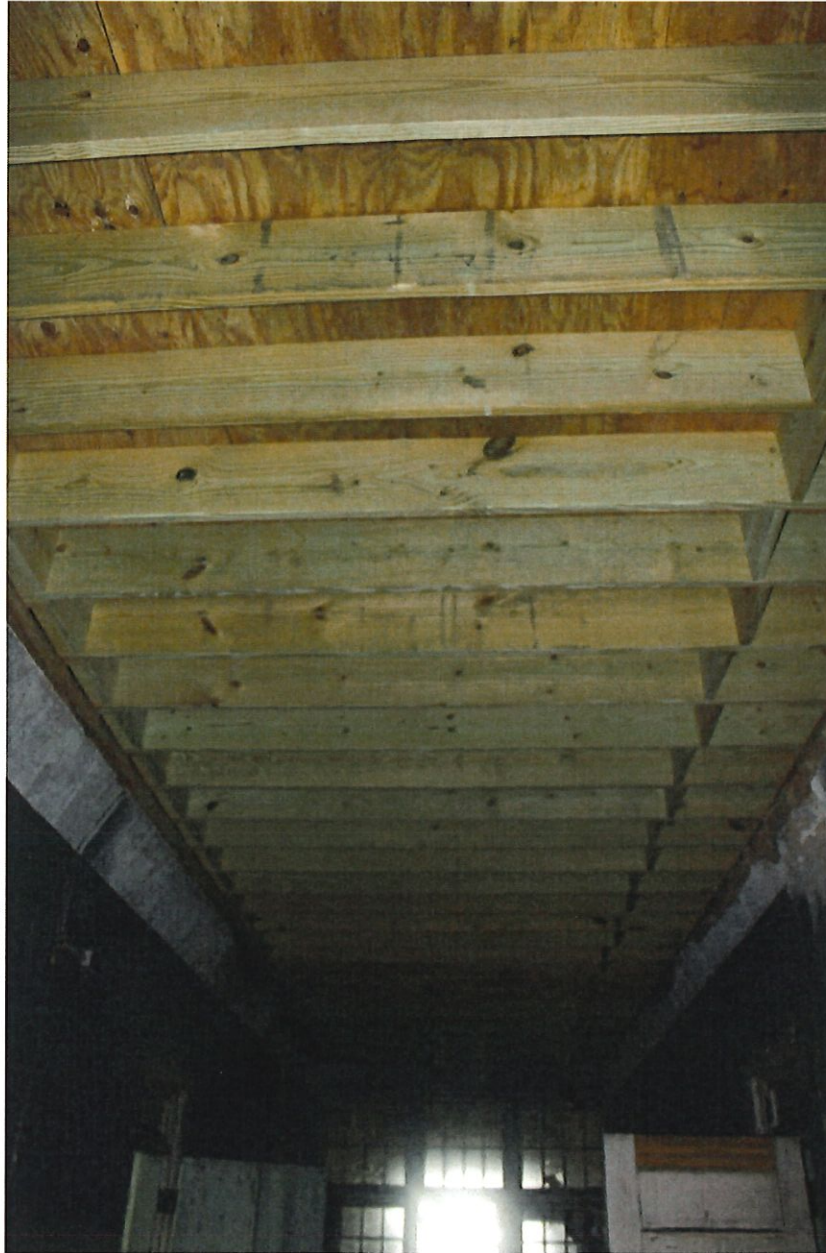
Photo 2 – Babcock Building  
2150 Bull St. Columbia, SC  
New ceiling joists where originals burned, third floor ceiling, southeast section of building  
8/15/2019

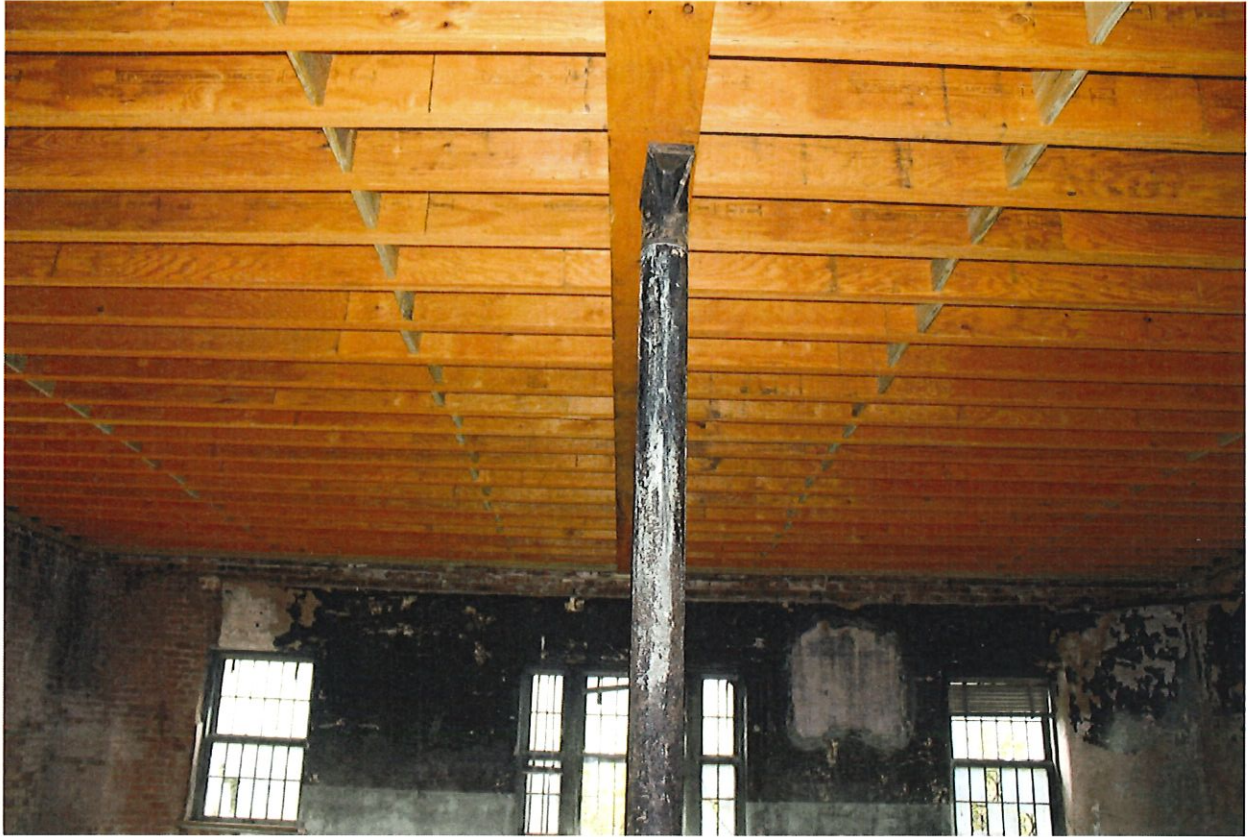
Photo 3 – Babcock Building  
2150 Bull St. Columbia, SC  
New third floor ceiling joists replacing burned joists  
8/15/2019

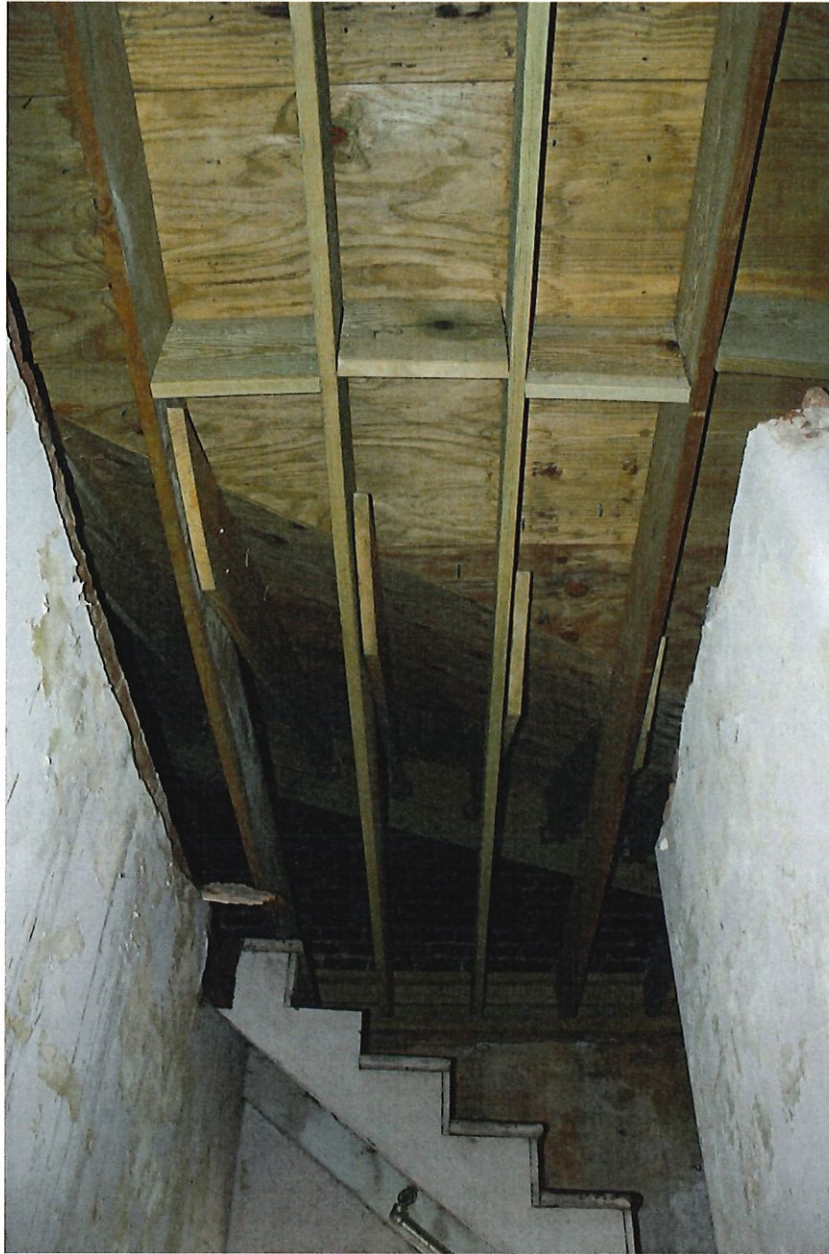
Photo 4 – Babcock Building  
2150 Bull St. Columbia, SC  
New joists and ceiling system in stairwell  
8/15/2019

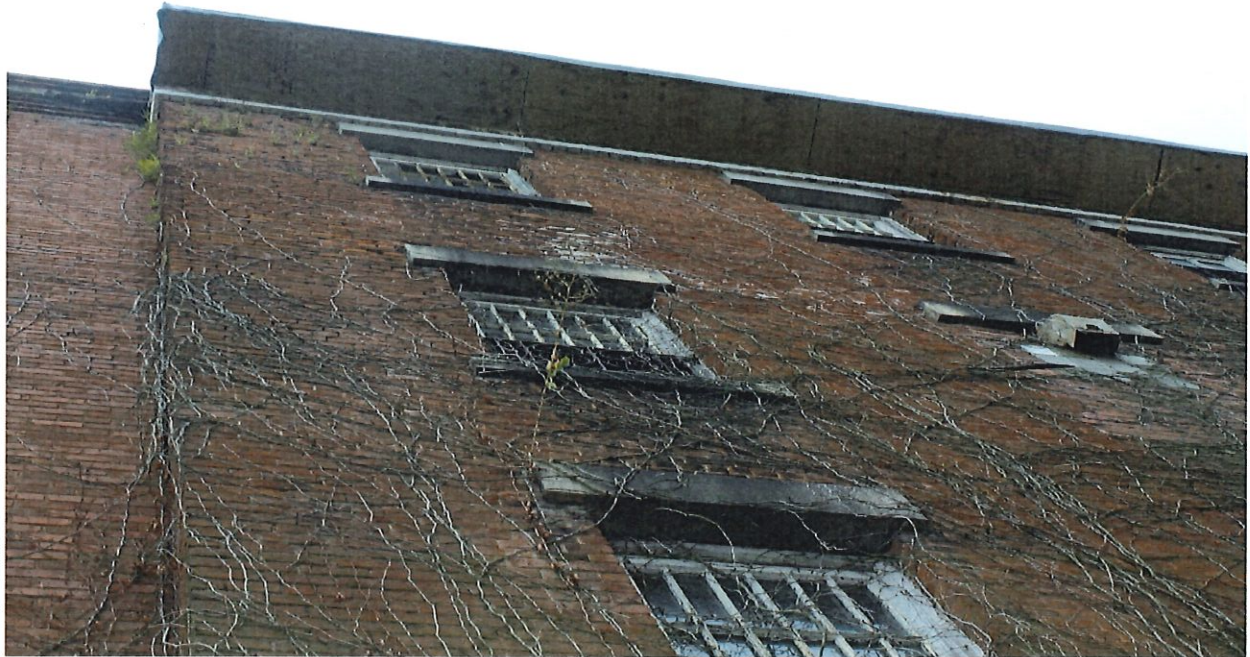
Photo 5 – Babcock Building  
2150 Bull St. Columbia, SC  
New, temporary eave, southeastern corner of building  
8/15/2019
