# D/DRC Case

1219 Assembly Street

National Register Structure, City Center Design/Development District

**DESIGN/DEVELOPMENT REVIEW COMMISSION**  
**DESIGN REVIEW DISTRICT**  
**CONSENT AGENDA**  
**EVALUATION SHEET**  
Case # 5

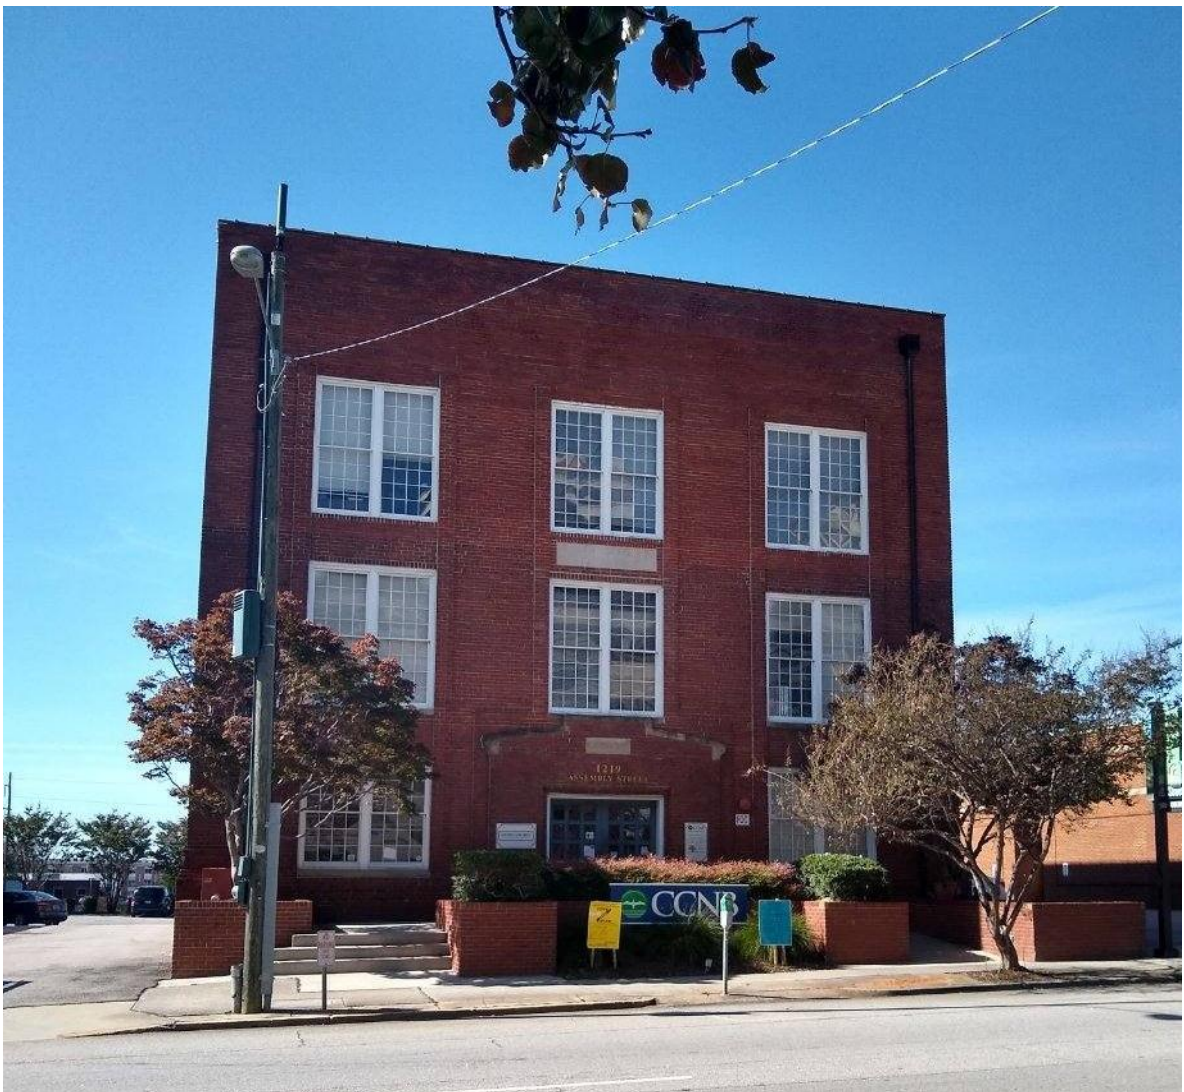
1219 Assembly, front, photo by staff

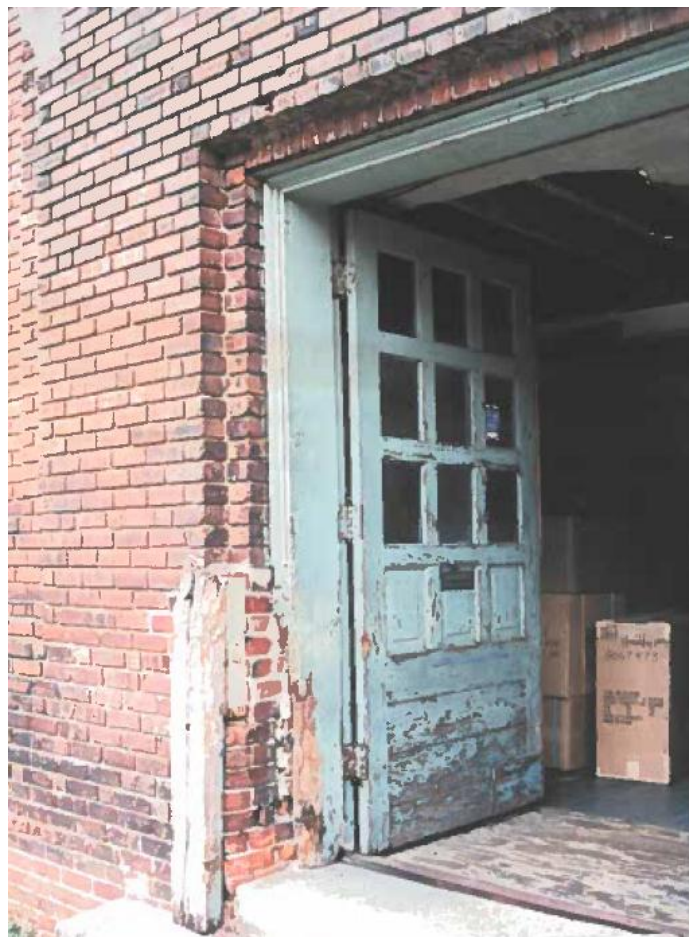
1219 Assembly, original door, image courtesy of SHPO

The front door of the building is either the original front door or is a good replica of the original/historic 9-light door; the proposed new front door is an 8-light, full glass door, not matching the old door and therefore not in keeping with this standard. As such, staff recommends altering the proposal for the front door: if additional investigation finds the door is original, the front doors should be maintained and repaired with modifications to meet modern code; or, if the front door is found to be non-original, the front door may be removed with a new door fabricated to replicate the historic 9-light door.

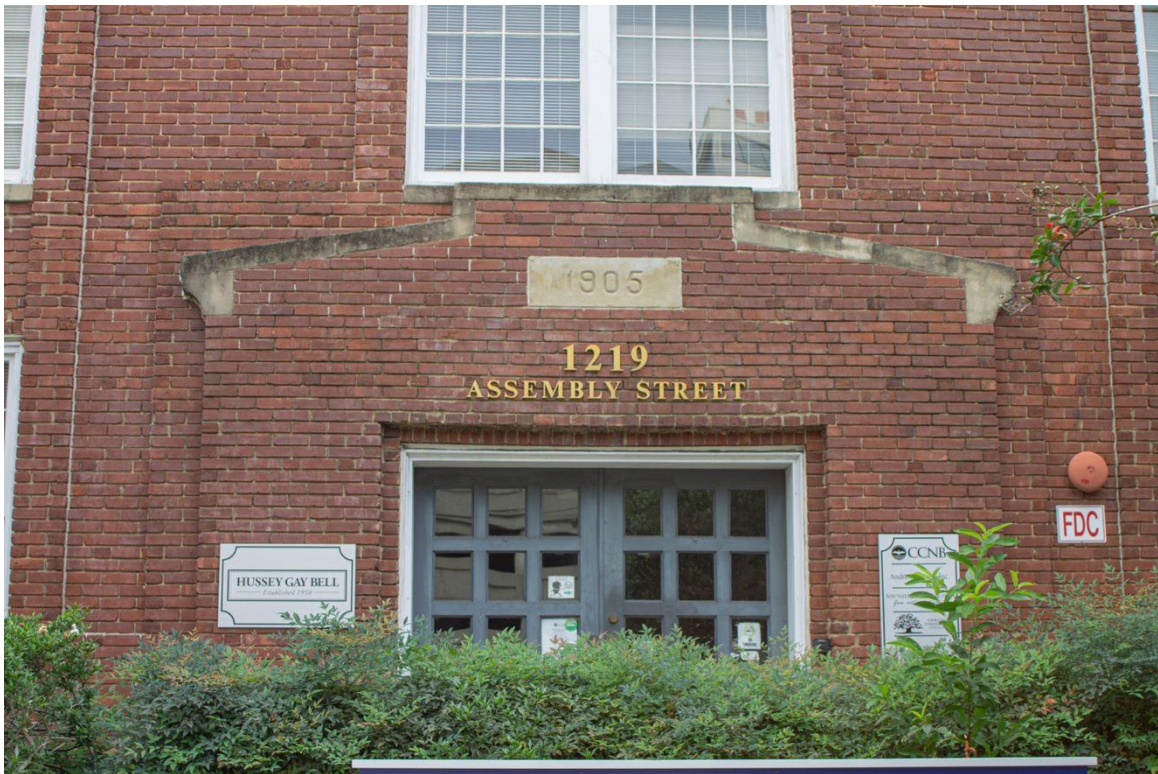
Photo 3 – Façade/East elevation (main entry detail view)

The non-historic, inward-opening, double front doors will be replaced by modern, outward-opening doors for code compliance. The proposed 8-lite glazing pattern will have a reflectivity harmonious with that found on the existing, 1998-era windows. All secondary doors on the northwest corner of the building will be removed and the created voids enclosed for construction of interior walls in the proposed addition.

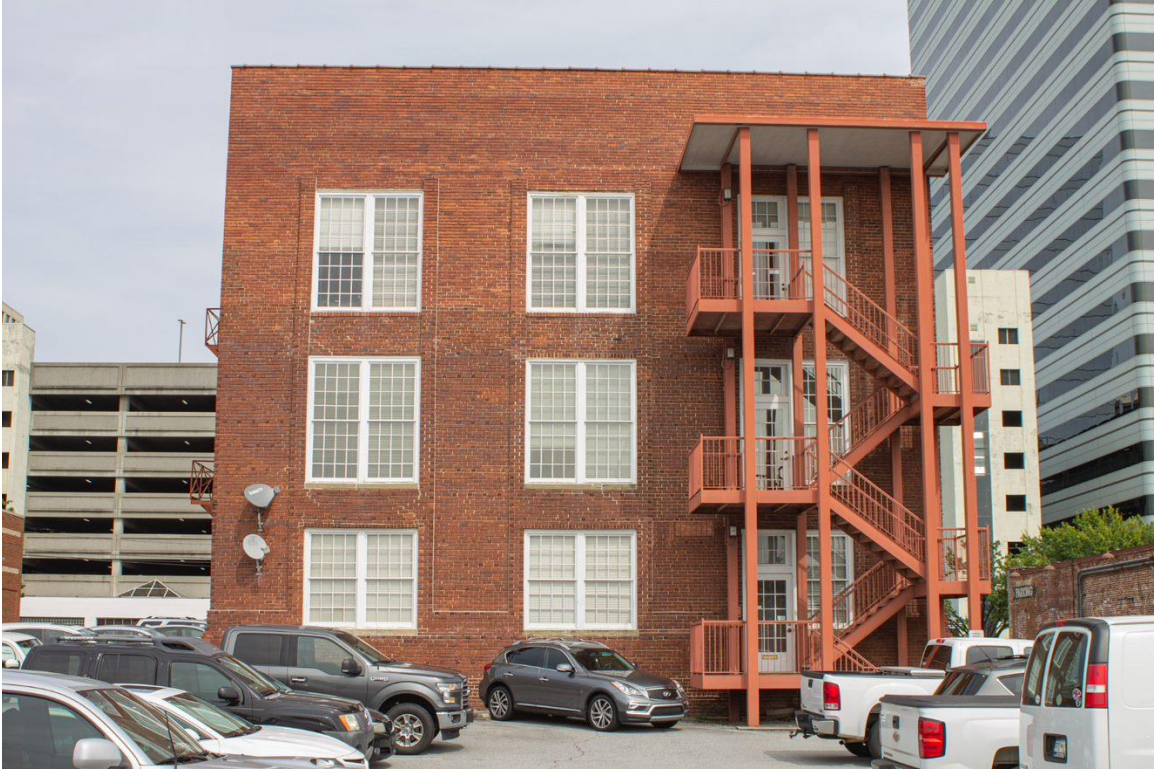
Photo 6 – West elevation illustrating three-story structural steel staircase.

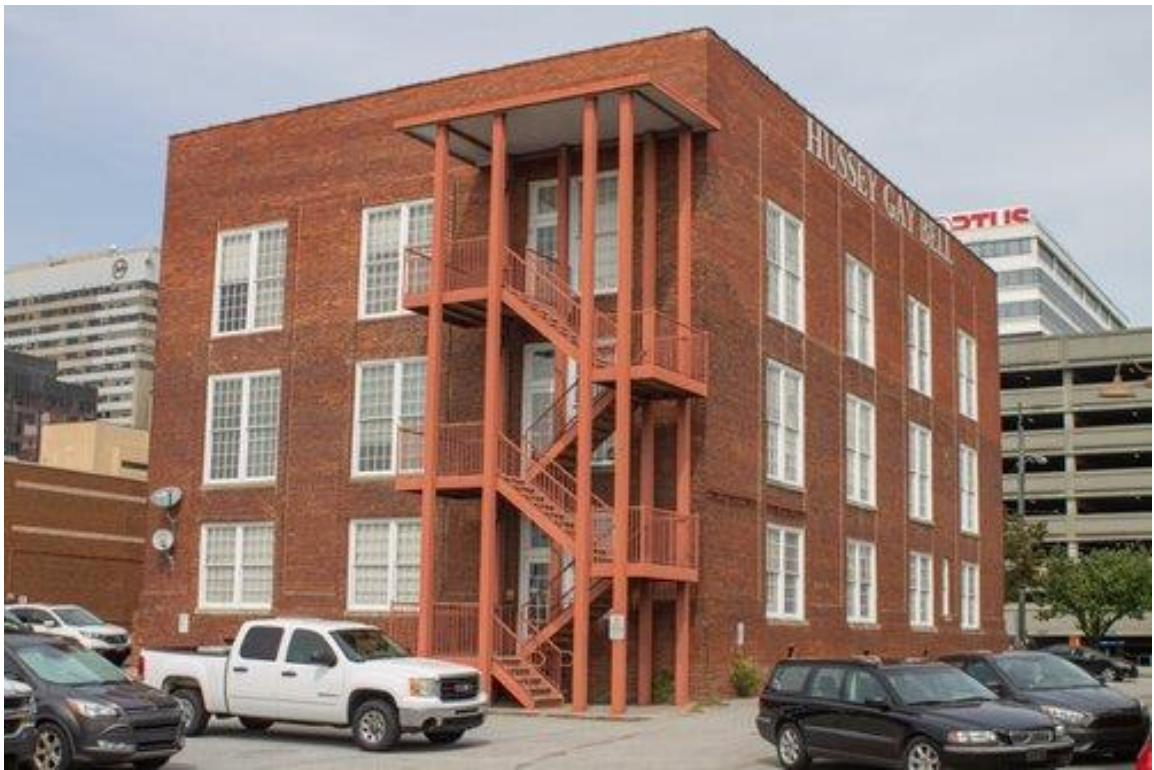
Photo 7 – West elevation & south elevation (southwest oblique view). Note visual vertical emphasis created by placing windows in one-half-depth brick butters/projection.

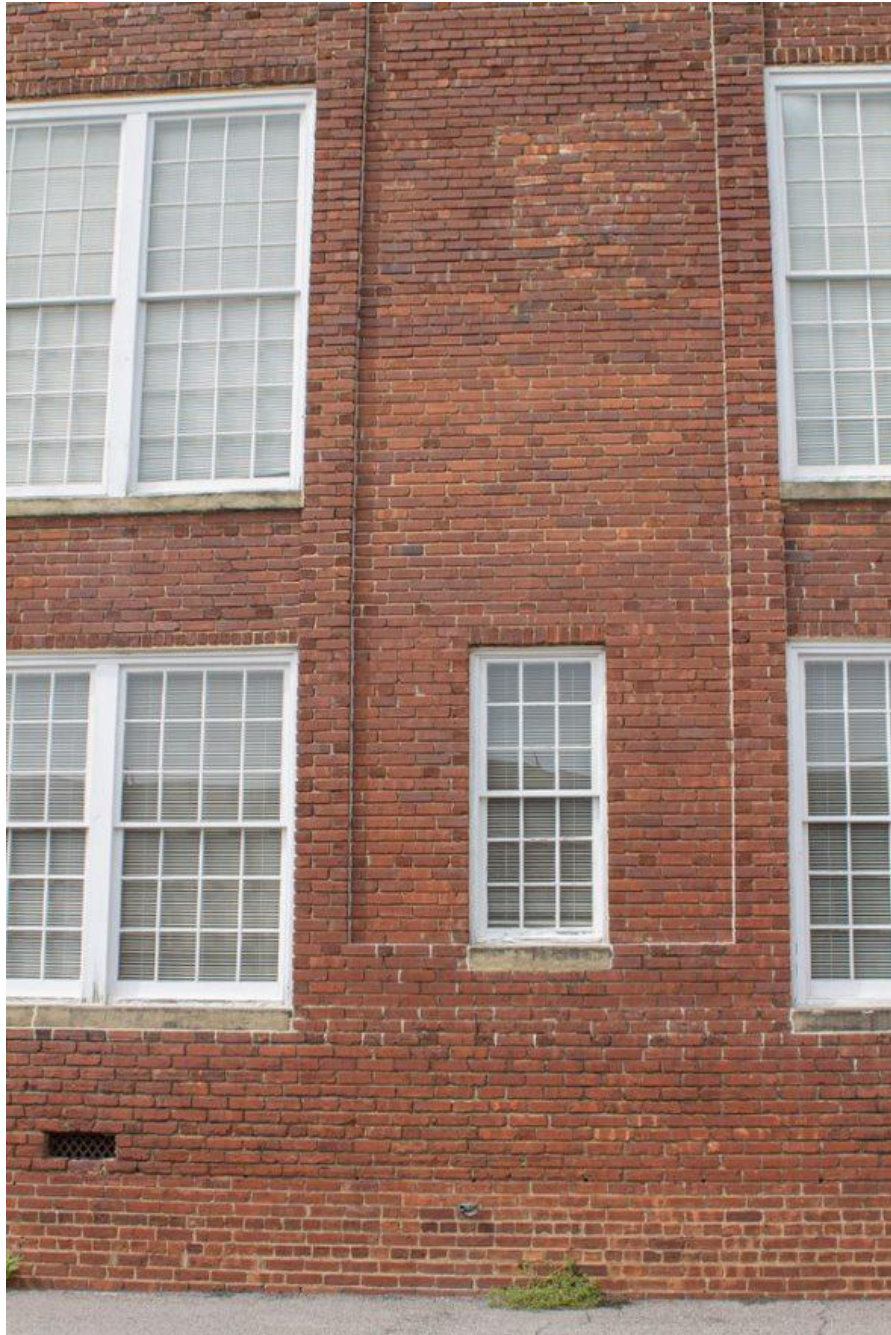
Photo 8 – South elevation illustrating general 1998-era window composition and appearance and singular exceptional window. Note 7/1 Flemish bond brick pattern with contrasting headers to stretchers and discoloration from earlier masonry patching between second-story windows.

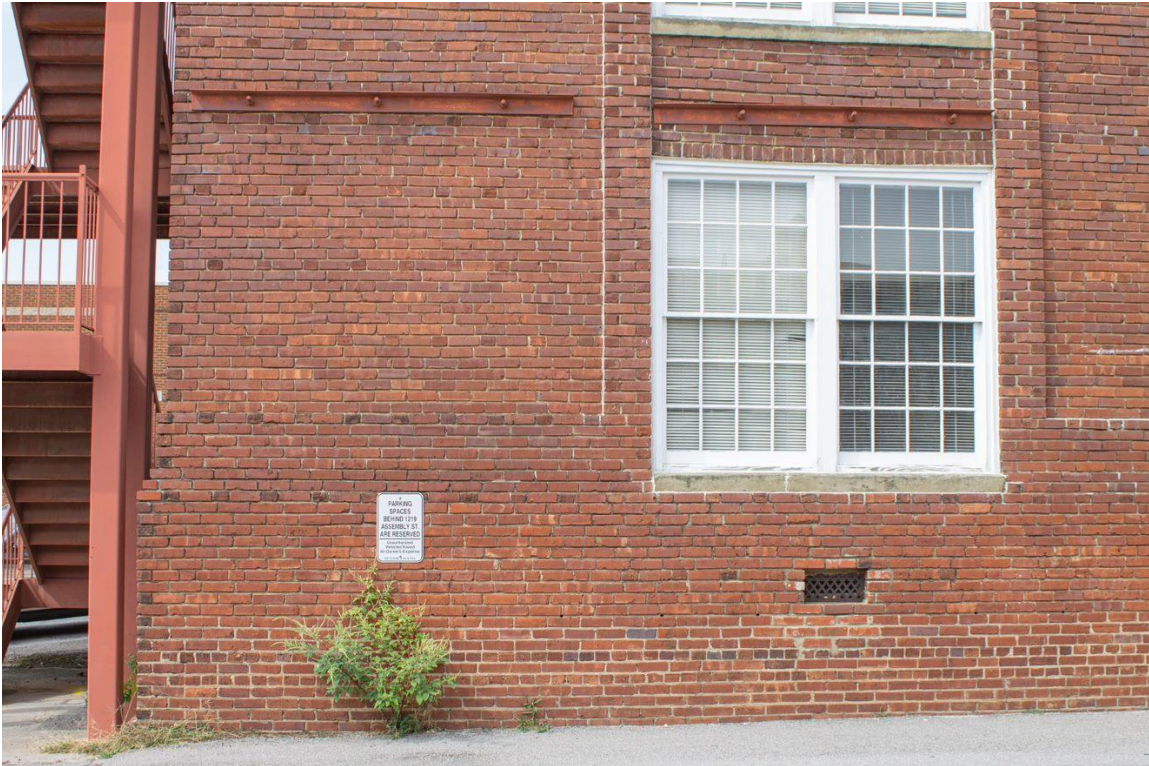
Photo 9 – South elevation detail. Note L-angle steel supplemental structural supports.

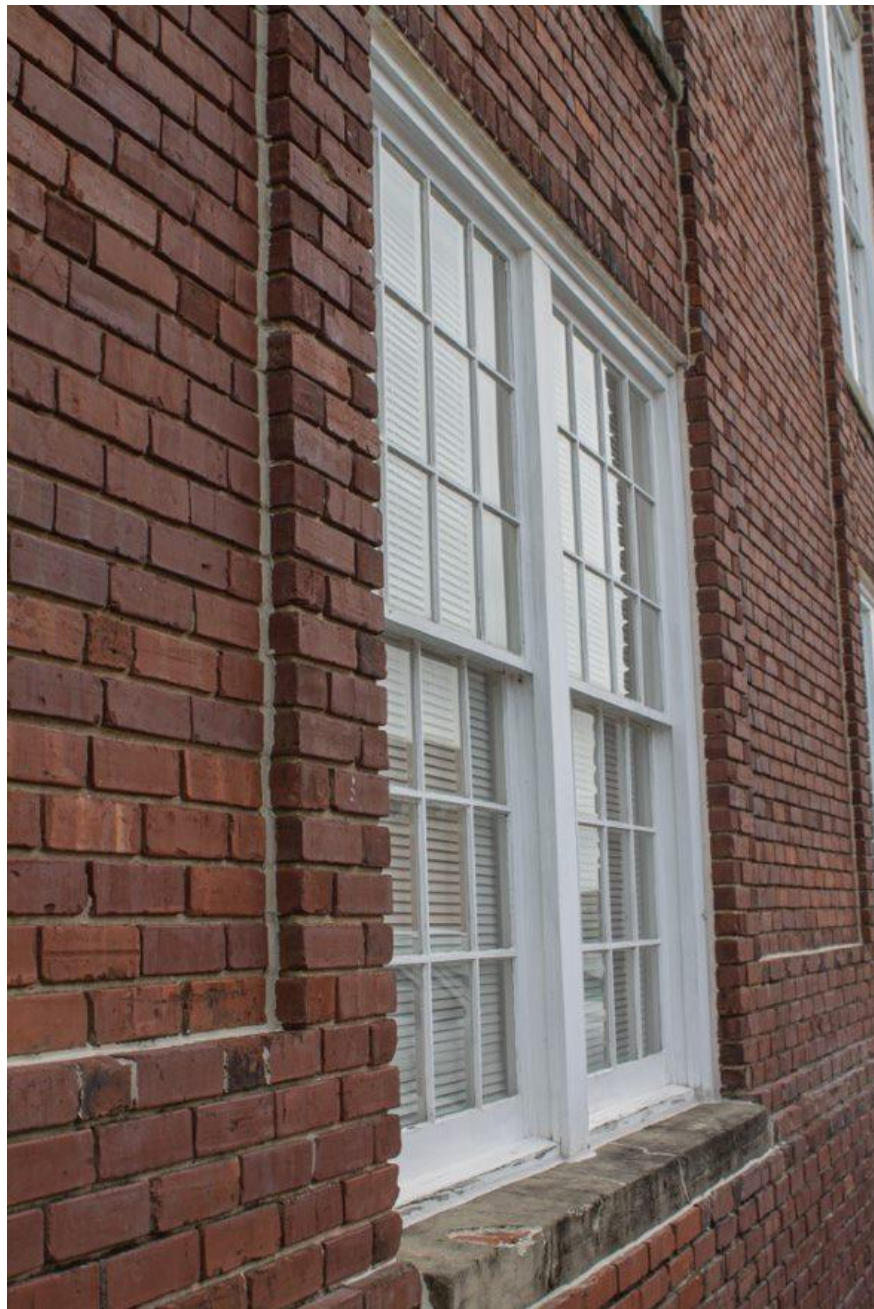
Photo 12 – North elevation detail. Note 1998-era windows, chipped, concrete-parged, masonry windowsill and caulking used in joint between wall face and in one-half-depth brick buttress/projection.

The entirety of the building's masonry will be cleaned with a mild detergent and re-pointed with a rake joint using mortar consistent in color and composition to original materials. Damaged concrete-parged masonry window sills will be repaired.

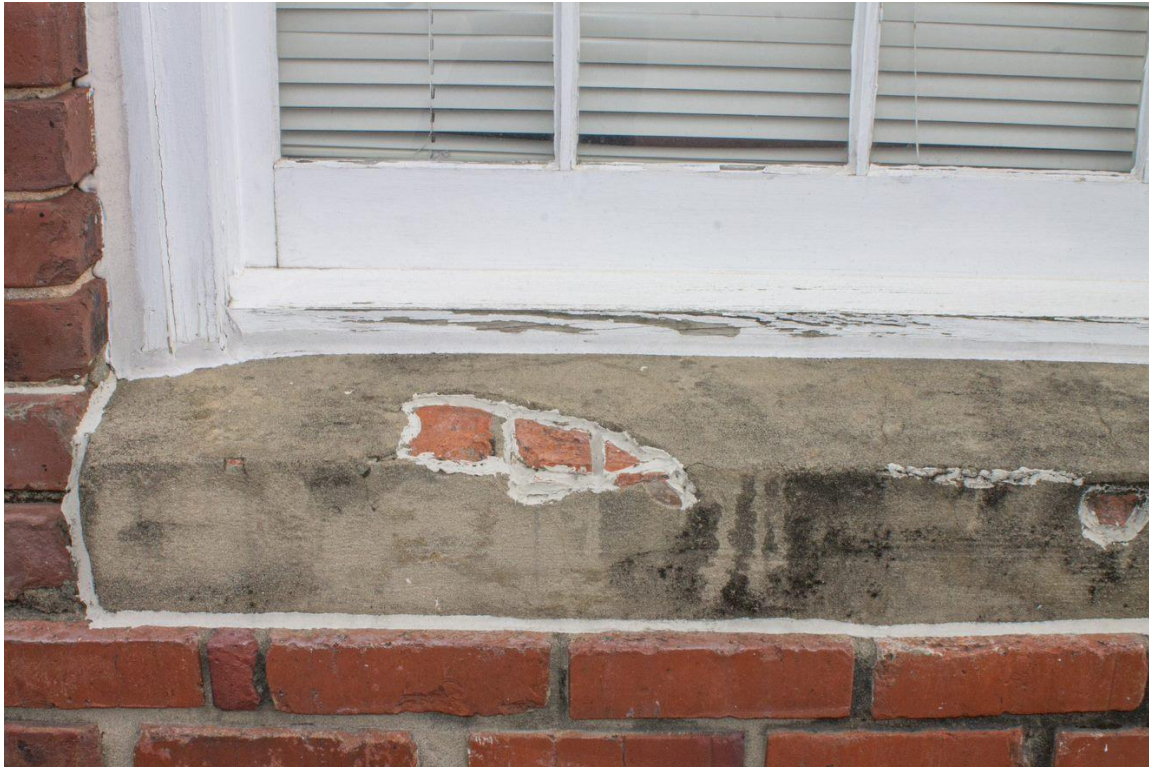
Photo 13 North elevation detail. Note 1998-era wood window and chipped, concrete-parged, masonry windowsill.

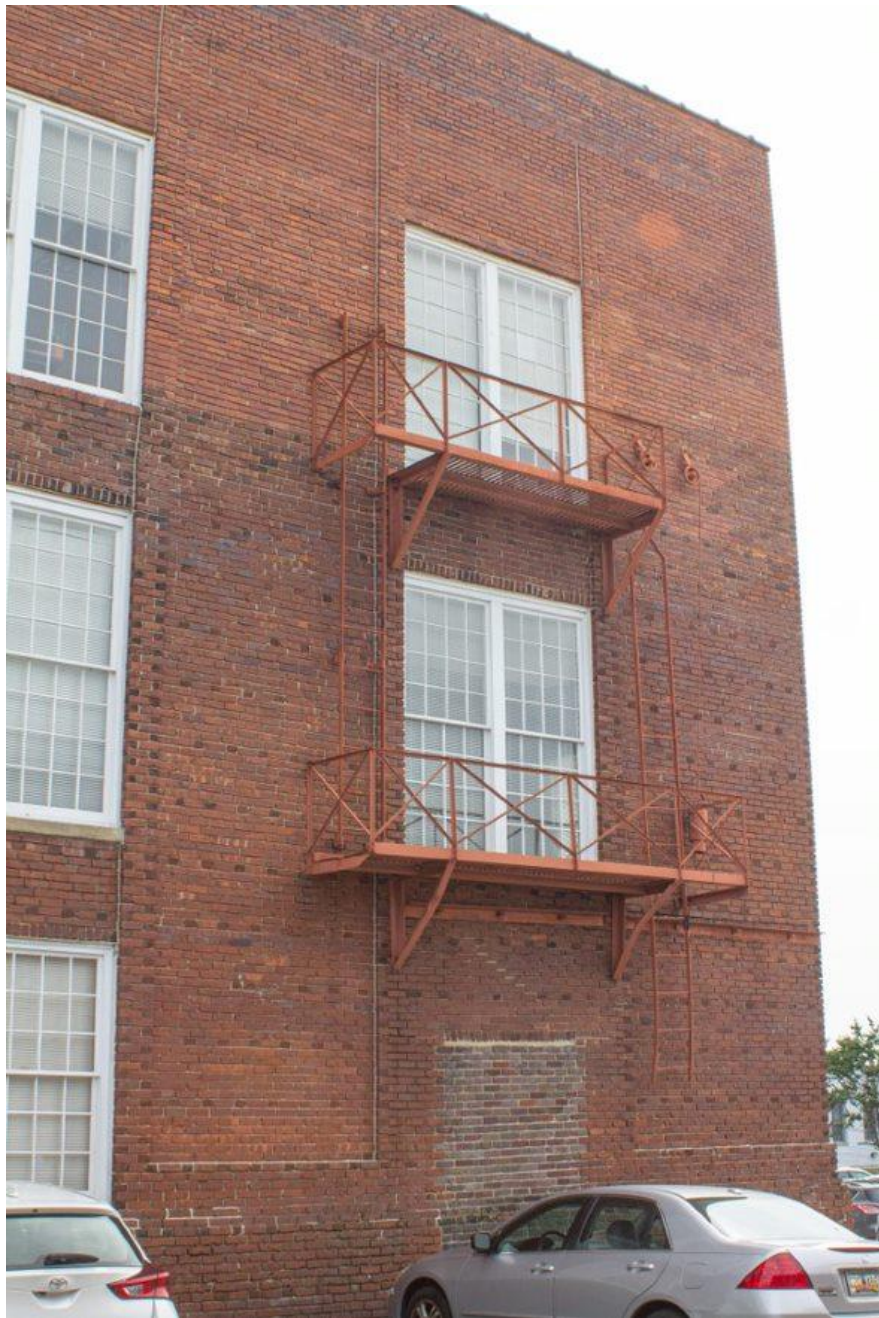
Photo 14 North elevation detail. Note ca.-1933 fire escape and visually contrasting, early masonry infill on first story and steel L-angle structural supplemental support.

The historic fire escape's metal will be cleaned of loose paint through a non-aggressive method using a wire brush and sealed with one coat of primer and two coats of enamel paint.

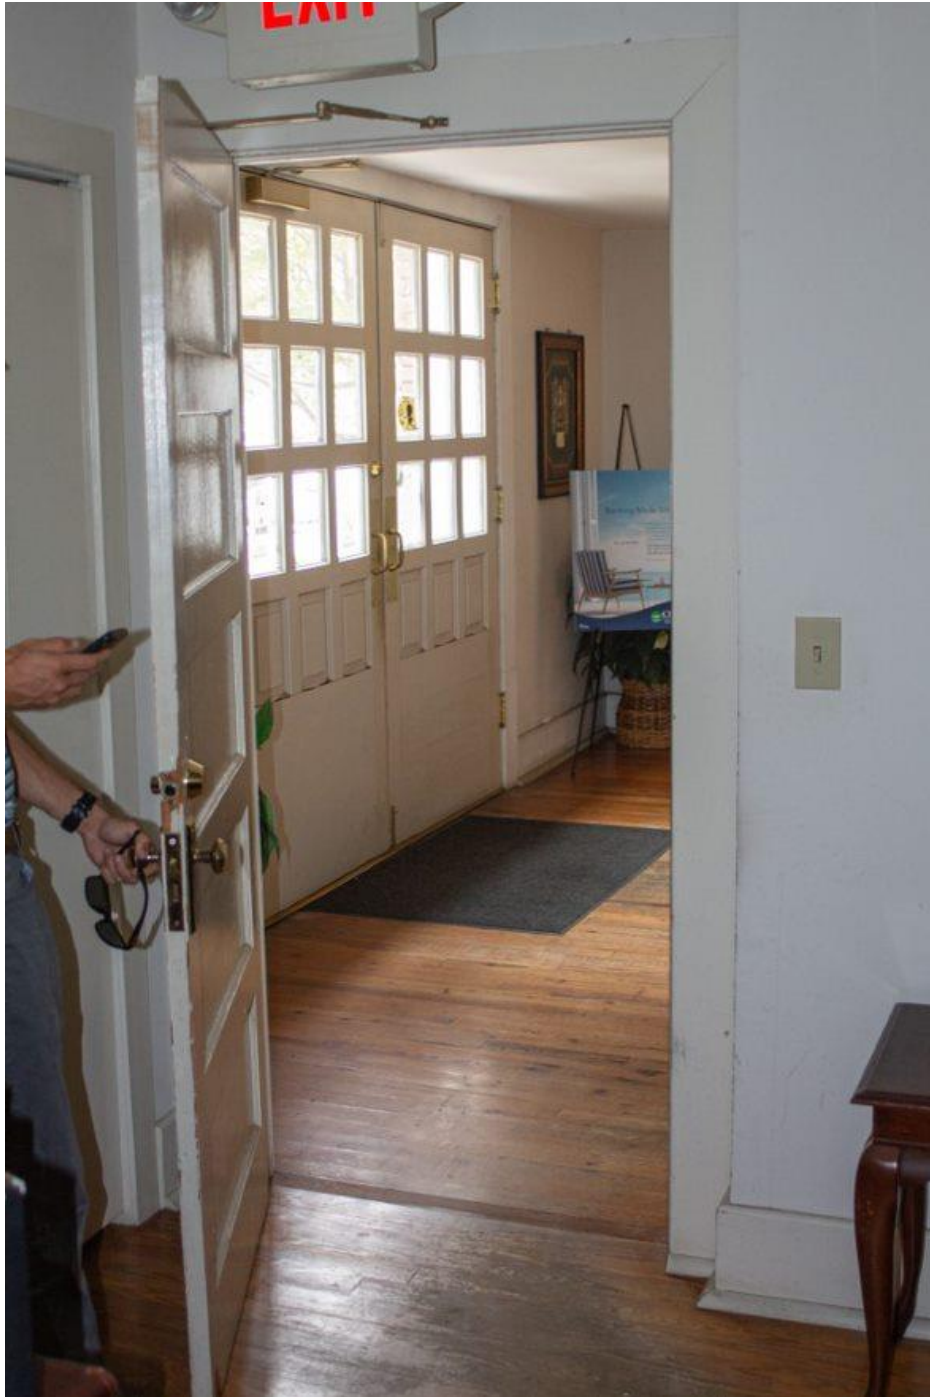
Photo 17 Front entrance detail, taken from the perspective of the northeast, first-story office looking south. Note ca.-1998 double-door, original floorboards, and historic interior door.

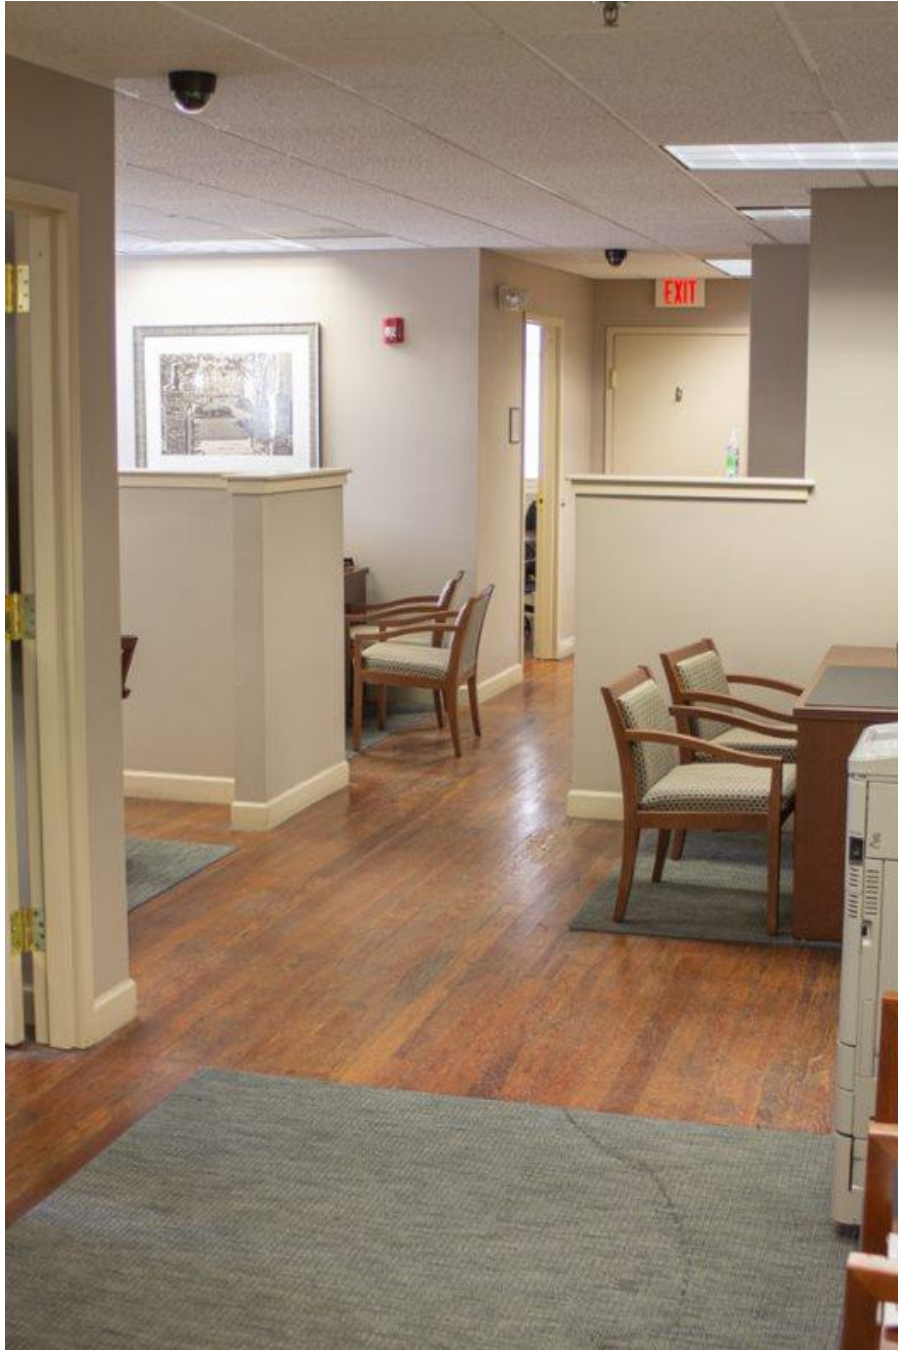
Photo 22 Southwest office detail, taken from the perspective of the southeast, first-story office looking west. Note single-door exit to west hallway, acoustic tile drop ceiling, and original hardwood floors.

Rehabilitation for use as a hotel will involve the removal of all existing acoustical tile and gypsum board drop ceilings, thus revealing the building's historic bead-board ceilings. Where necessary, damaged bead-board will be repaired with like-kind materials. All historic ceilings will be primed and painted. The building's trusses will be repaired as needed and repainted so that this character-defining interior element remains visible.

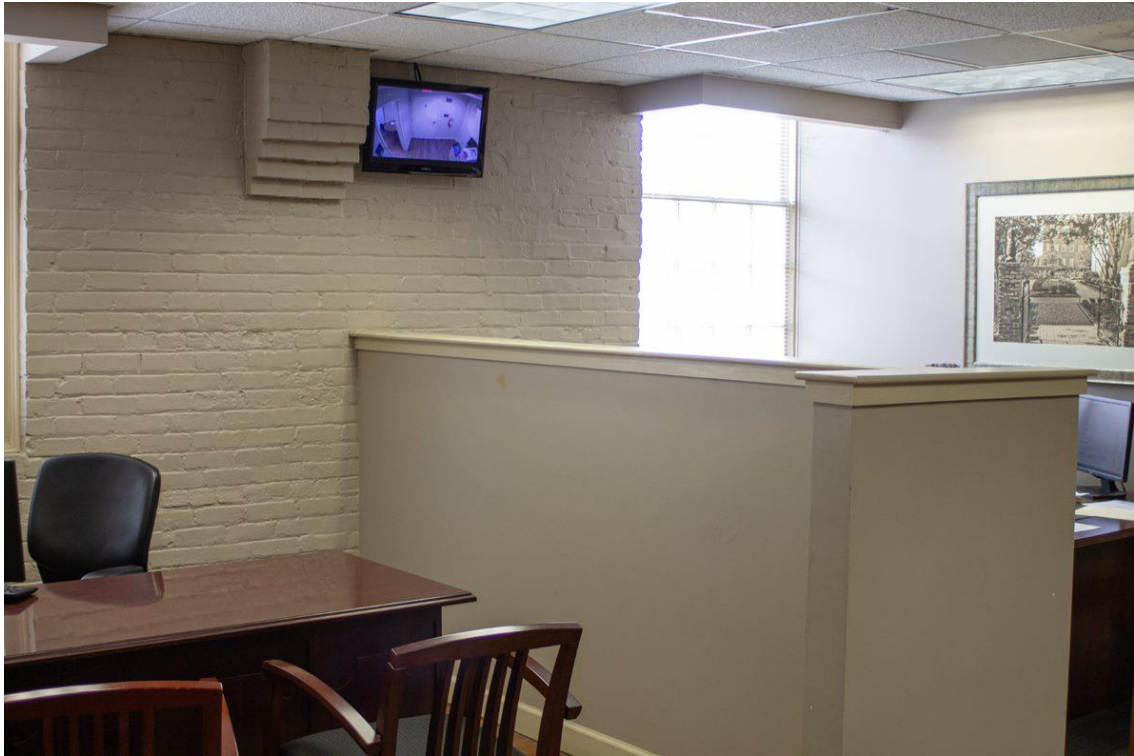
Photo 23 Southwest office detail. Note acoustic panel drop ceiling articulated to accommodate historic window height and corbeled brick terminus of second-story, narrow chimney originally used for coal-burning stoves.

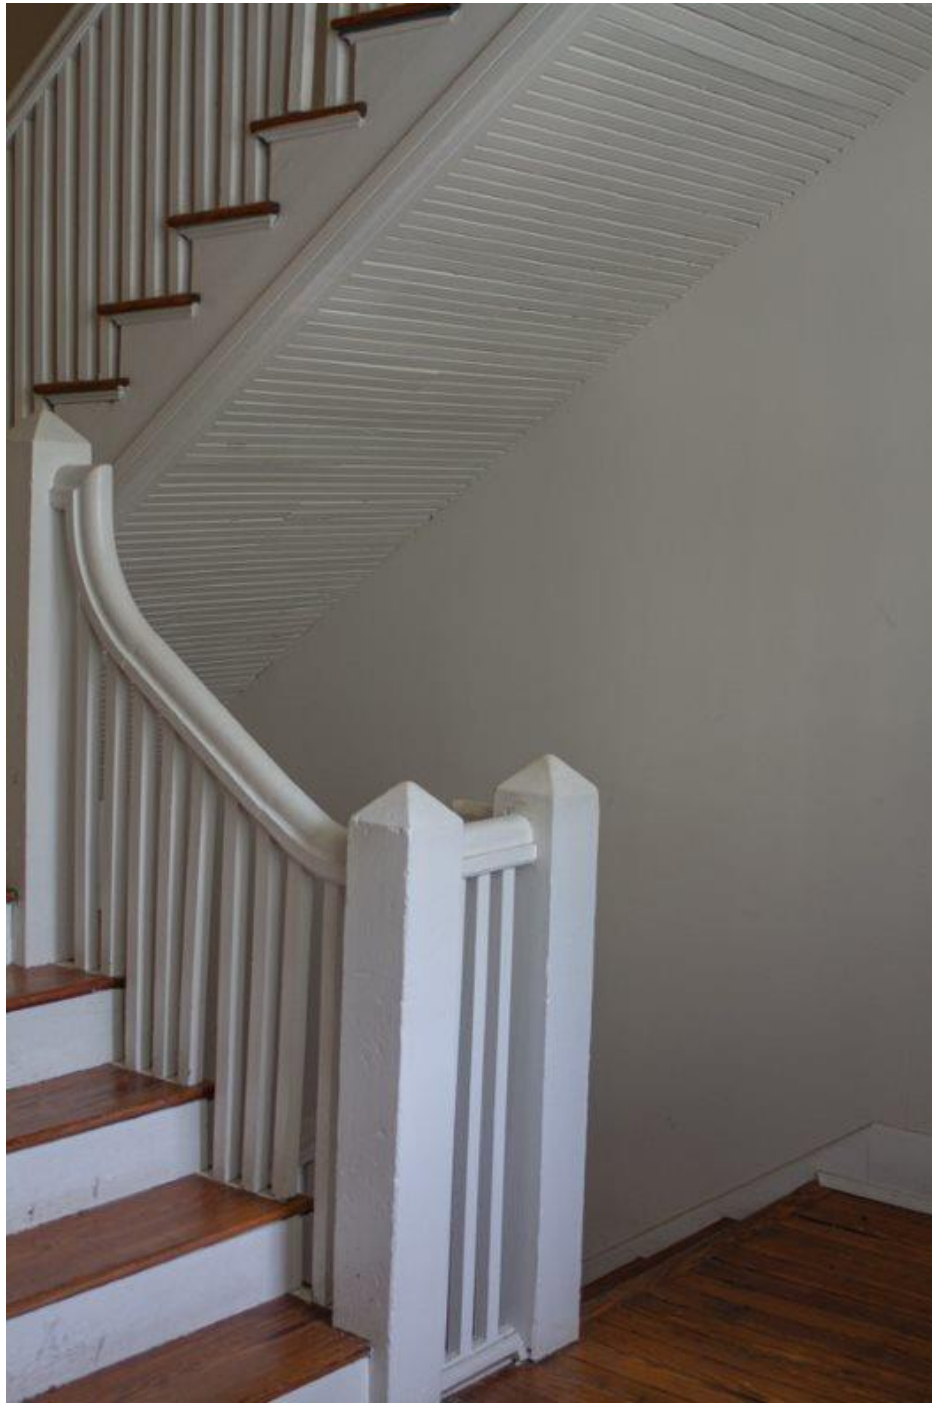
Photo 25 Second-story landing. Note original hardwood floors and staircase details including newel posts, balusters, and handrails.

The building retains its historic, three-story staircase. Its condition is good and has changed little since the property's 1998 rehabilitation. At that time the staircase risers, balusters newel posts, handrail, and exposed stringer bead-board ceilings were painted.

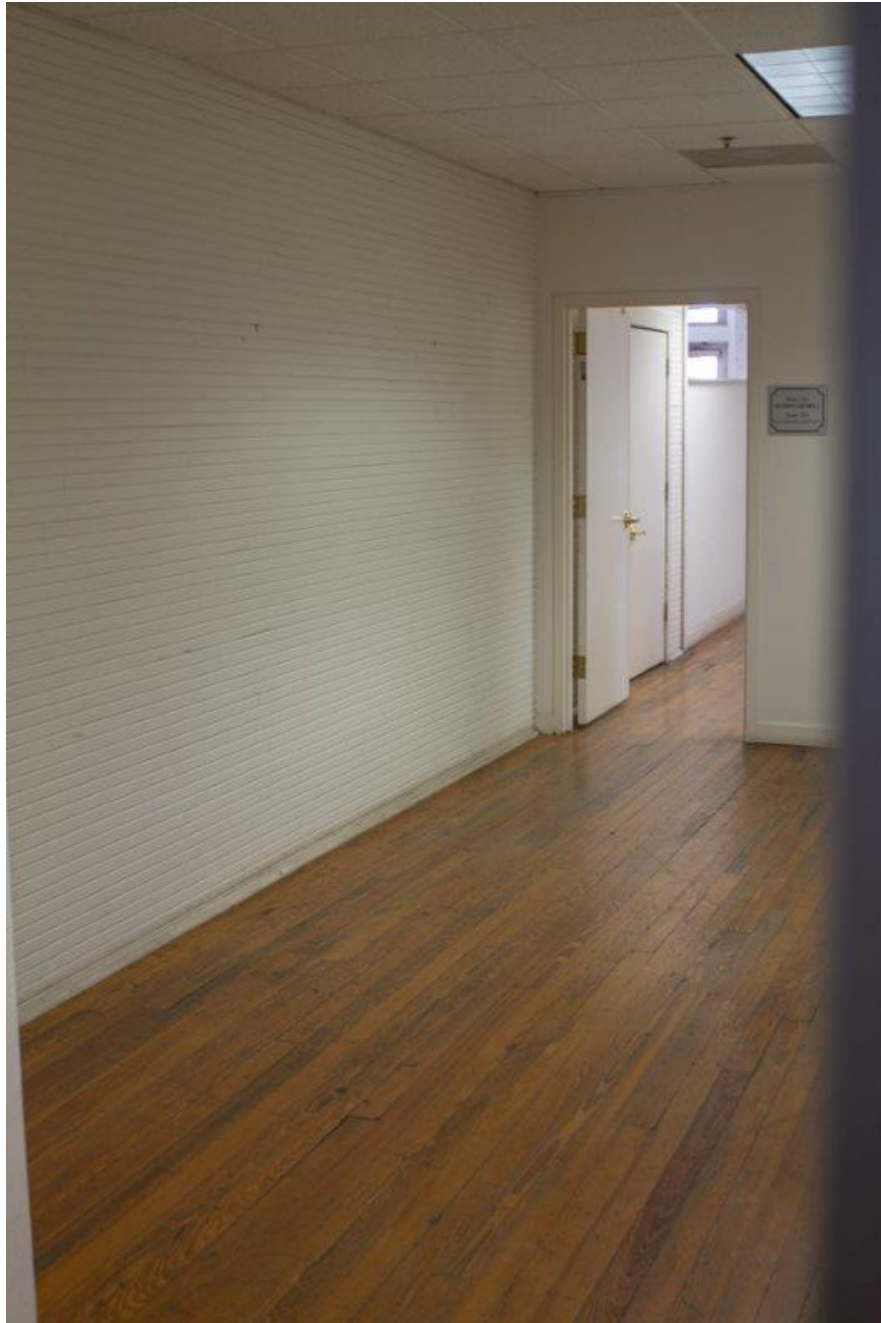
Photo 28 Second-story primary hallway. Note historic, vertically oriented, beadboard panel wall.

Rehabilitation for use as a hotel will involve the removal of 1998-era interior walls on three floors. Due to guestroom requirements, moderate portions of the horizontally oriented wood bead-board walls on the second floor and a very minimal portion on the third floor will be removed and the removed elements salvaged for use in new walls and for any repairs that may be necessary.

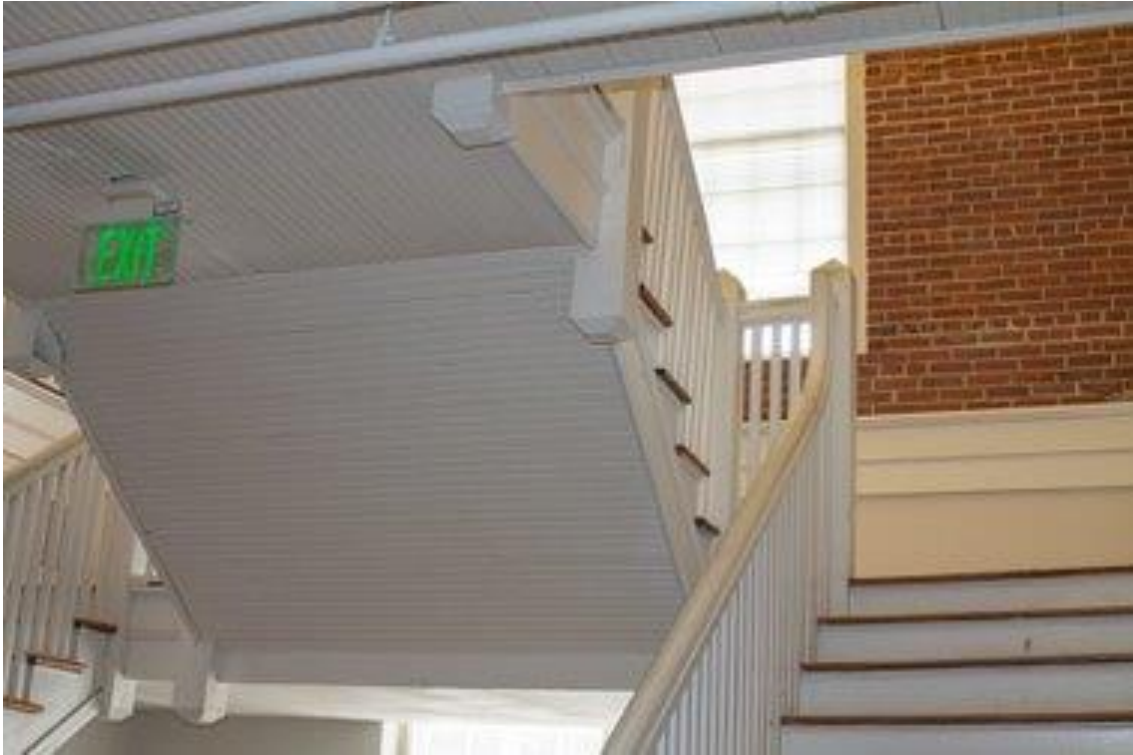
Photo 32 Third-story stair landing. Note exposed brick wall and beadboard on underside of stair stringer.

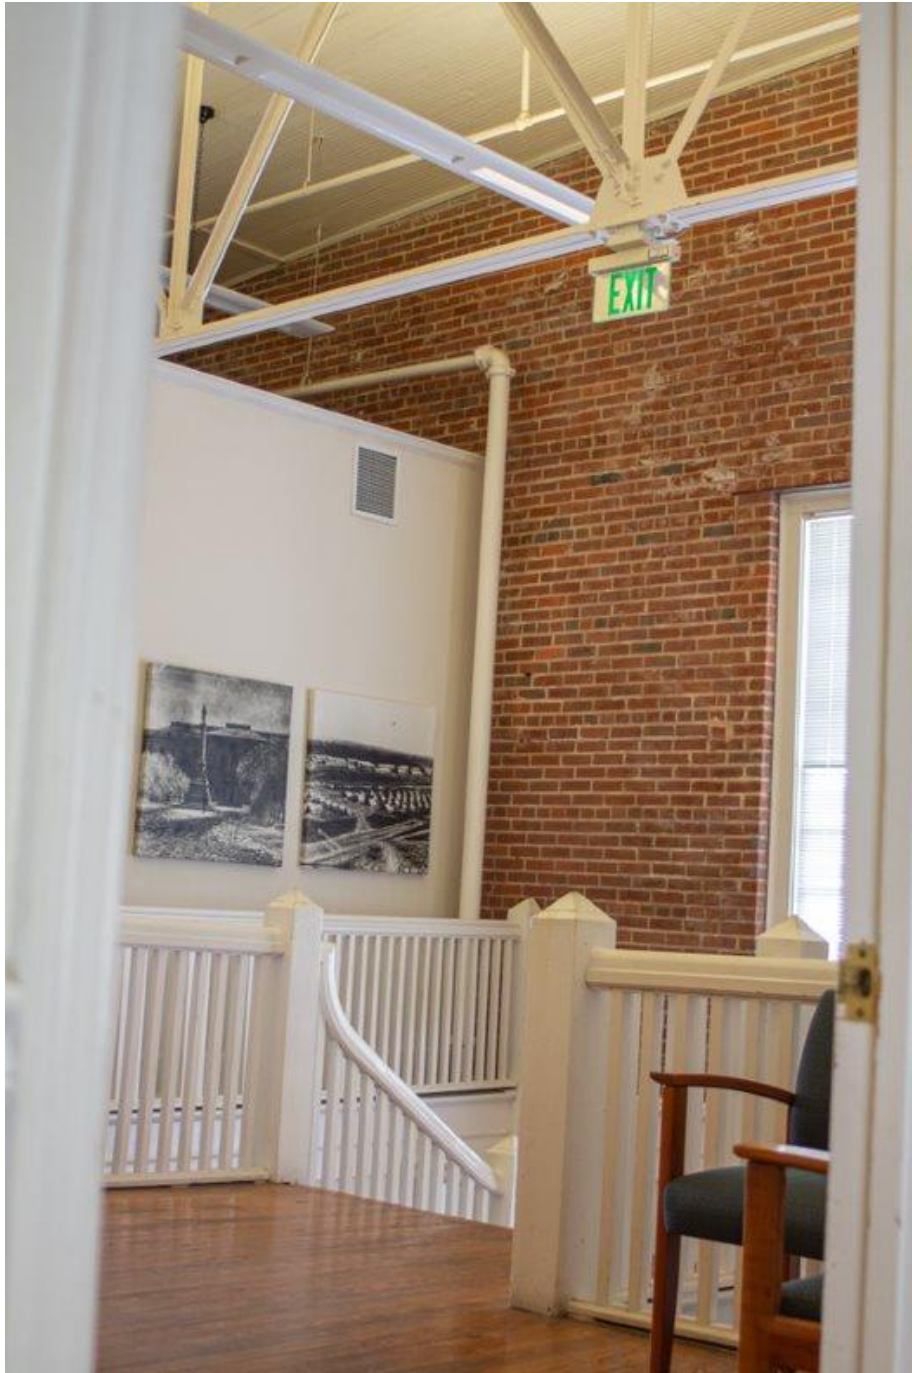
Photo 33 Third-story landing. Note original floor, exposed brick wall, balustrade, newel post and steel bow-truss details.

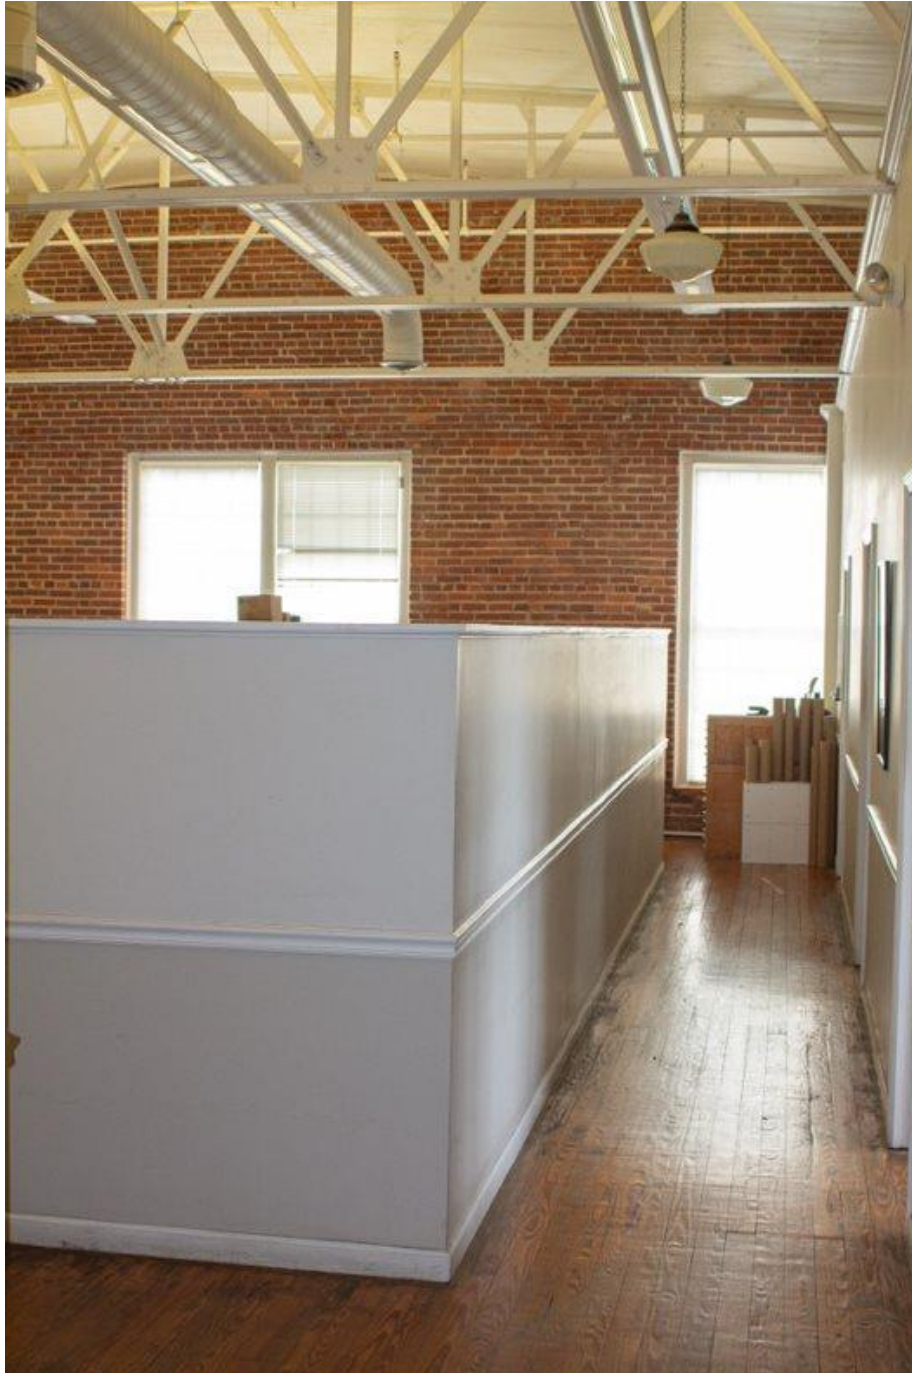
Photo 35 Third-story central office general conditions. Note steel bow-truss details, exposed masonry wall and original hardwood flooring.

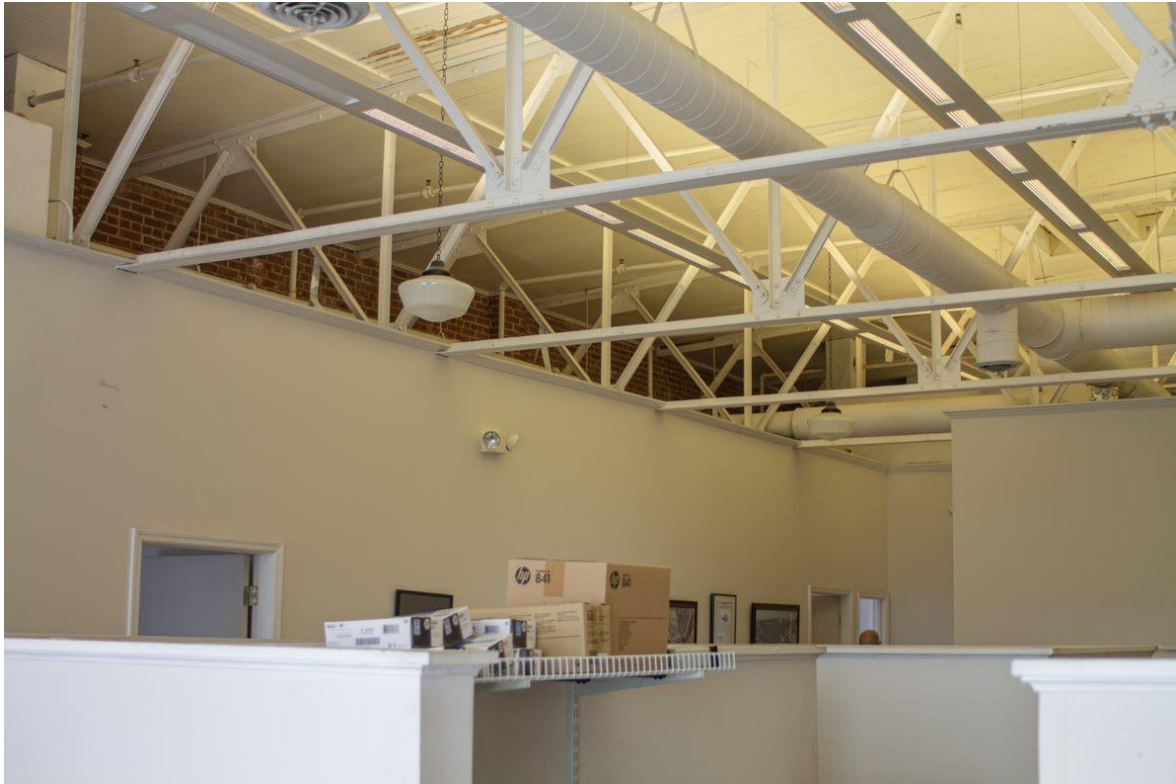
Photo 36 Third-story central office general conditions. Note steel bow truss details, exposed HVAC ductwork and historically inspired pendant lights.

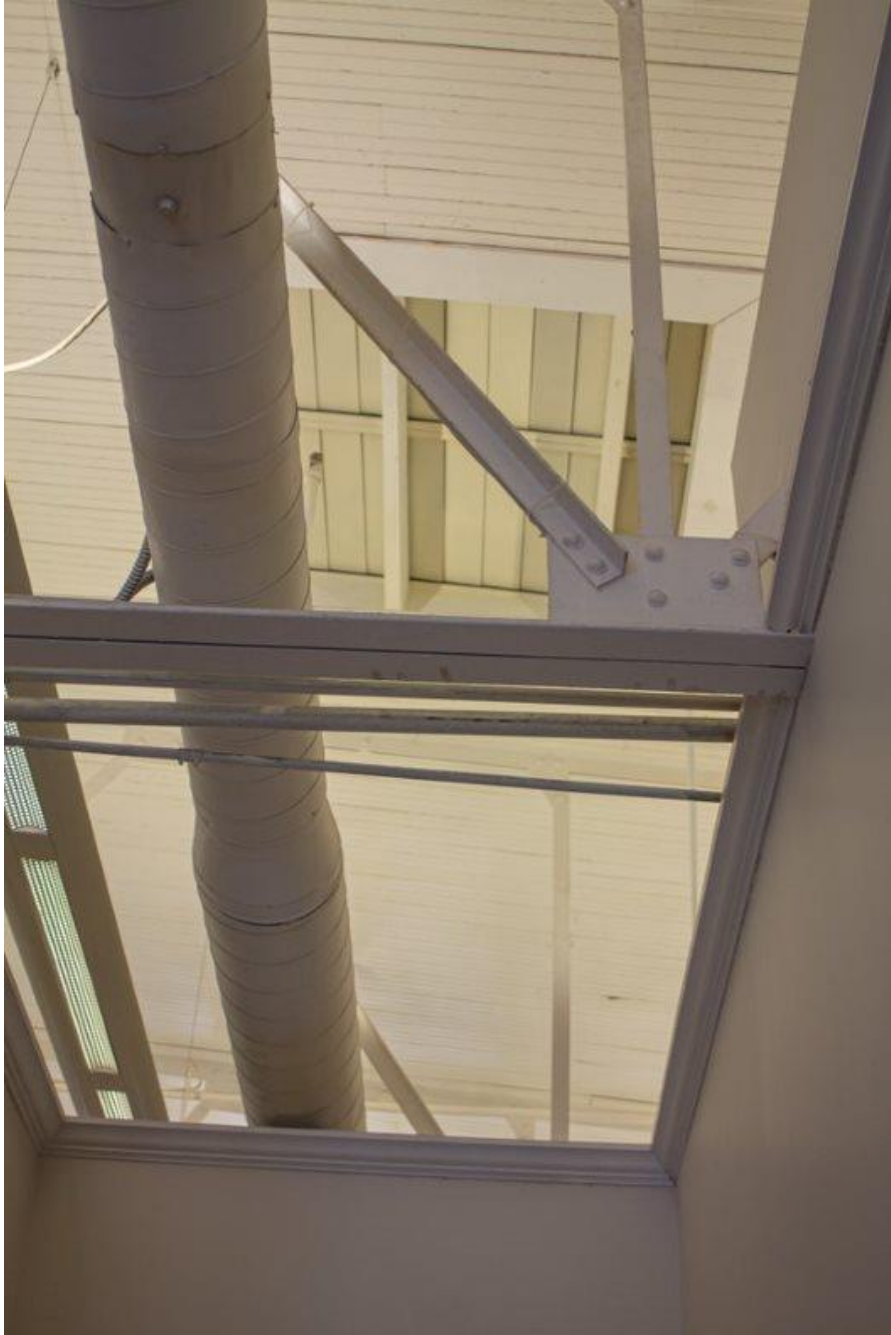
Photo 37 Third-story central office ceiling detail. Note steel bow truss configuration, exposed HVAC ductwork beadboard ceiling, roof scuttle, and ca.-1998 era sheetrock walls and trim.
