# D/DRC Case

1219 Assembly Street

National Register Structure, City Center Design/Development District

**DESIGN/DEVELOPMENT REVIEW COMMISSION**  
**DESIGN REVIEW DISTRICT**  
**CONSENT AGENDA**  
**EVALUATION SHEET**  
Case # 5

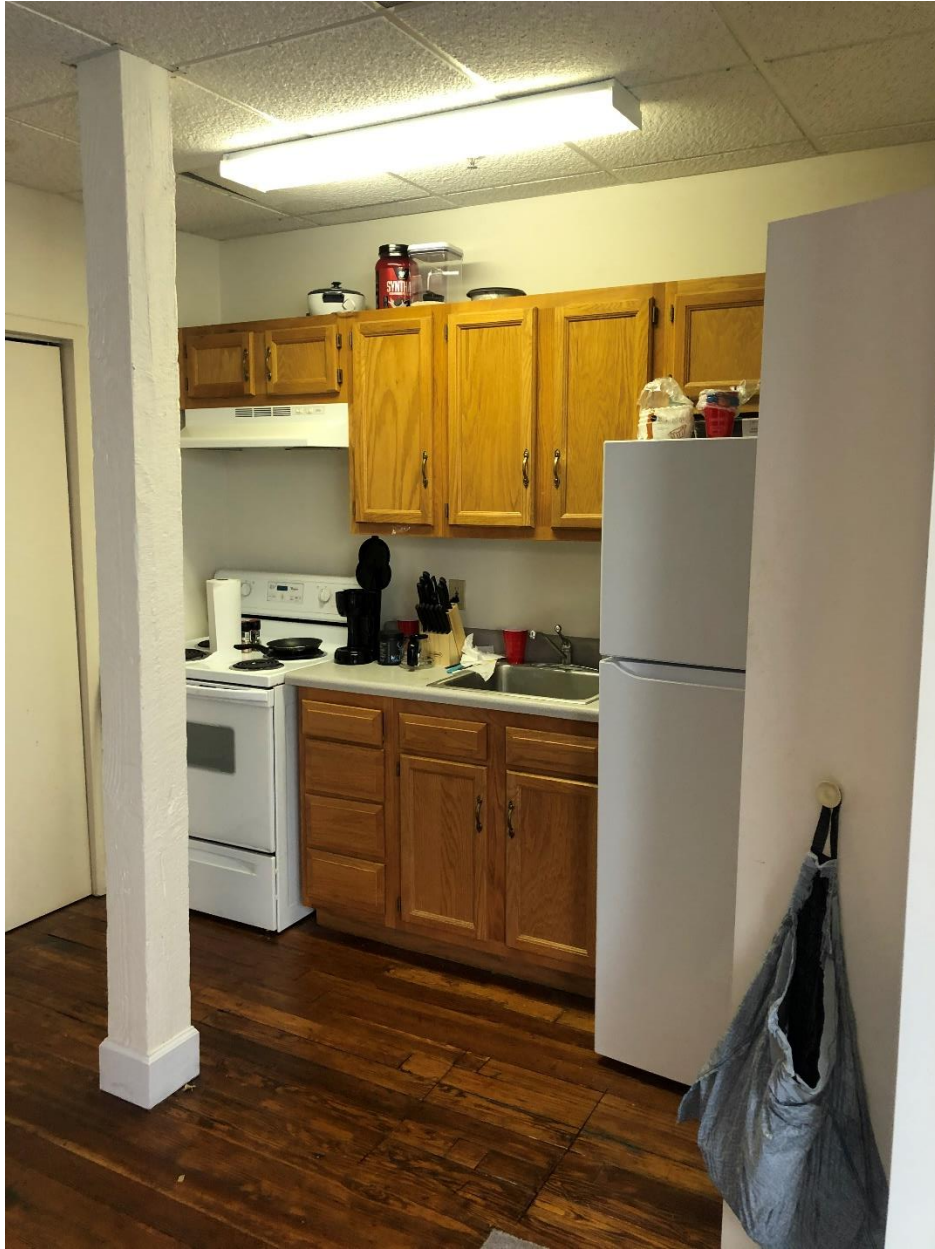
Photo 40 Southwest apartment detail. Note historic, rough-cut wood column.

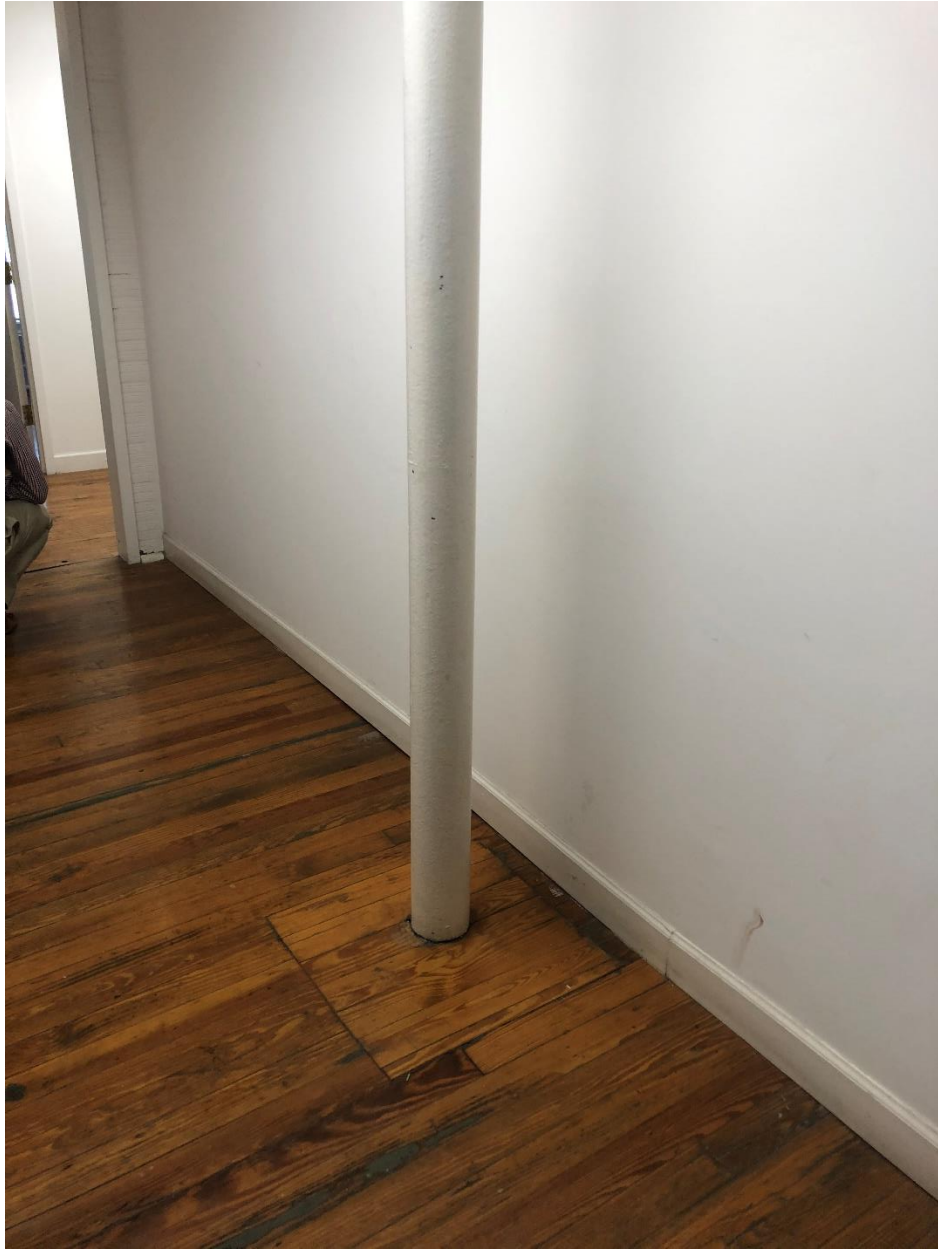
Photo 41 Southwest office detail. Note pipe column of unknown date.

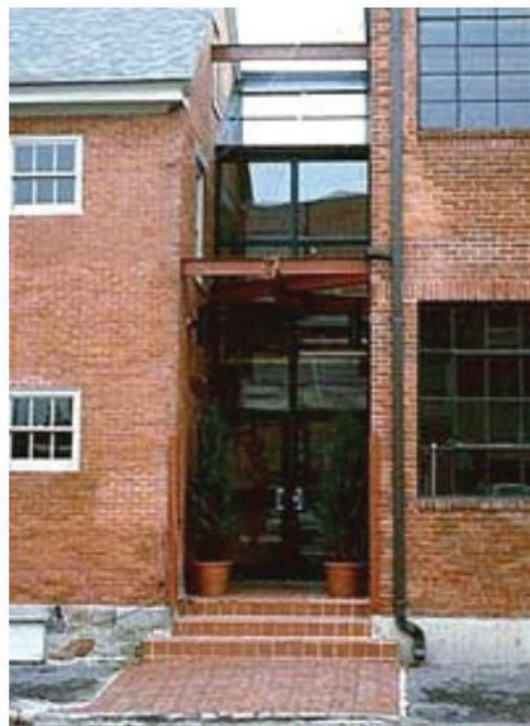
**Small glass connector between two historic buildings with appropriate setback.**

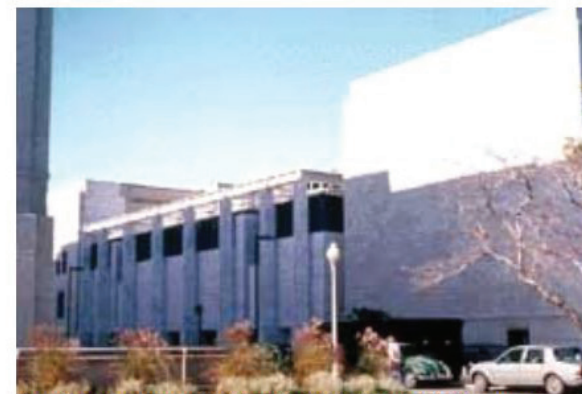
**Contemporary addition (left) to historic library appropriately placed on secondary side elevation.**

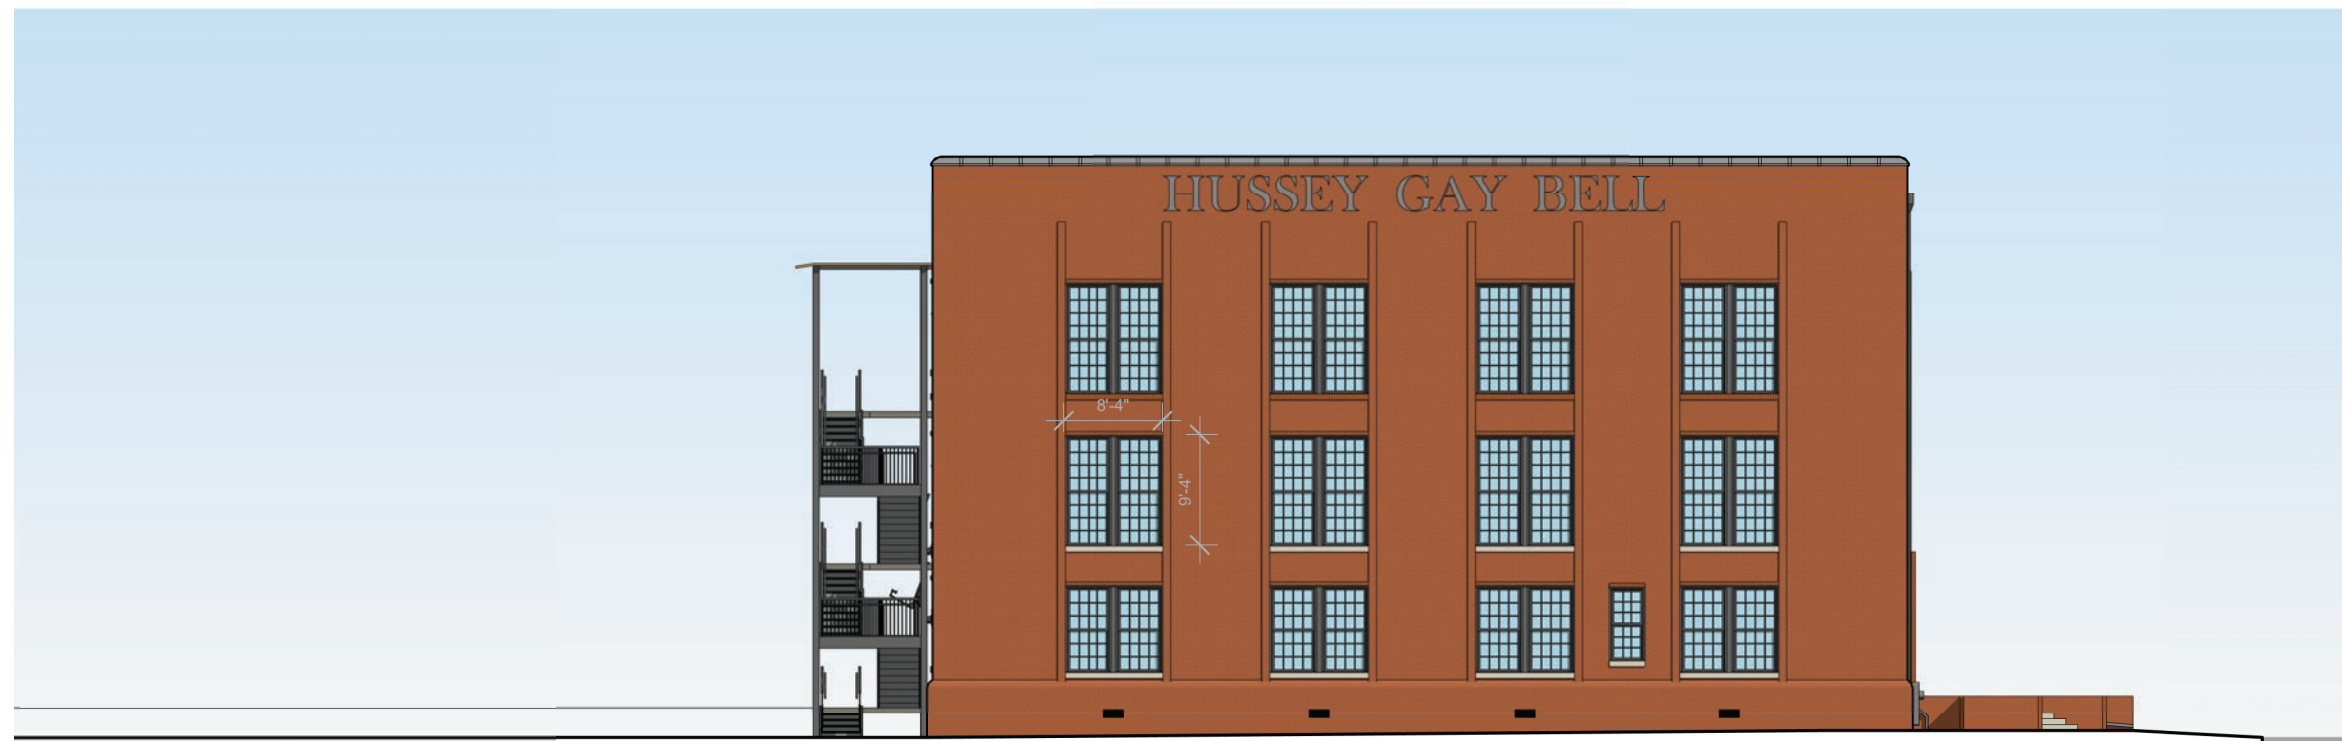
**EXISTING HISTORIC BUILDING  
{1905}**

FACADE MADE WITH  
MODULAR BRICK

PROJECTED BRICK  
DETAIL AT WINDOW  
JAMBS

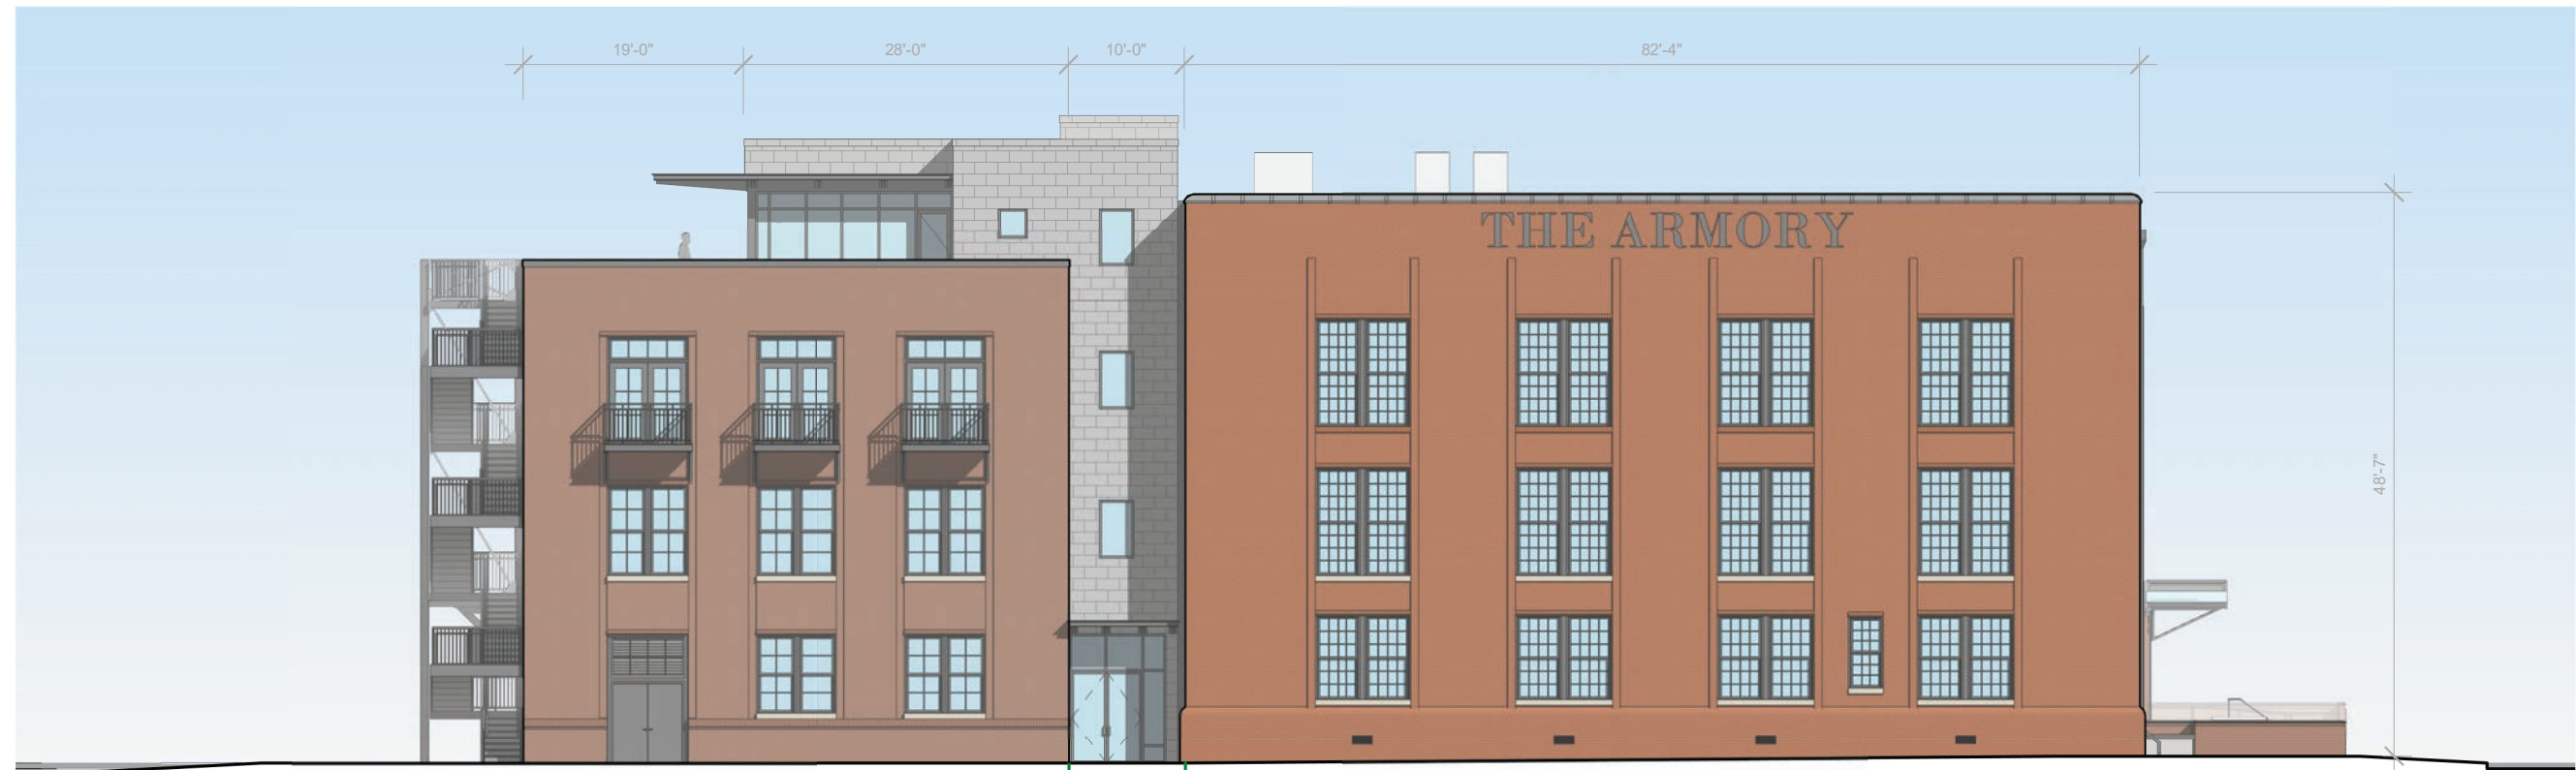
**NEW CONTEMPORARY BUILDING  
 {2021}**

FACADE MADE WITH  
 QUEEN BRICK

PROJECTED BRICK  
 DETAIL AT WINDOW  
 JAMBS

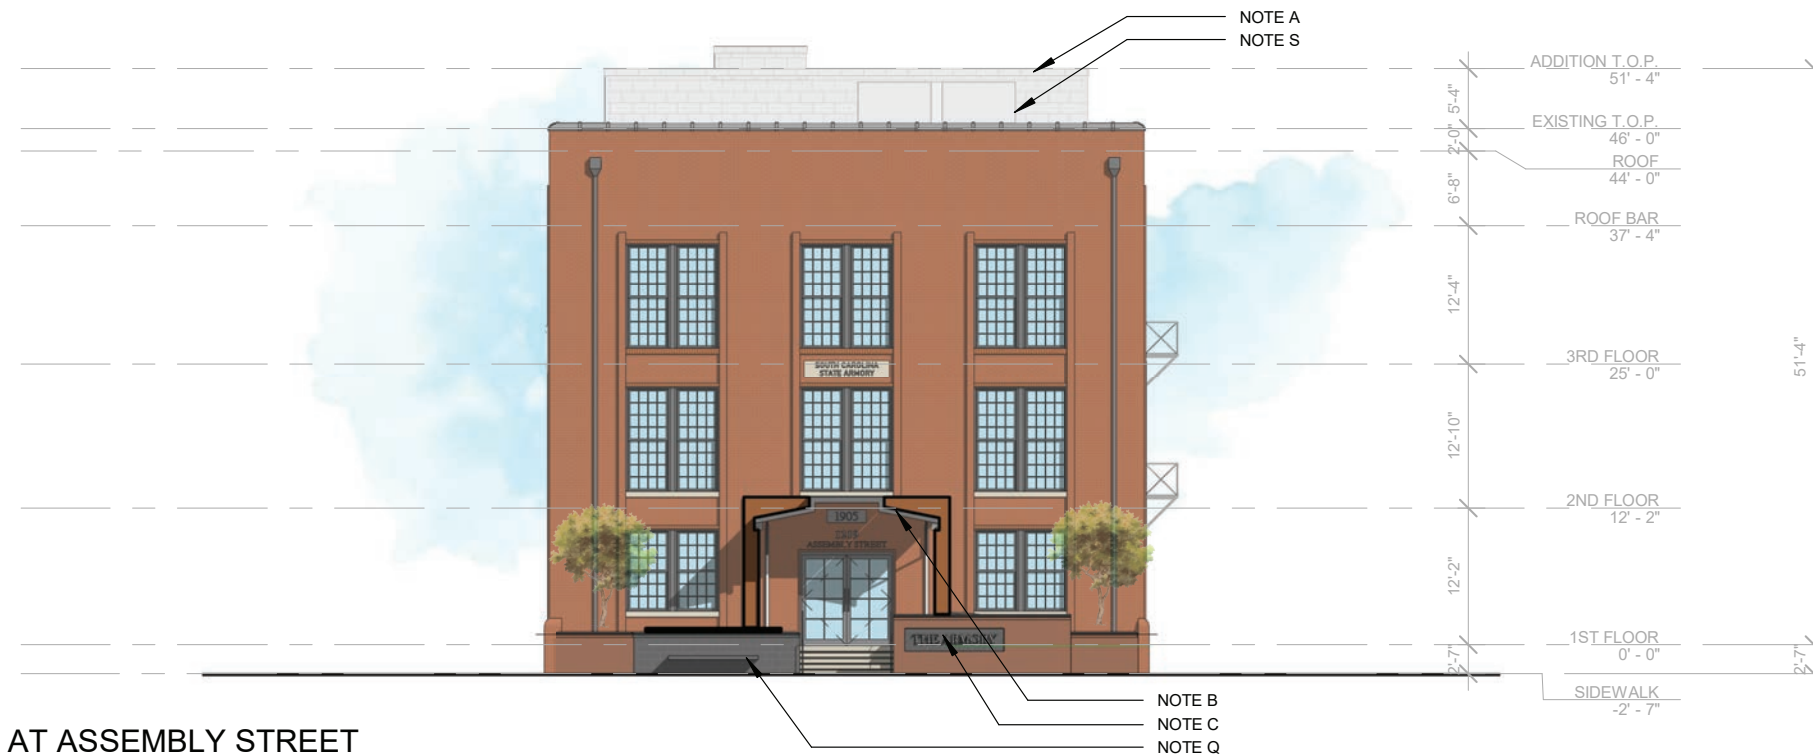
NEW EAST ELEVATION AT ASSEMBLY STREET

- N. ALUMINUM-CLAD WOOD FRENCH DOORS WITH TRANSOM WINDOW
- O. 8" BLACK RUBBER EXPANSION JOINT
- P. NEW WOOD DOUBLE HUNG WINDOW TO MATCH EXISTING HISTORIC WINDOWS.

- Q. SLATE SITE WALL AND CANTILEVERED BENCH
- R. JULIET BALCONY. PAINTED STEEL BRACKETS AND FASCIA. MILD STEEL RAILINGS.
- S. NEW MECHANICAL EQUIPMENT SET BACK FROM FACADE.

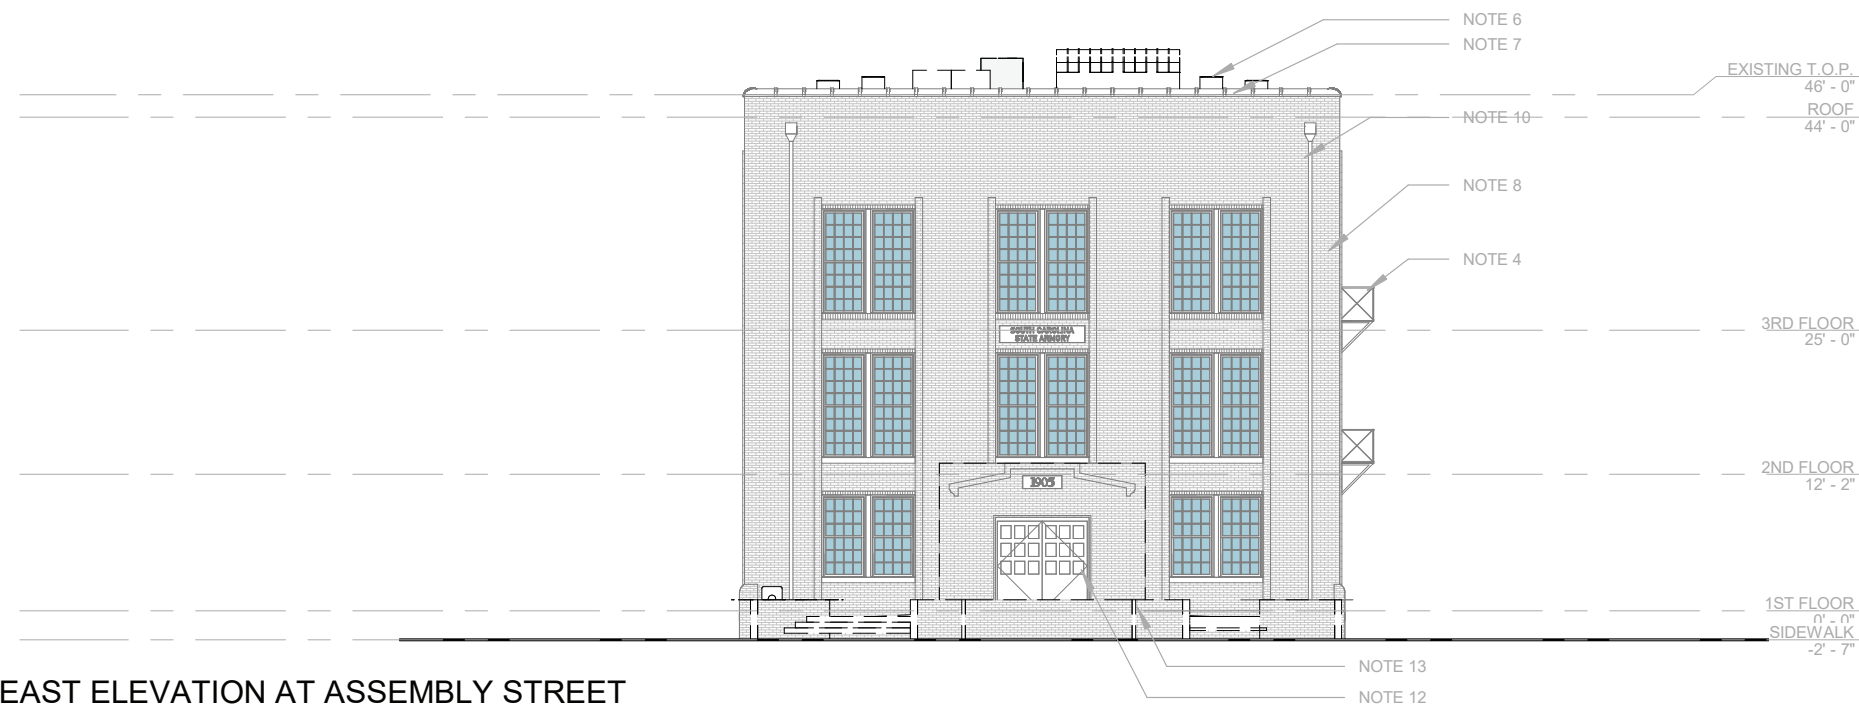
EXISTING EAST ELEVATION AT ASSEMBLY STREET

- 5. SATELLITE DISHES TO BE REMOVED. ANY DAMAGED BRICK TO BE REPLACED WITH SALVAGED MATERIAL.
- 6. MECHANICAL UNITS TO BE REMOVED.
- 7. TERRACOTTA COPING TO REMAIN. IF ANY TILES ARE DAMAGED DURING RENOVATION, THEN THEY ARE TO BE REPLACED IN KIND.

- 11. ALL CRAWL SPACE VENTS TO BE REPLACED IN KIND.
- 12. EXTERIOR FRONT ENTRANCE DOOR TO BE REMOVED AND PREPPED FOR REPLACEMENT DOOR.
- 13. EXTERIOR STAIR, RAMP AND SITE WALLS TO BE REMOVED.

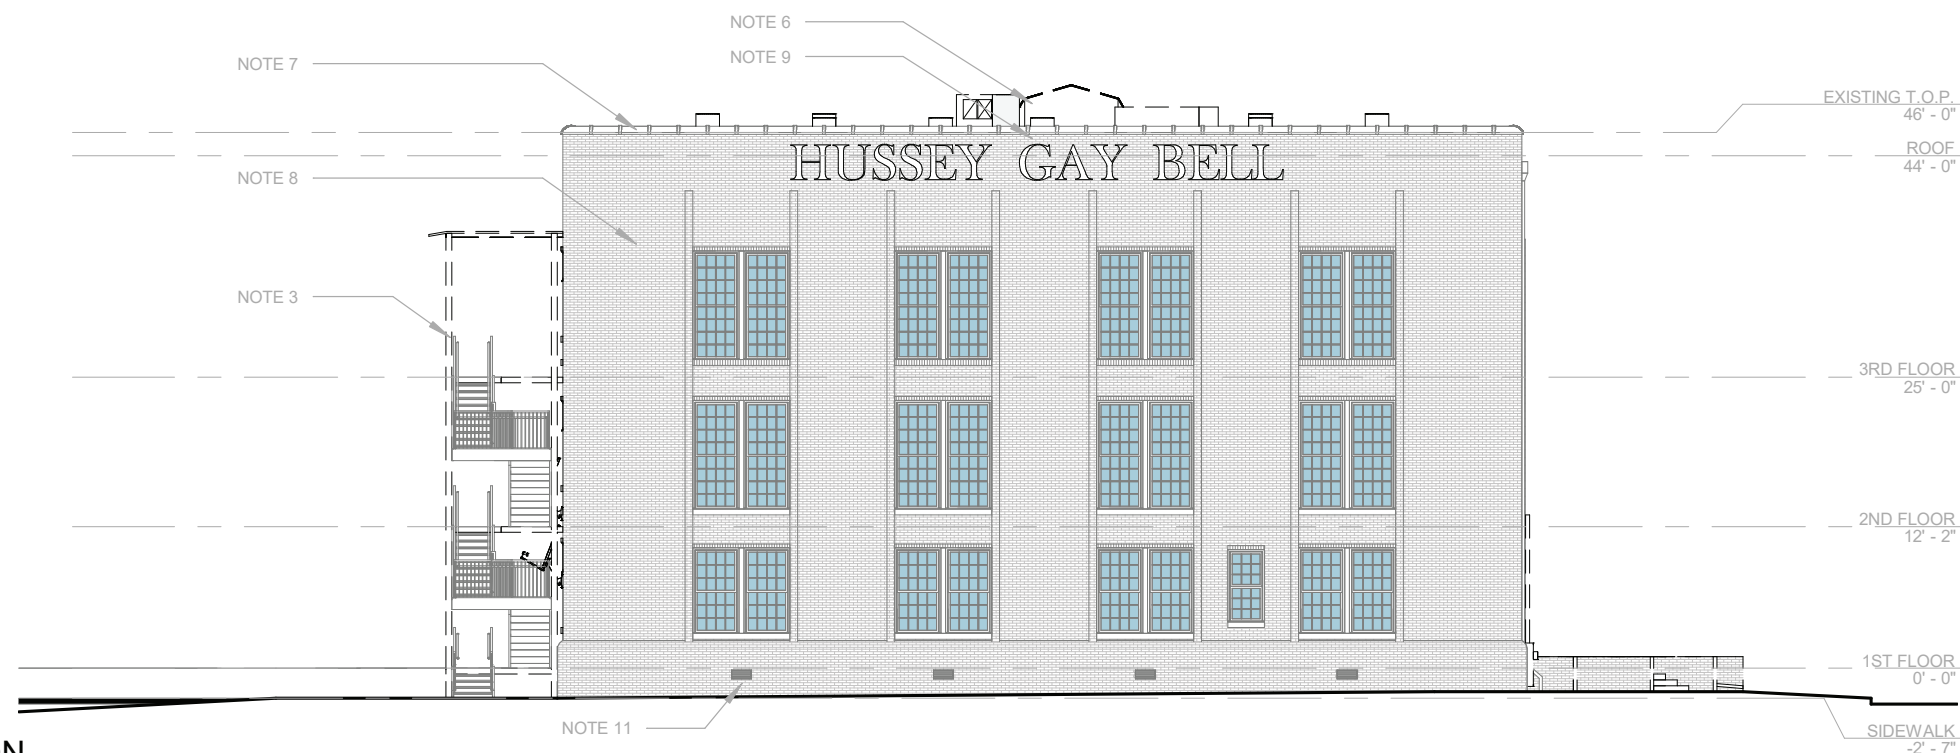
EXISTING SOUTH ELEVATION

- 5. SATELLITE DISHES TO BE REMOVED. ANY DAMAGED BRICK TO BE REPLACED WITH SALVAGED MATERIAL.
- 6. MECHANICAL UNITS TO BE REMOVED.
- 7. TERRACOTTA COPING TO REMAIN. IF ANY TILES ARE DAMAGED DURING RENOVATION, THEN THEY ARE TO BE REPLACED IN KIND.

- 10. ALL CRAWL SPACE VENTS TO BE REPLACED IN KIND.
- 11. EXTERIOR FRONT ENTRANCE DOOR TO BE REMOVED AND PREPPED FOR REPLACEMENT DOOR.
- 12. EXTERIOR STAIR, RAMP AND SITE WALLS TO BE REMOVED.

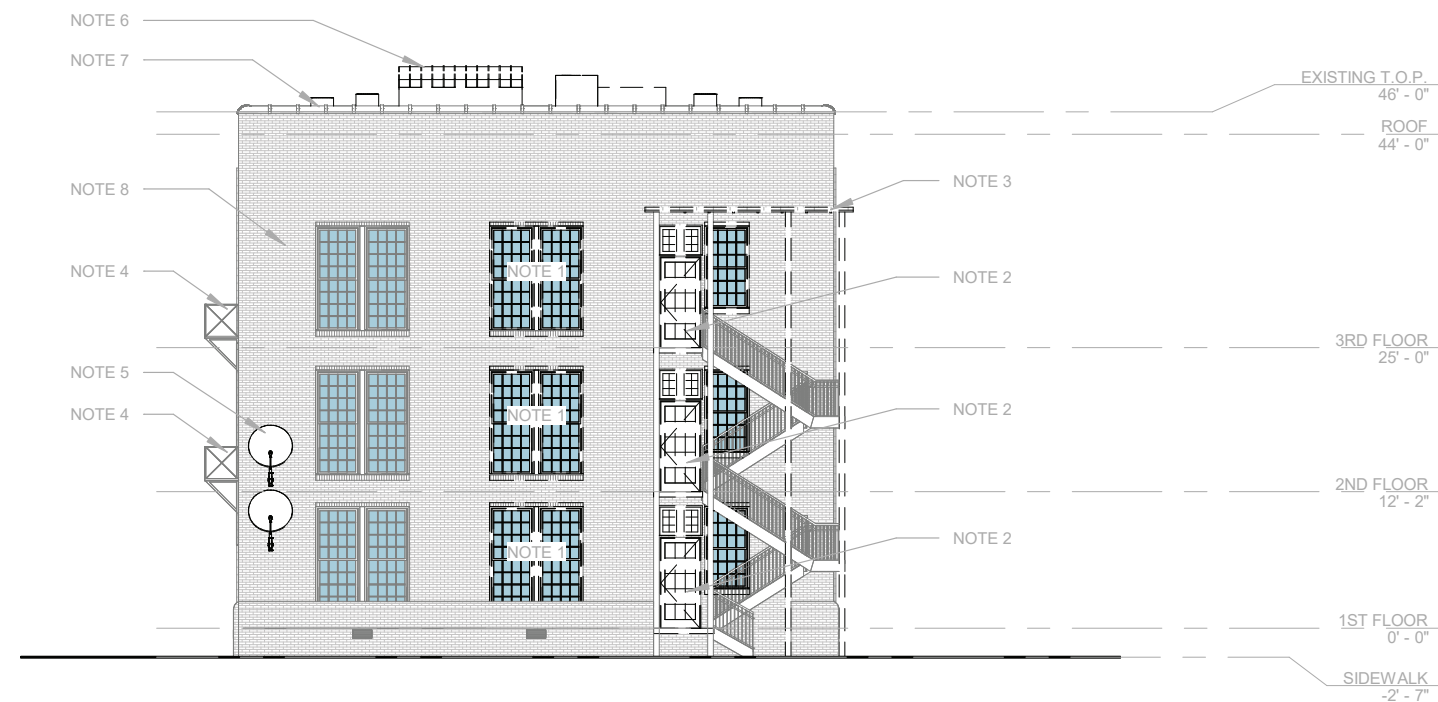
EXISTING WEST ELEVATION

- 5. SATELLITE DISHES TO BE REMOVED. ANY DAMAGED BRICK TO BE REPLACED WITH SALVAGED MATERIAL.
- 6. MECHANICAL UNITS TO BE REMOVED.
- 7. TERRACOTTA COPING TO REMAIN. IF ANY TILES ARE DAMAGED DURING RENOVATION, THEN THEY ARE TO BE REPLACED IN KIND.

- 11. ALL CRAWL SPACE VENTS TO BE REPLACED IN KIND.
- 12. EXTERIOR FRONT ENTRANCE DOOR TO BE REMOVED AND PREPPED FOR REPLACEMENT DOOR.
- 13. EXTERIOR STAIR, RAMP AND SITE WALLS TO BE REMOVED.

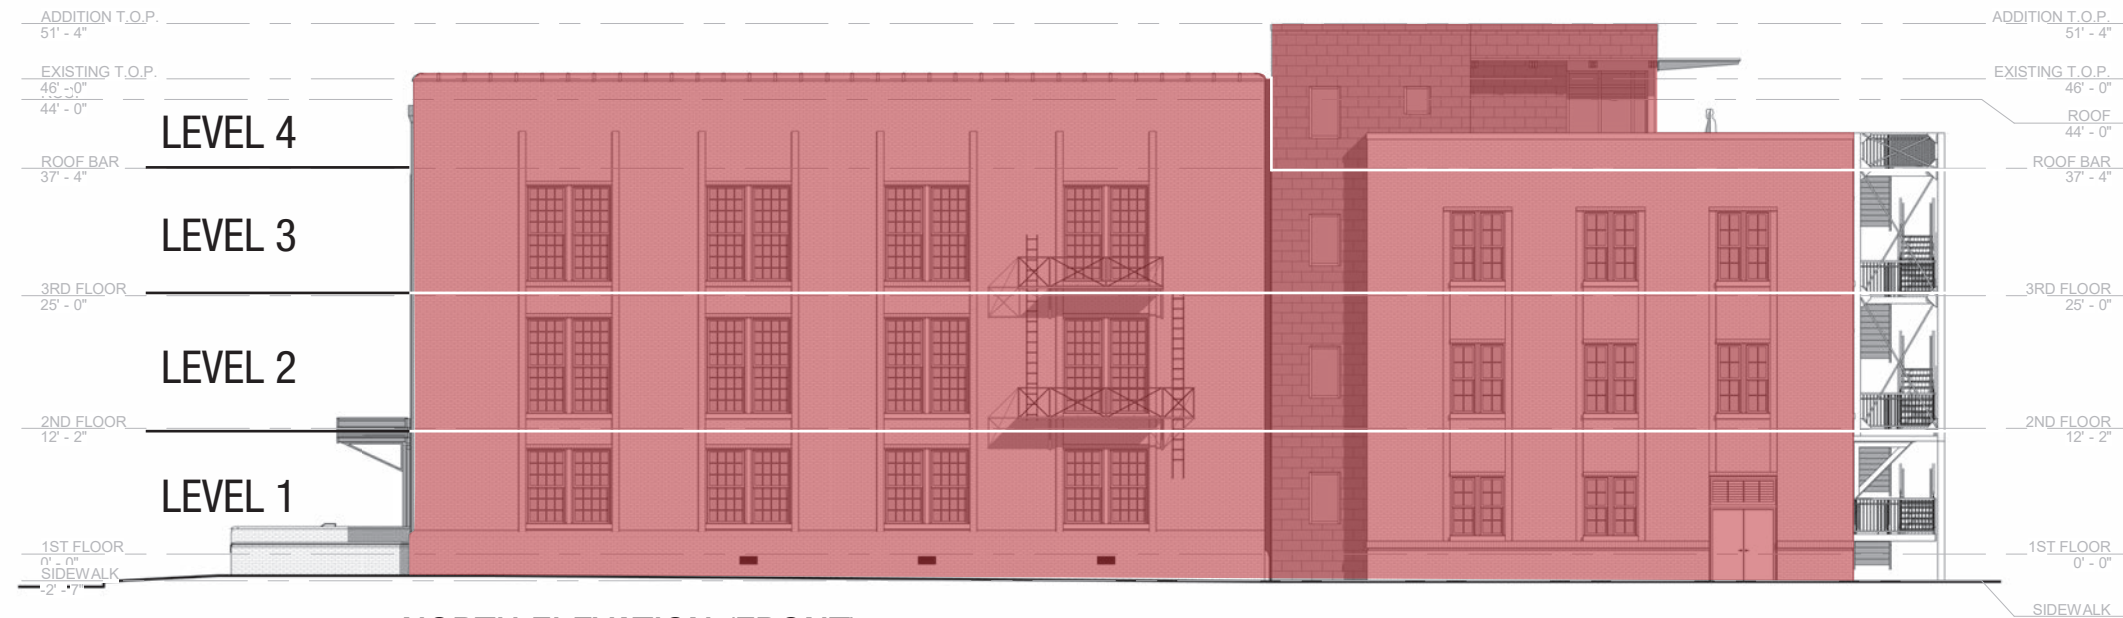
NORTH ELEVATION (FRONT)

| Level 4: | 16% |

**North Elevation**  
Not to Scale

Due to proximity to the North property line, we are limited on glazing percentages

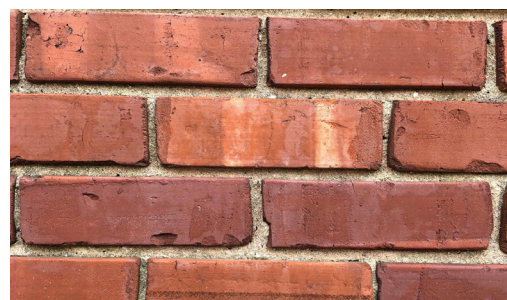
1. Existing Brick

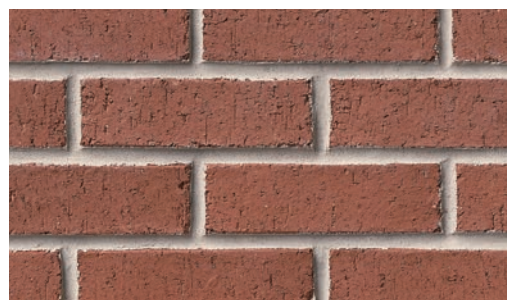
2. New Brick: Red Wirecut (Queen Size)

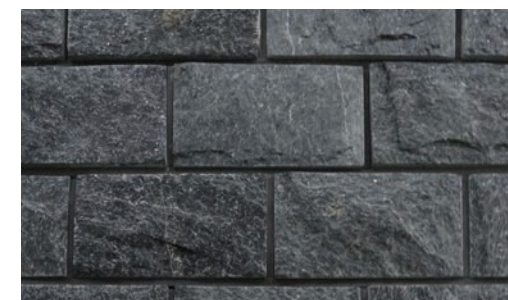
4. Slate Slab

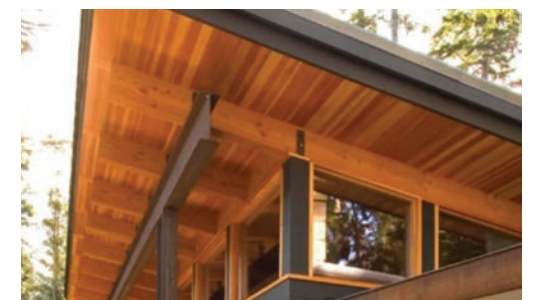
5. Stained Wood Soffit

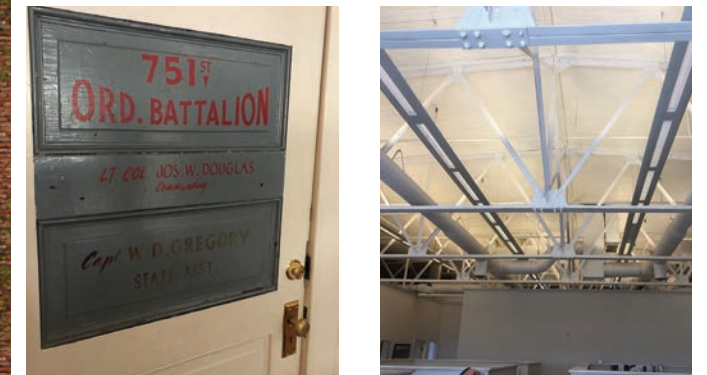
### RESTORING HISTORIC DETAIL

- (A) Preserve existing Battalion sign on five panel door.
- (B) Restore 3rd floor metal roof trusses
- (C) Existing Wood Windows to Remain: Paint to Match Zinc
