# D/DRC Case

100 Huger Street

**Granby Architectural Conservation District**

**DESIGN/DEVELOPMENT REVIEW COMMISSION**  
**DESIGN REVIEW DISTRICT**  
**CONSENT AGENDA**  
**EVALUATION SHEET**  
Case #7

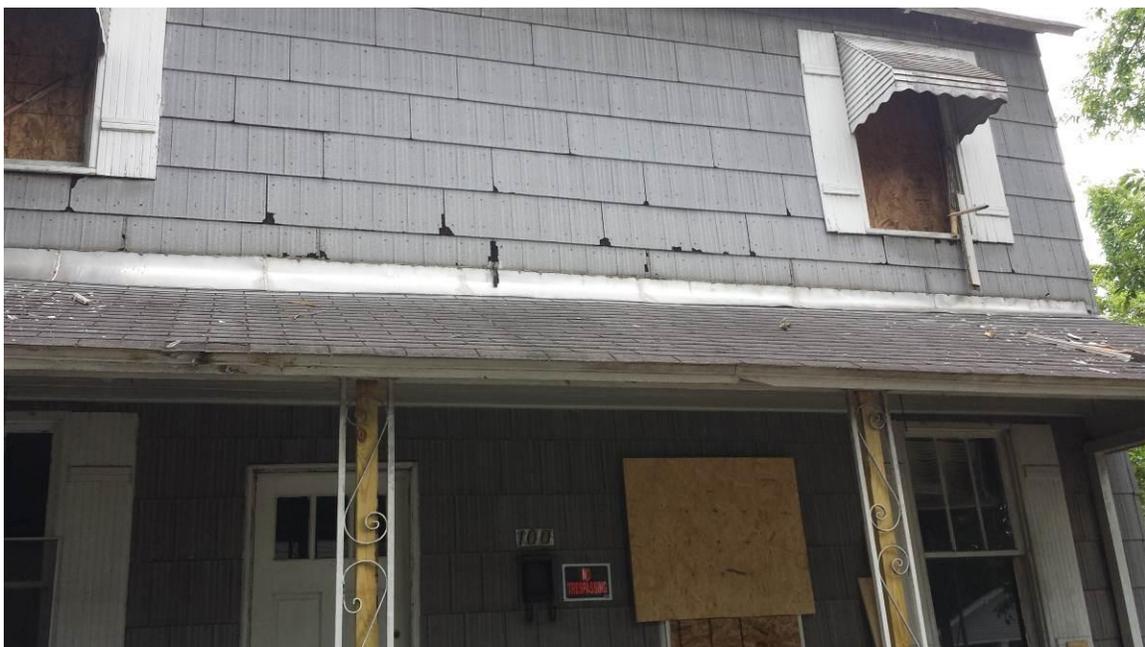
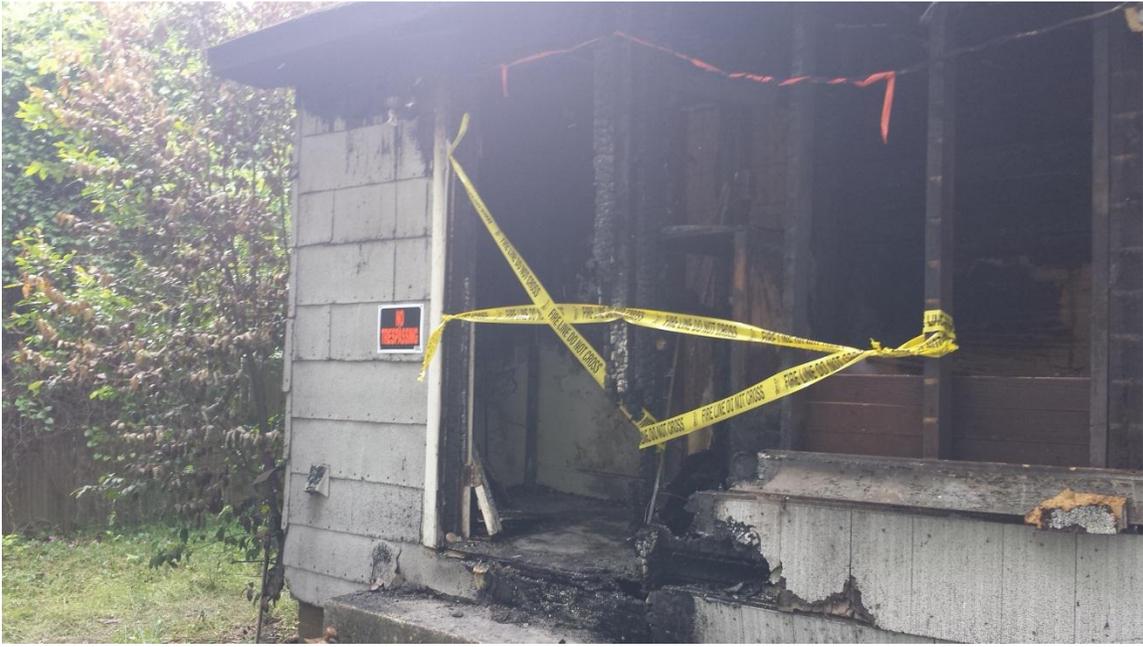
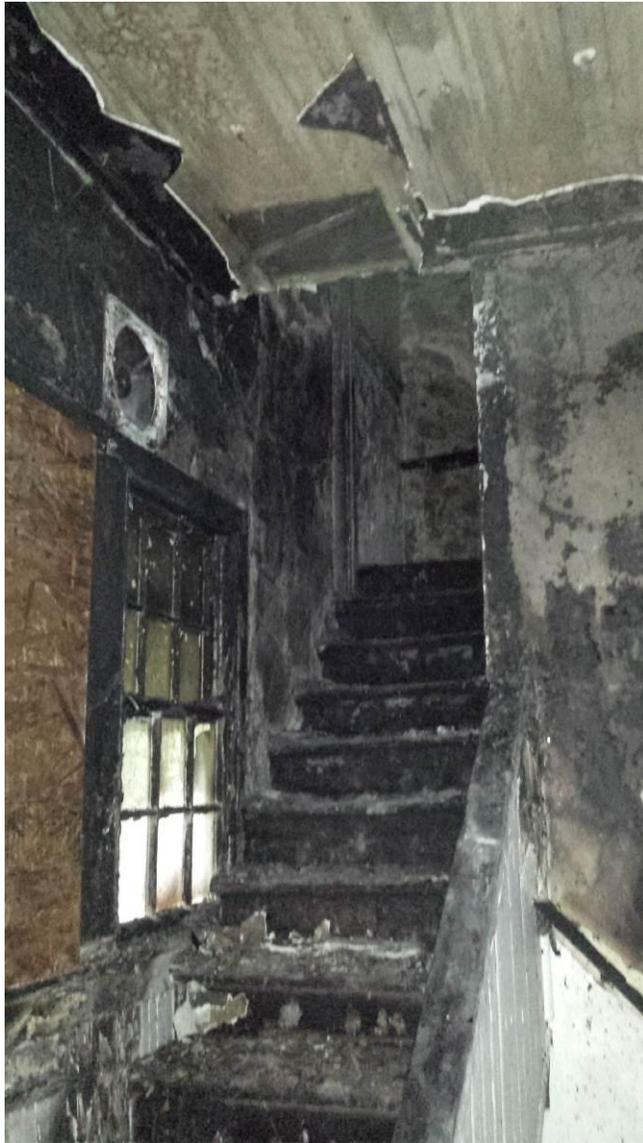
100 Huger Street – Existing Conditions

The Granby Mill Village Historic District was listed in the National Register of Historic Places in 1993, and the neighborhood became a locally designated Architectural Conservation District in 2010. The building located at 100 Huger Street is a contributing structure in both districts. The owner intends to rehabilitate the home, after a fire largely gutted the structure. The building has asphalt siding applied over original wood siding.

The home currently has asphalt siding over wood clapboards. Due to the fire, the applicant is proposing cement fiberboard siding on the rear and right side of the structure.

The current porch supports are non-historic metal.

A fire engulfed the structure making the windows not repairable. The applicant would like to replace all of the existing historic wood windows with wood windows matching the existing profile. An alternative would be a 6/6 pattern to better match the original windows as the existing 3/1 pattern was likely a c.1930s replacement. Muntin widths should be 5/8 inch to match historic profiles.

The new windows will be wood and match the existing in all detailing, or match what would have been original to the house, which is a 6/6 pattern.

Cement fiberboard is proposed to replace asphalt siding where fire/water damage is present.

New supports and a balustrade will be installed out of wood and will be compatible with the structure.
