## D/DRC Case

3848 Wilmot Avenue

**DESIGN/DEVELOPMENT REVIEW COMMISSION**  
**DESIGN REVIEW DISTRICT**  
**HISTORIC AGENDA**  
**EVALUATION SHEET**  
Case # 6

**NATURE OF REQUEST:** Request Certificate of Design Approval for demolition

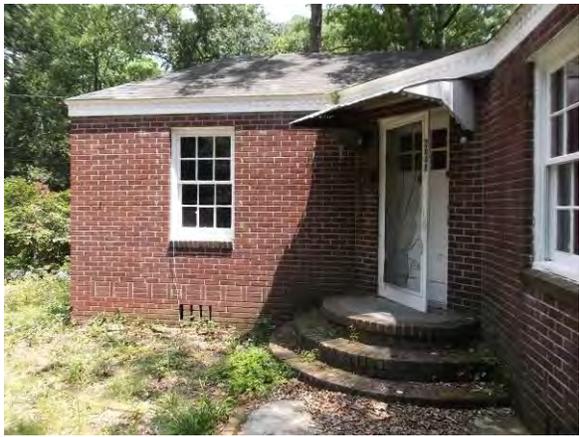
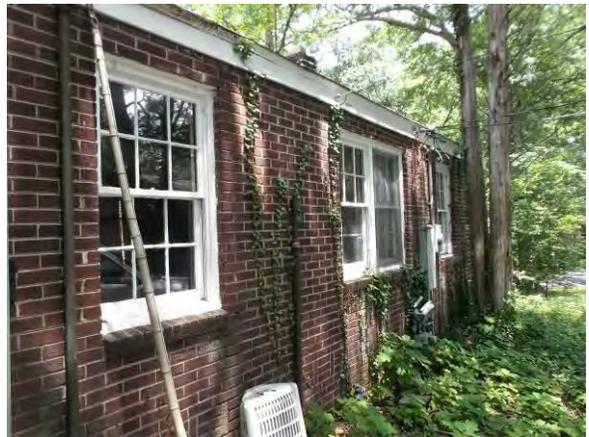
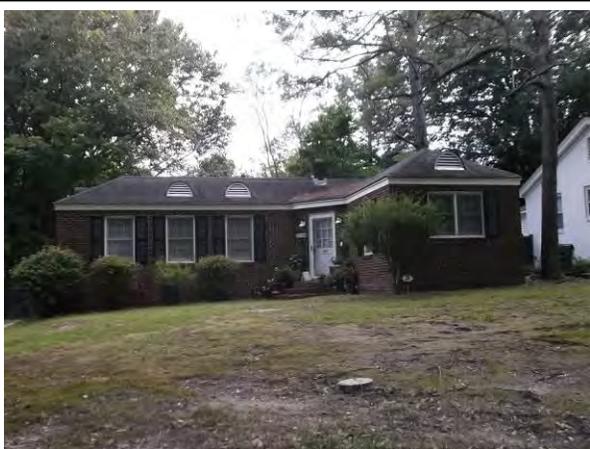
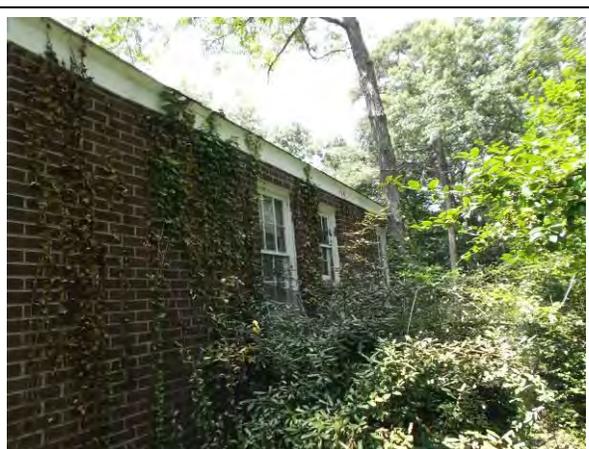
Staff was able to make a visit to this building and noted the condition at that time. The overall impression was that the house was sound, and staff noted no weak areas while walking in the kitchen, living room or bedrooms, but did not walk in the bathroom, where it was noted that there is some water damage to the ceilings and walls. There are a few minor areas of peeling paint on a few walls, a hole in a bedroom wall that appears to have been made to access plumbing, and a number of the wood windows showed signs of deterioration and some mold, including some of their sills. The hardwood floors appear generally intact and a majority of the building shows some signs of normal wear and tear. The outside has had vines grow up on the walls as high as the roofline.

Lack of maintenance on exterior of 3848 Wilmot Avenue

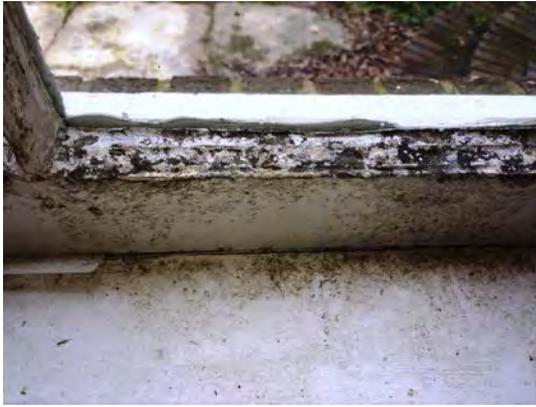
that they can clean the plaster walls but not the wood windows and trim. In truth, the mold apparent on the windows and trim can likely be cleaned off. Mold cannot penetrate sound wood and cannot grow on plaster, which means it is likely growing on the surface of the paint and the wallpaper; these are things that can be cleaned or removed by a homeowner following basic safety principles for dealing with mold. The mold present in this building is likely due to several factors: the water damage in the bathroom, the lack of residents in the building and the lack of an operating air conditioning/heating system, which aids in reducing moisture in a building.

**Fungal Growth on Windows and Trim**

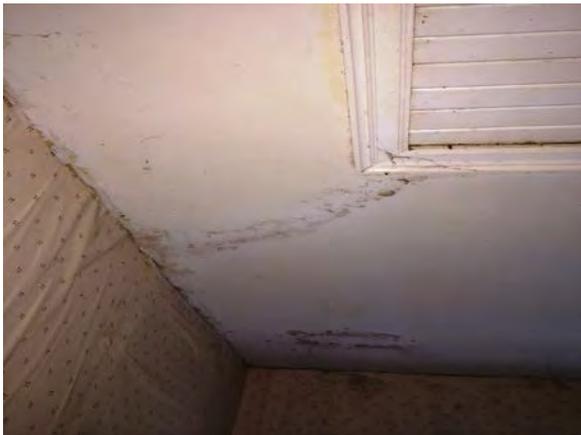
**Fungal Growth on Walls**
